**NORFOLK SOUTHERN
RAILWAY CO.
SHENANDOAH VALLEY RAIL
CORRIDOR
BRIDGE EVALUATION**

**STRASBURG, VIRGINIA
SHENANDOAH COUNTY**

**NORTHERN SHENANDOAH VALLEY
TRANSPORTATION PRESERVATION CORP.**

PROJECT NO. 23-1502.101
August 25, 2023
Revised August 31, 2023

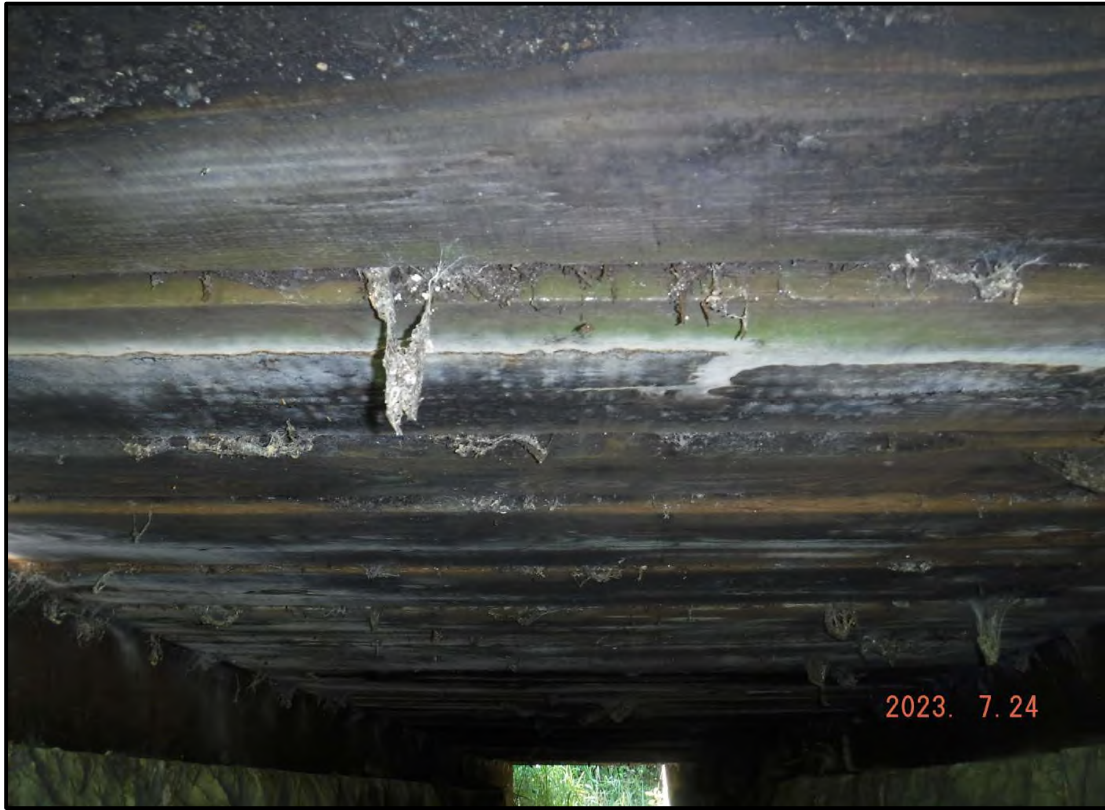
Photo 3: Typical Condition of Timber Slab

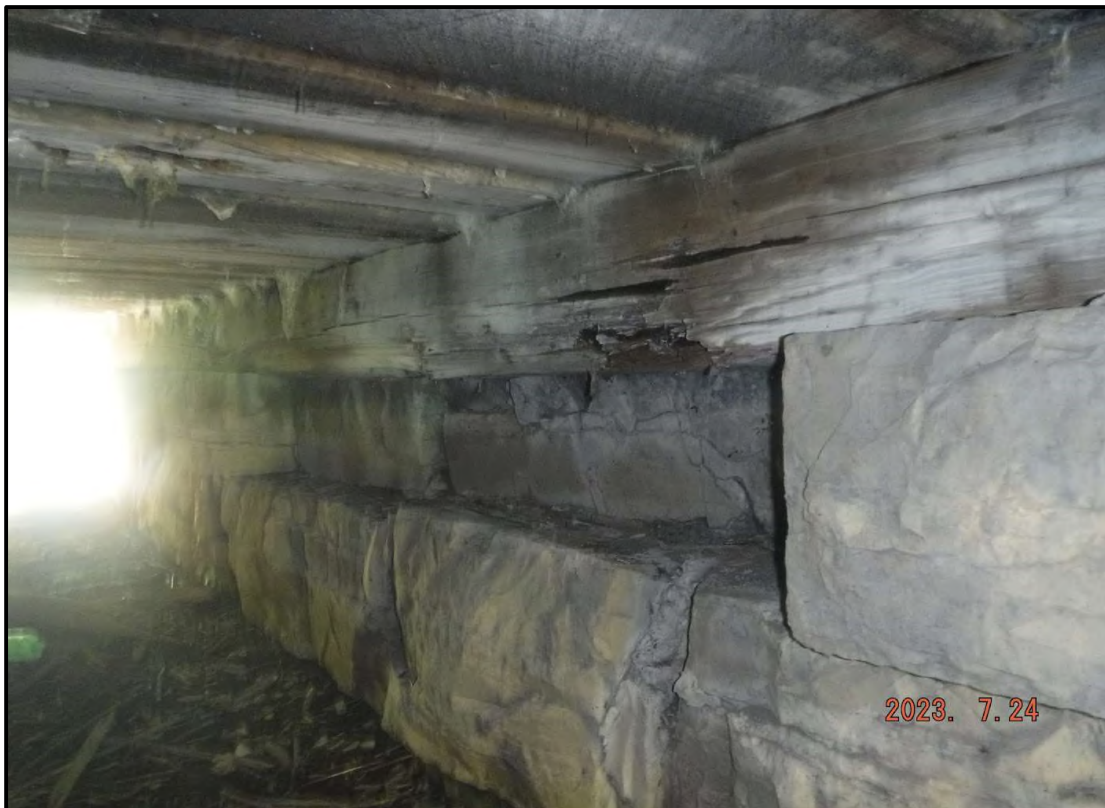
Photo 4: Spalled/Broken Stones At South End of West Abutment

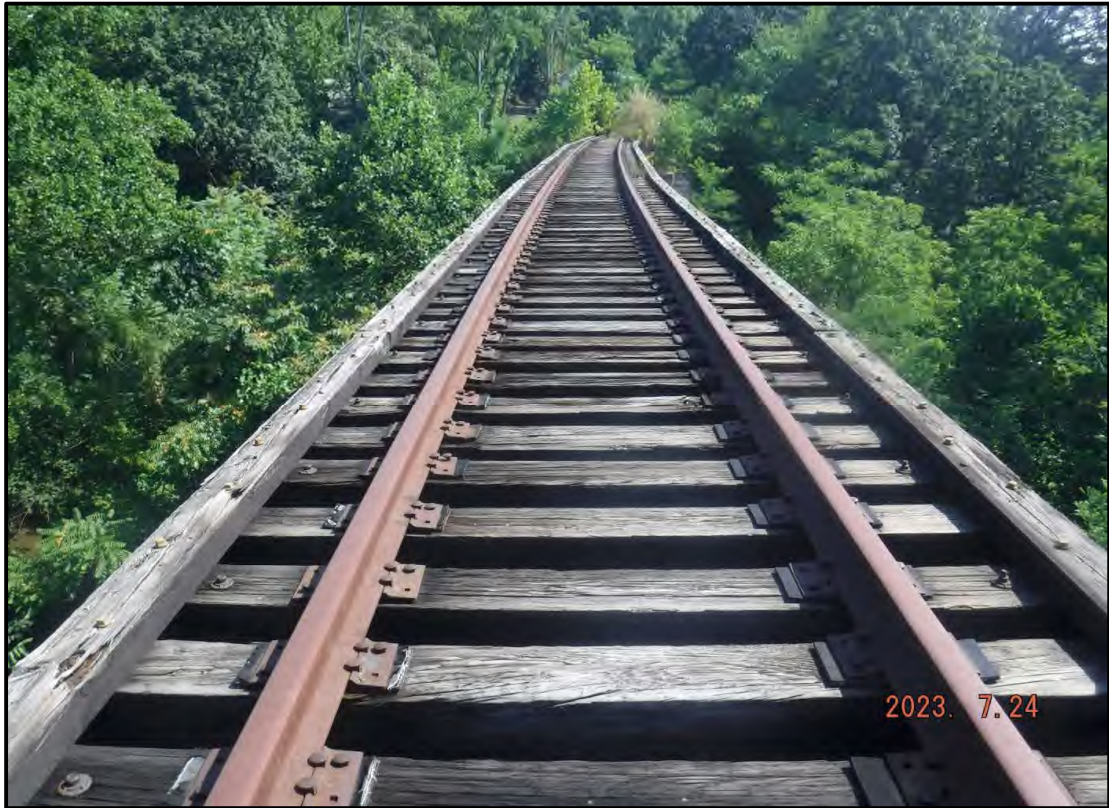
Photo 1: General Condition of Timber Tie Deck

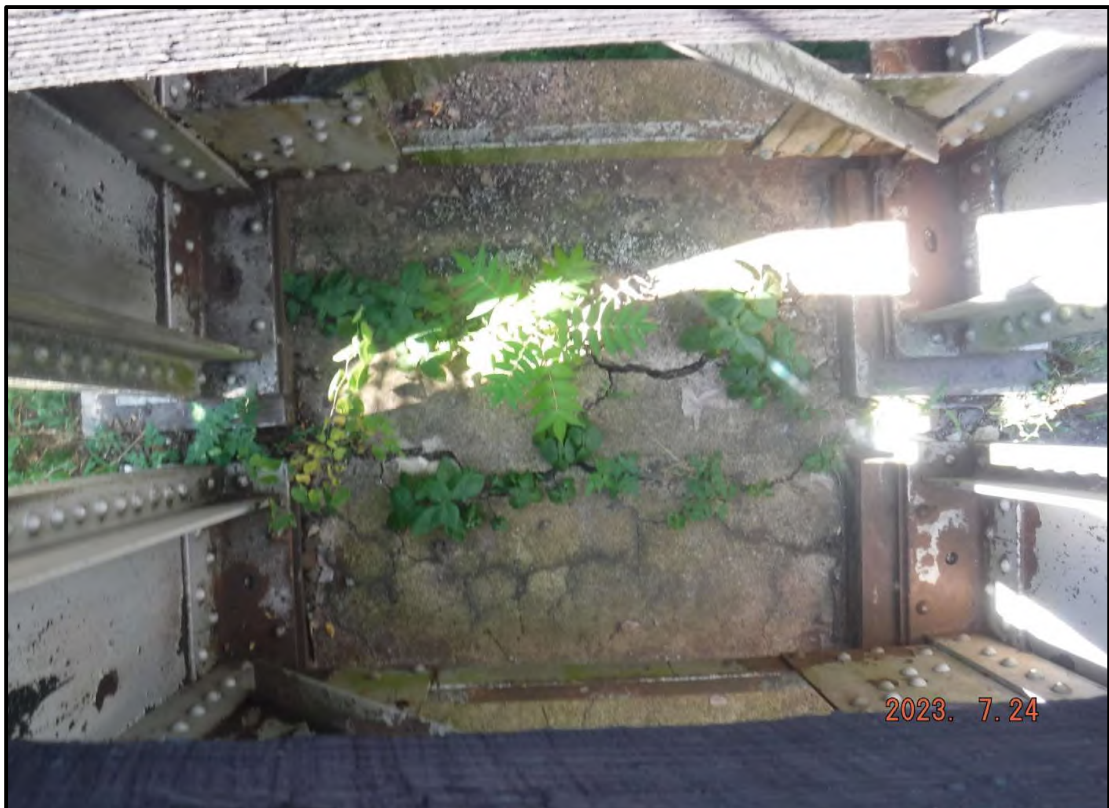
Photo 2: Pier 3 Bridge Seat With Wide Cracks

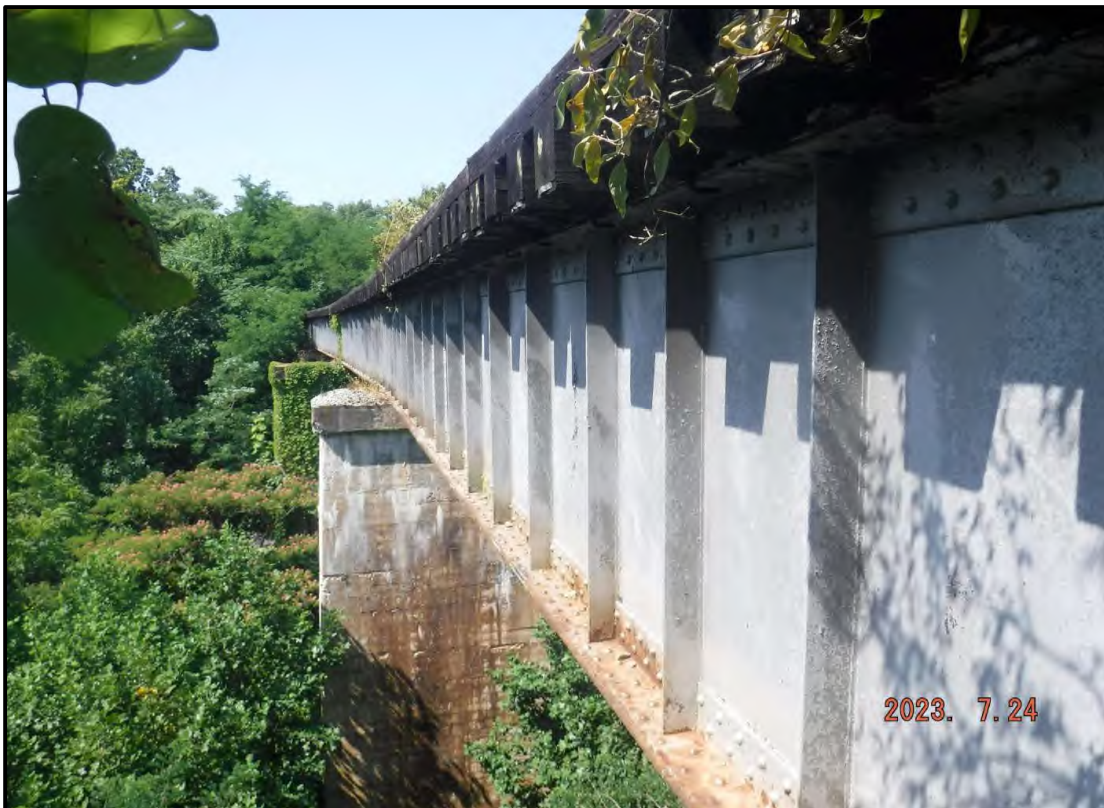
Photo 6: Typical Condition of Girders (From SE looking West)

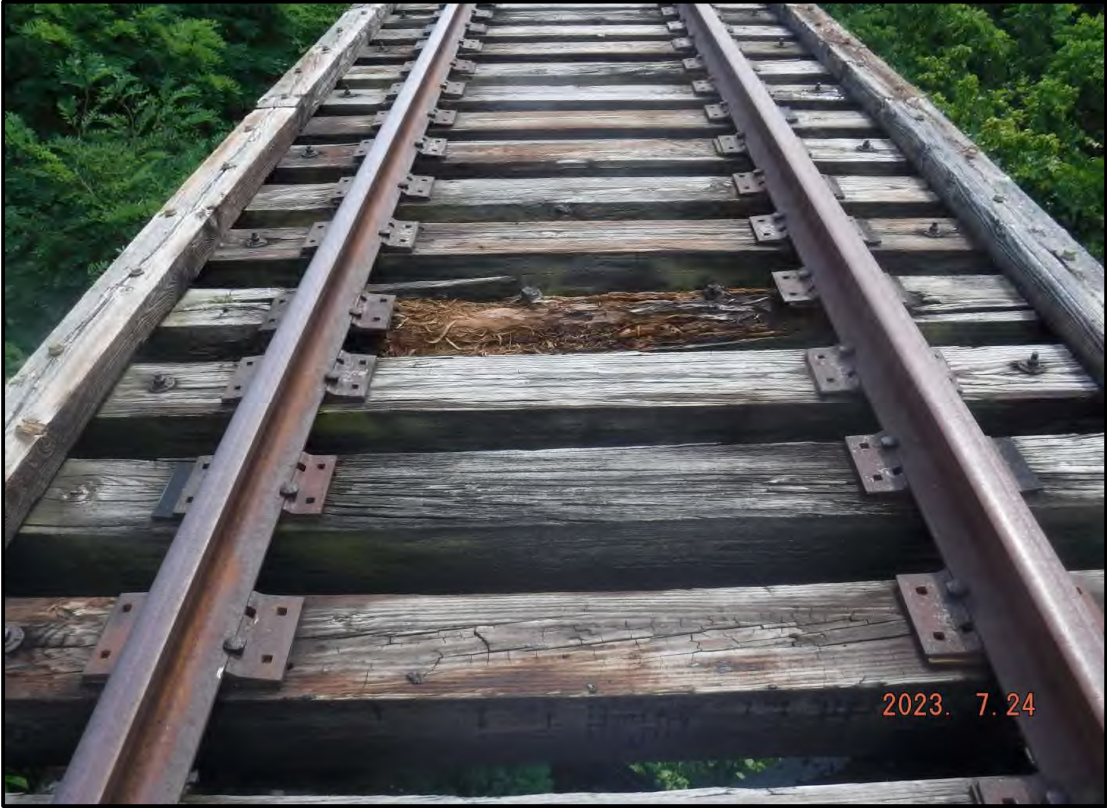
Photo 1: General Condition of Timber Tie Deck

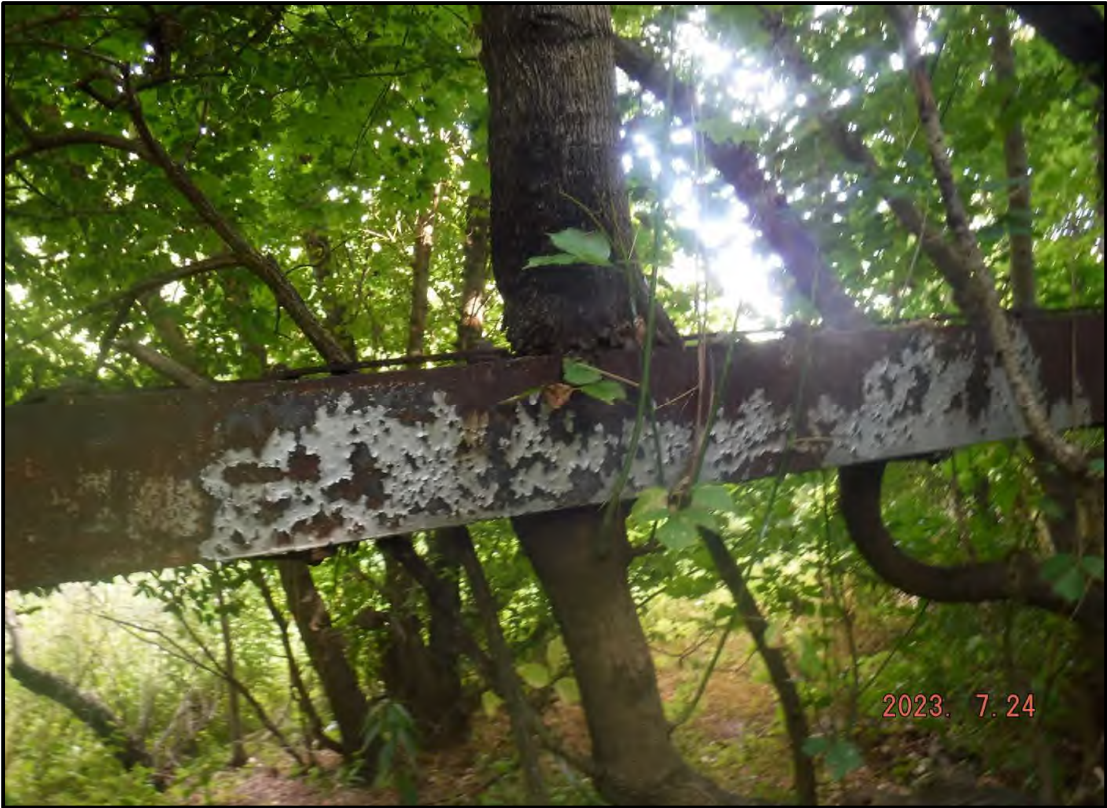
Photo 2: Vegetation Growth in Steel Bent Tower Bracing

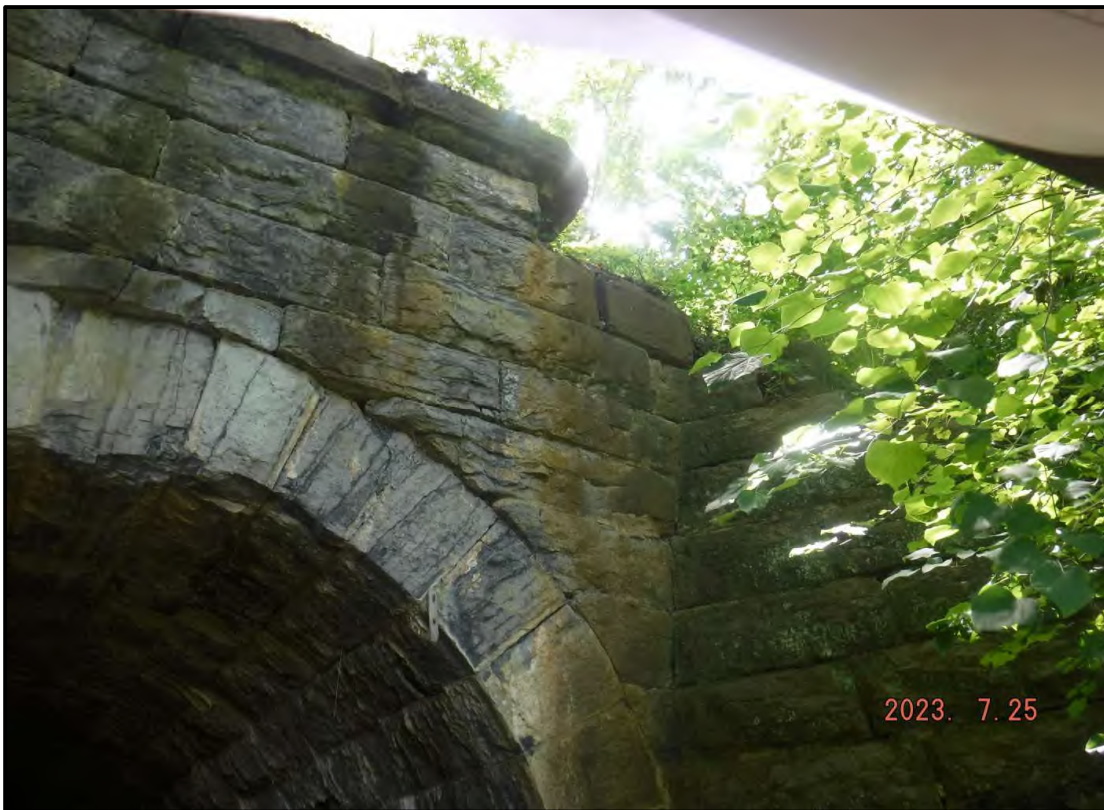
Photo 2: Missing Stones West End of North Headwall

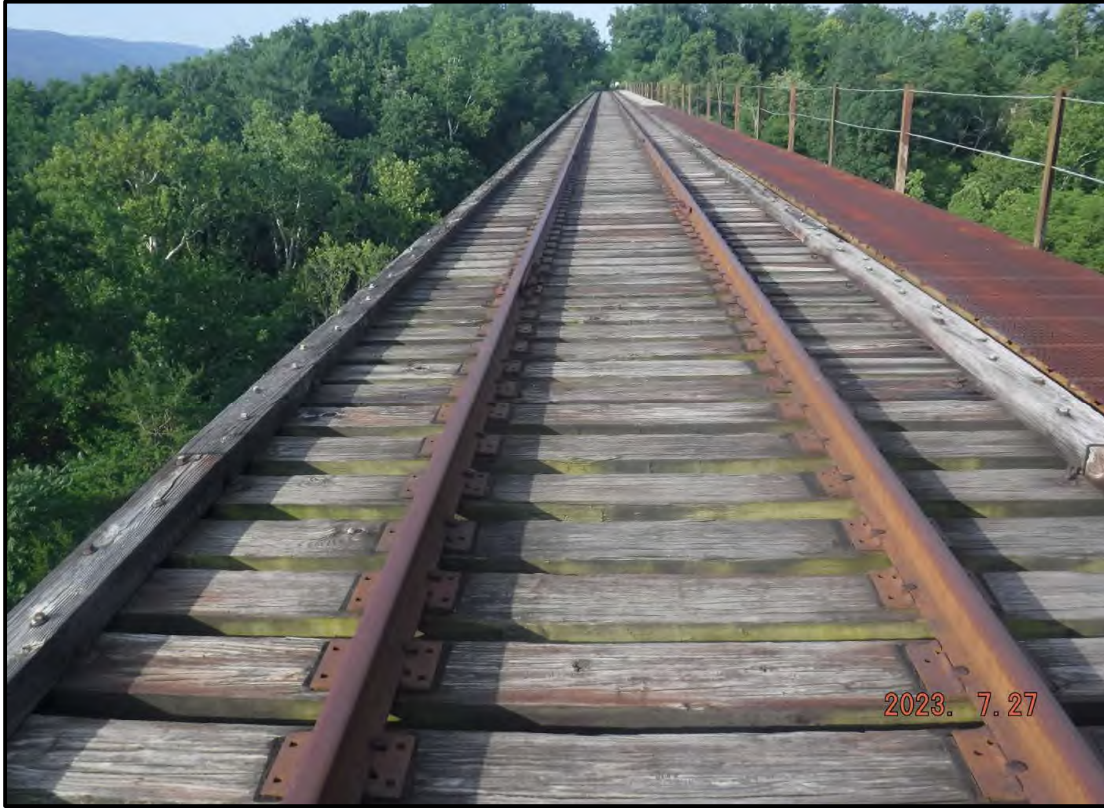
Photo 1: General Condition of Deck (Main Spans)

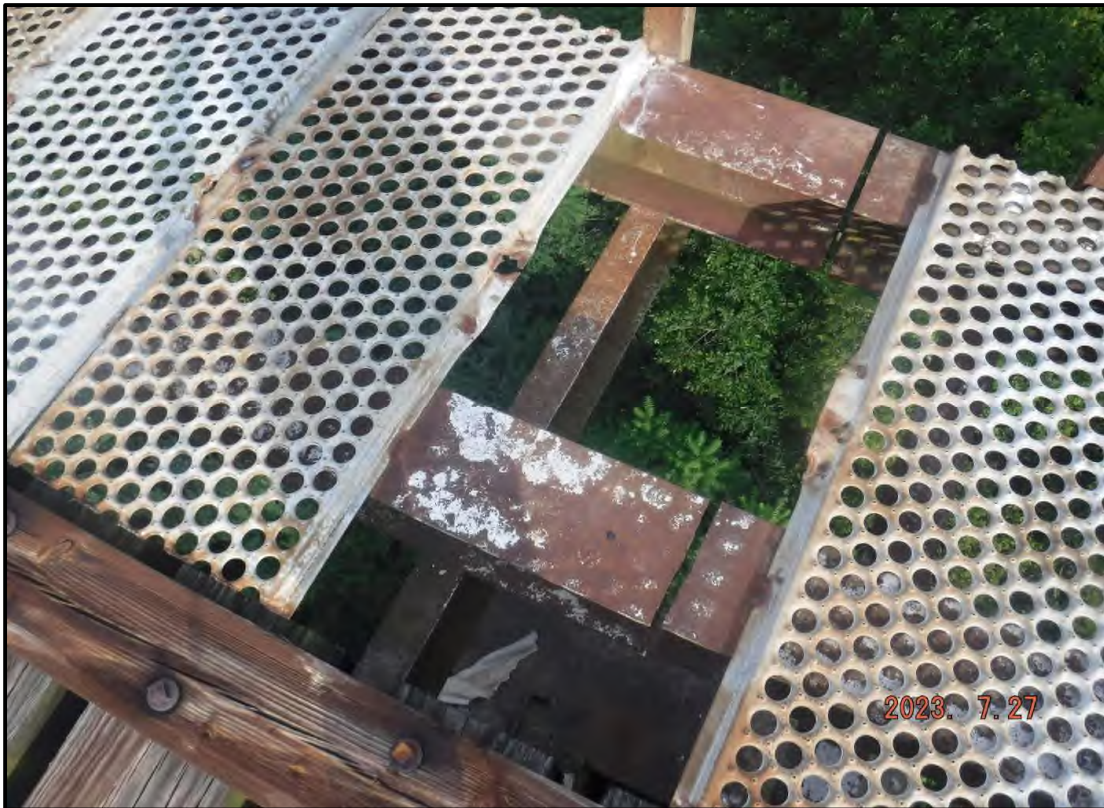
Photo 2: Missing Walkway Grate over Pier 3 of Main Spans

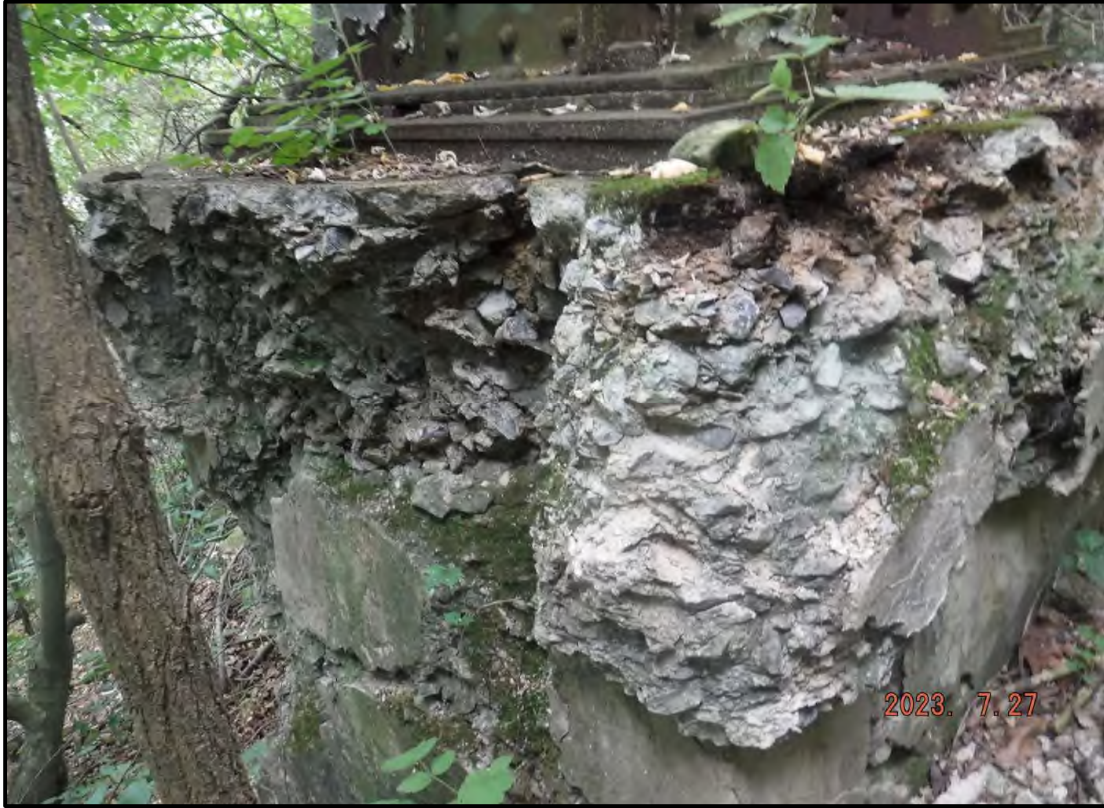
Photo 7: Spalled Concrete on Main Span Bent 2 North Pedestal

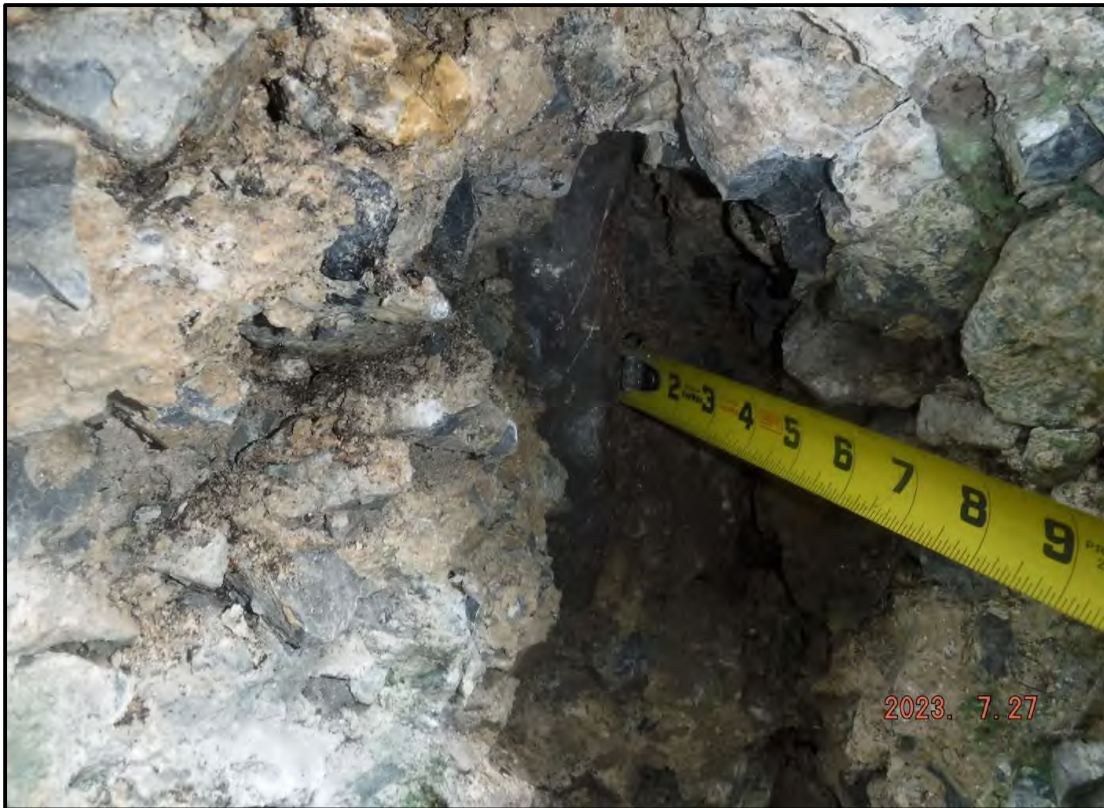
Photo 8: Spalled Concrete on Main Span Bent 2 North Pedestal

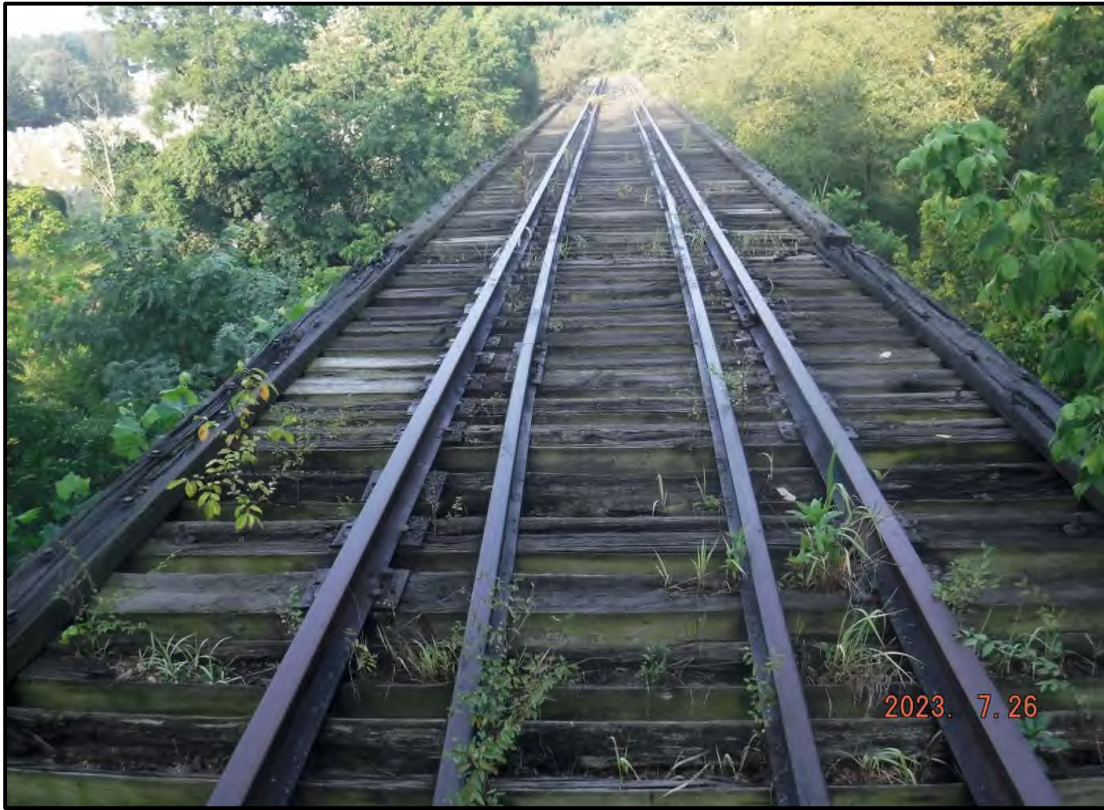
Photo 1: General Condition of Timber Tie Deck

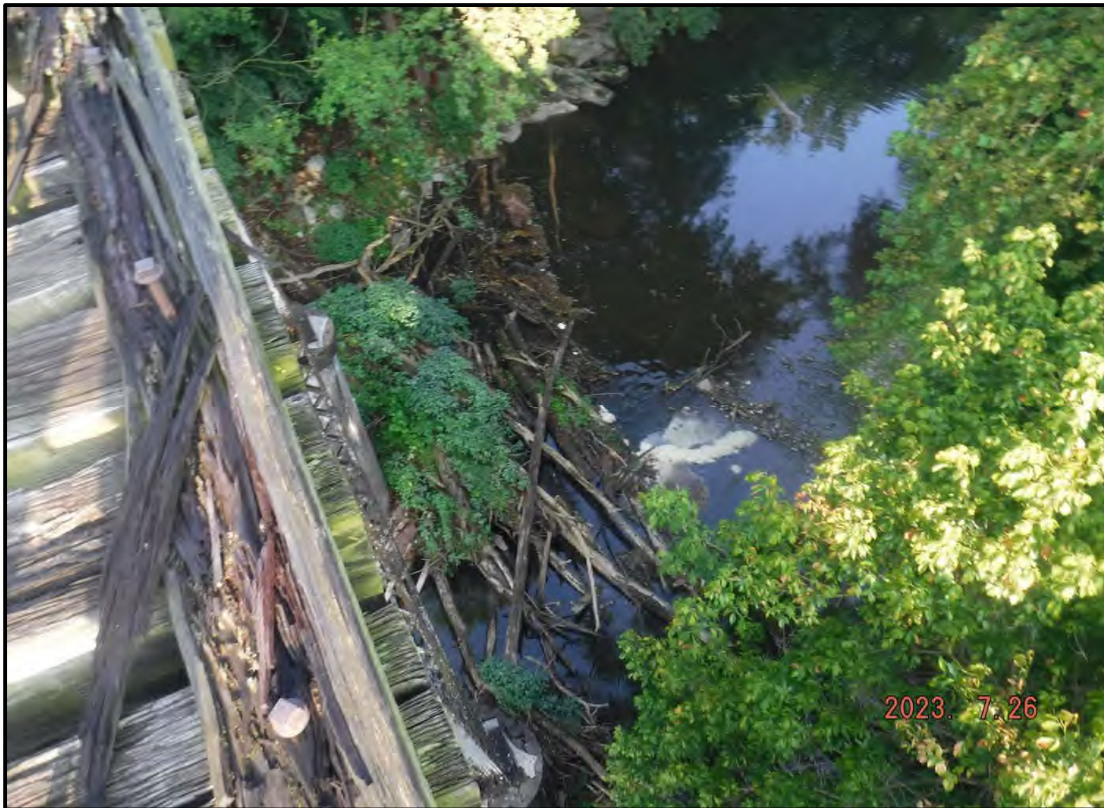
Photo 2: Flood Debris Against the North Side of the Steel Bent Tower

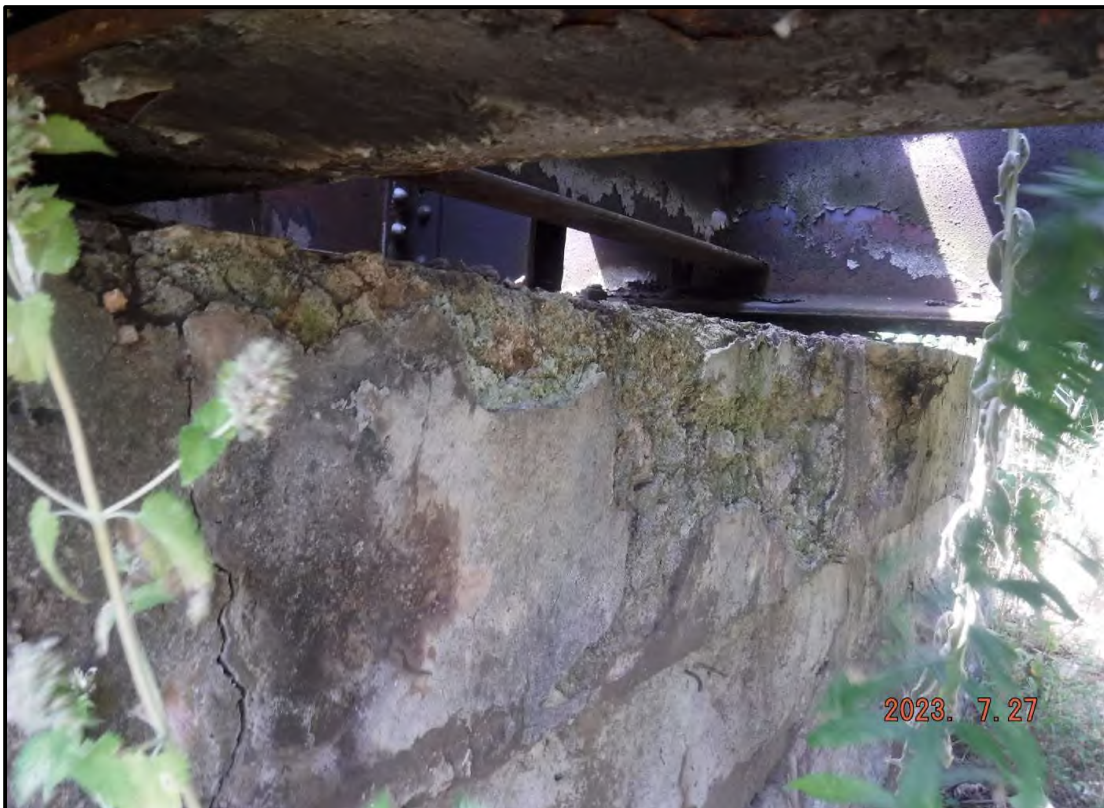
Photo 6: Typical Spalled Bridge Seat (Outside of Bearings)

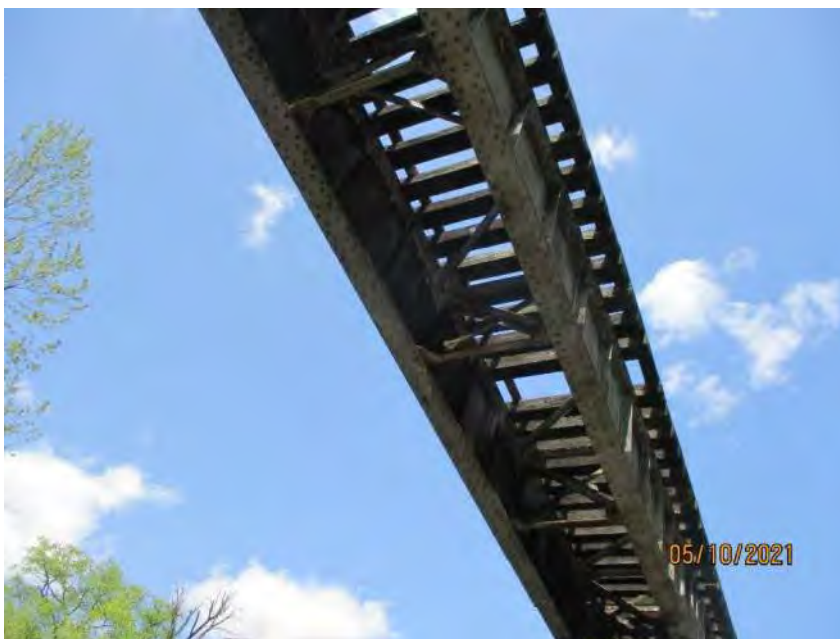
Looking north at top of structure toward Abutment B.

Deteriorated railroad ties throughout. Structure was not safe to cross.

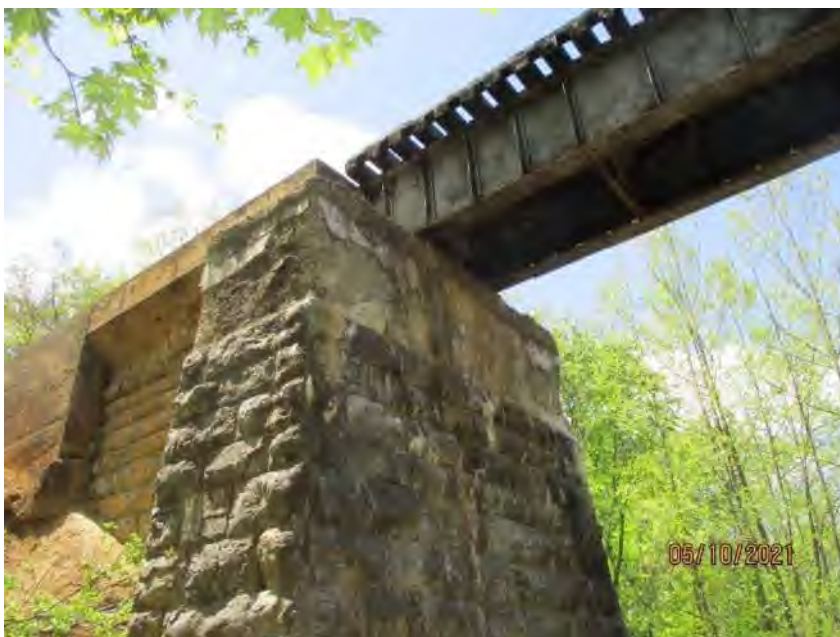
Looking at structure from downstream end.

Typical girder configuration with failed protective coating with minor surface rust thought out.

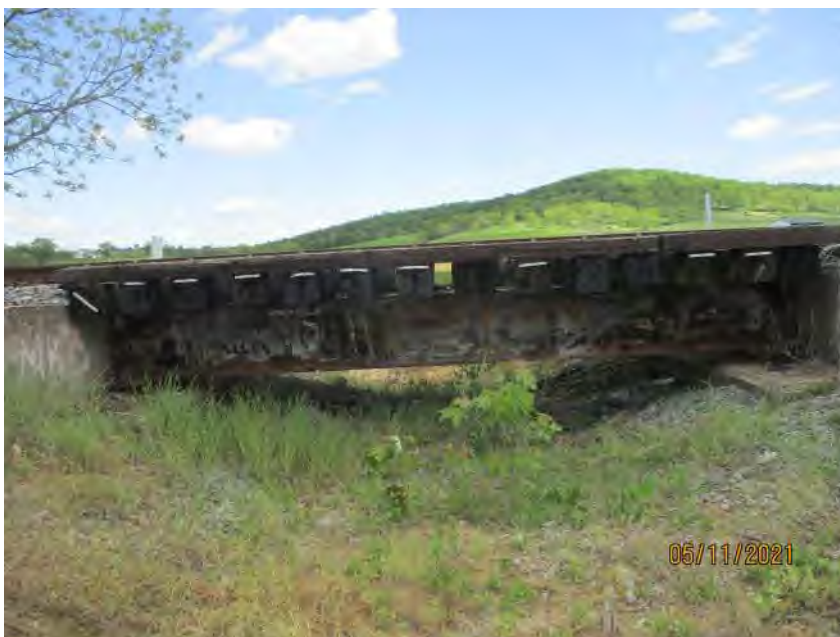
Spall 3" long x 3" wide x 2" deep.

Top of abutment seat covered in debris and erosion stones.

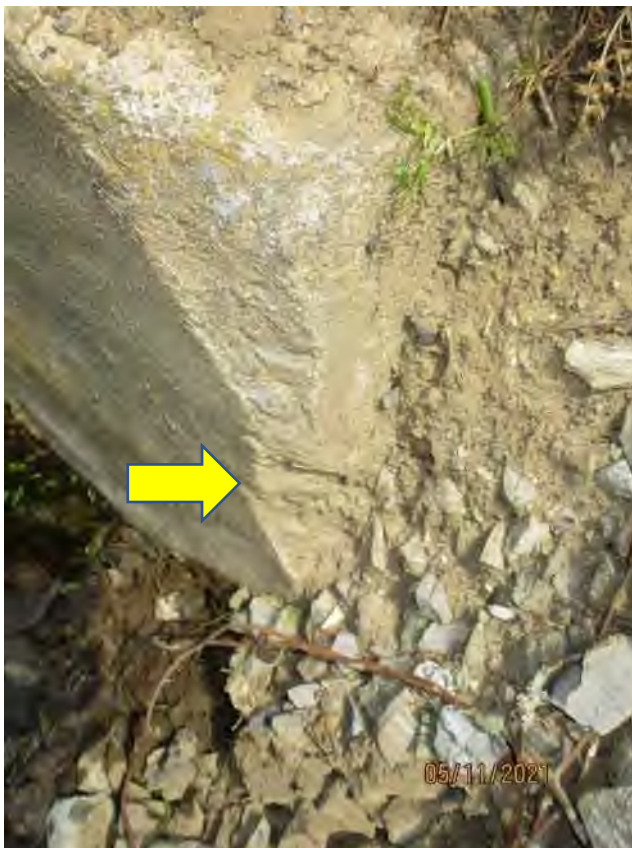
Vegetation growth at front of barrel.

Inside barrel full height hairline vertical cracks in random locations.

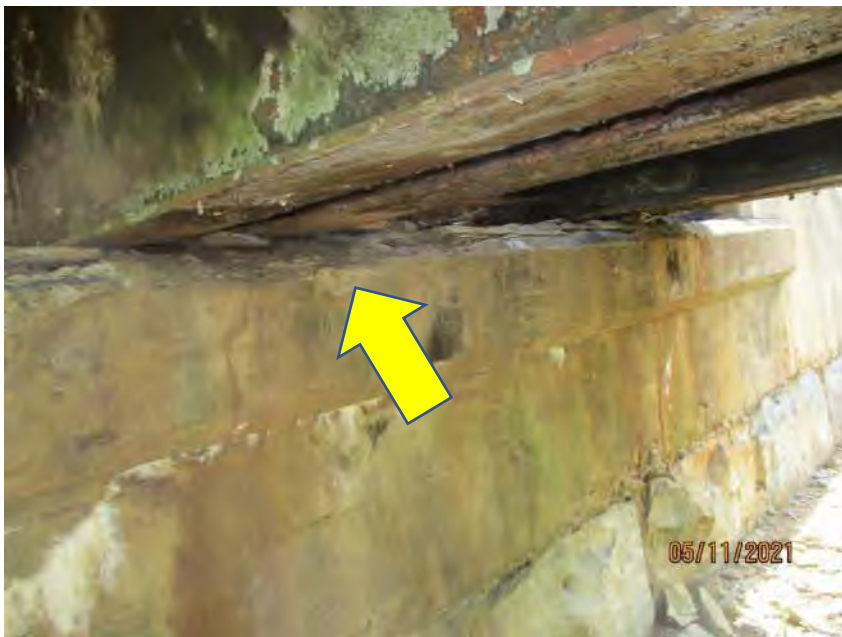
Abutment B upstream side.

Concrete spall:
2' long x 1' high x 2" deep.

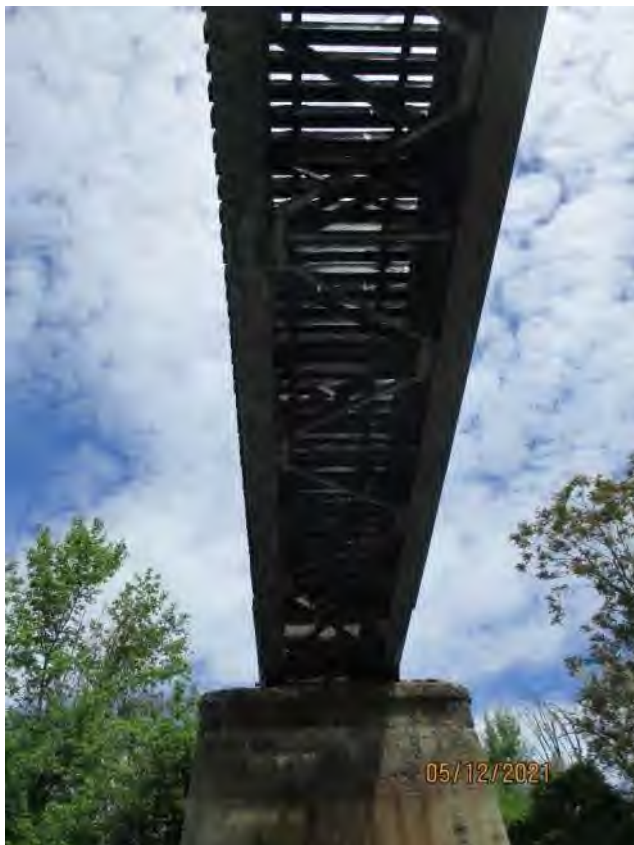
Looking south at top of structure toward Abutment A.

Timber railroad ties deteriorated. Structure unsafe to cross.

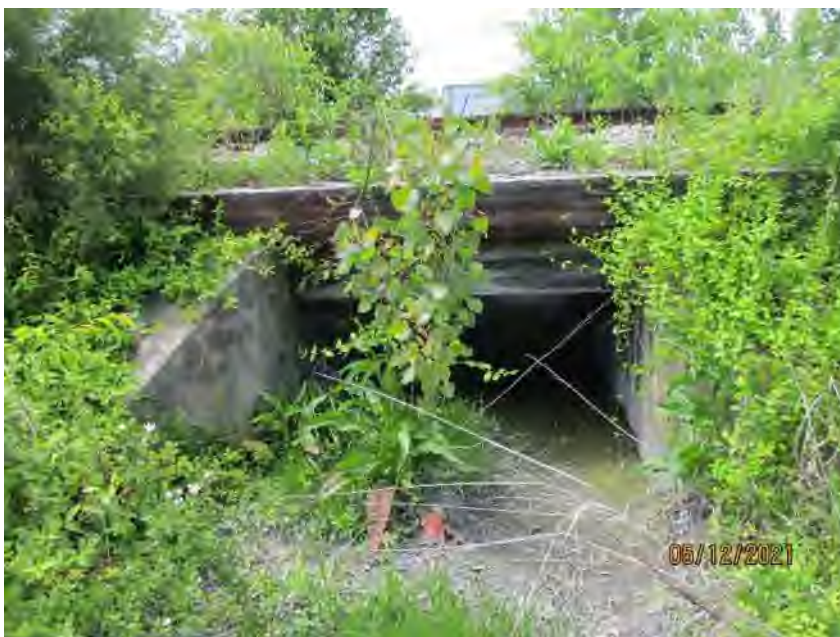
Upstream exterior beam.

Area of decay:
4' long x 11" high x 10" wide

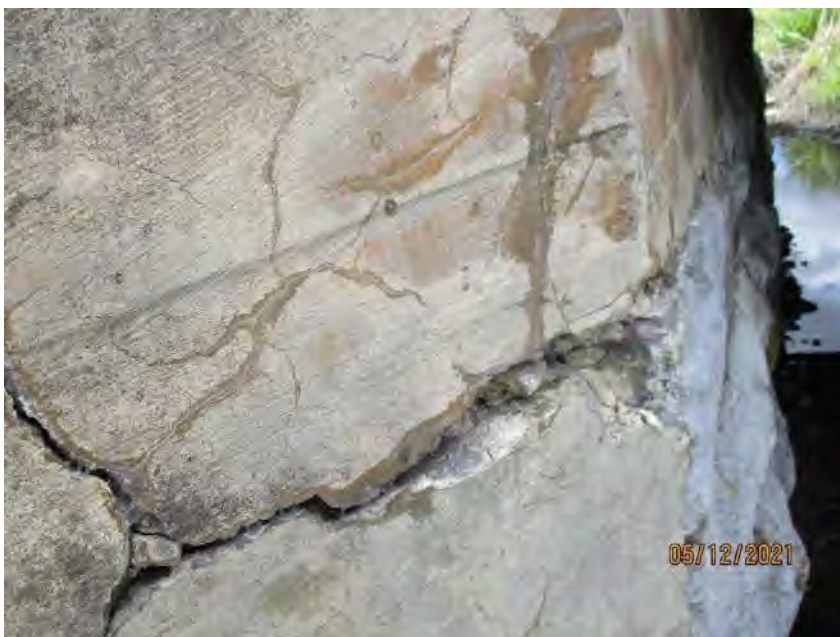
Downstream south wingwall

Area of spall:
19" long x 9" high x 3.5" deep
