**NORFOLK SOUTHERN
RAILWAY CO.
SHENANDOAH VALLEY RAIL
CORRIDOR
BRIDGE EVALUATION**

**STRASBURG, VIRGINIA
SHENANDOAH COUNTY**

**NORTHERN SHENANDOAH VALLEY
TRANSPORTATION PRESERVATION CORP.**

PROJECT NO. 23-1502.101
August 25, 2023
Revised August 31, 2023

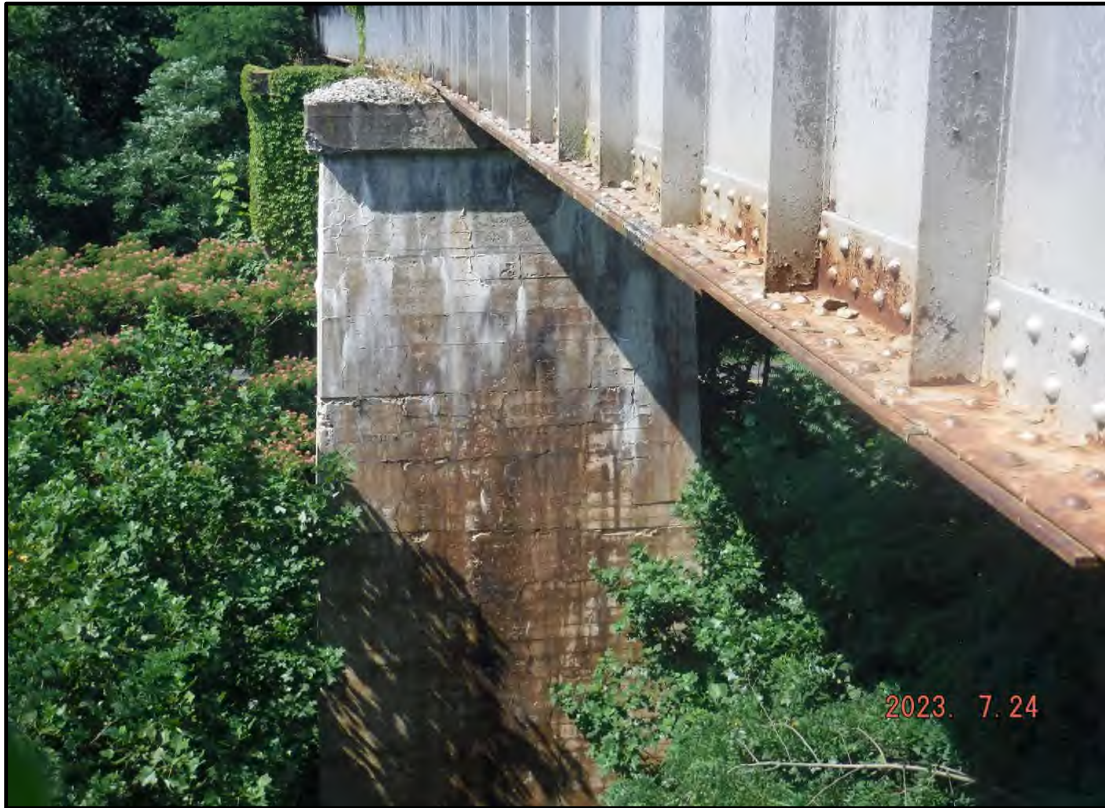
Photo 3: Typical Reinforced Concrete Portion of Pier

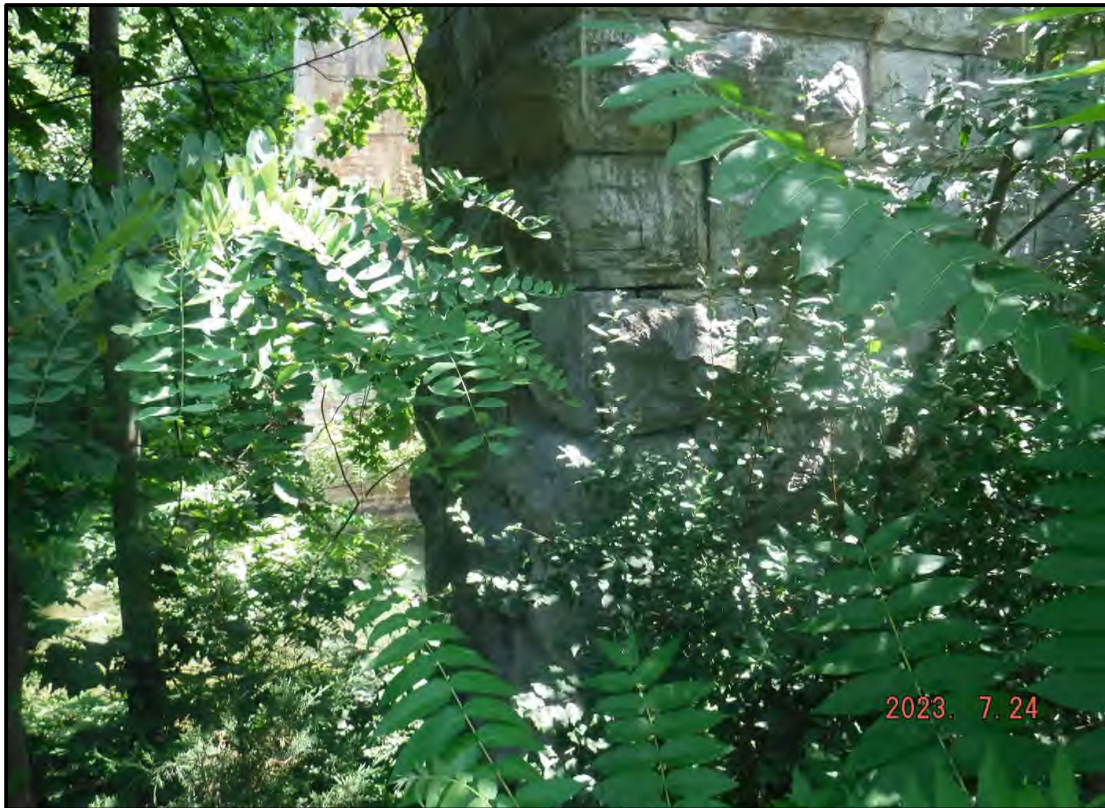
Photo 4: Typical Stone Masonry Portion of Pier

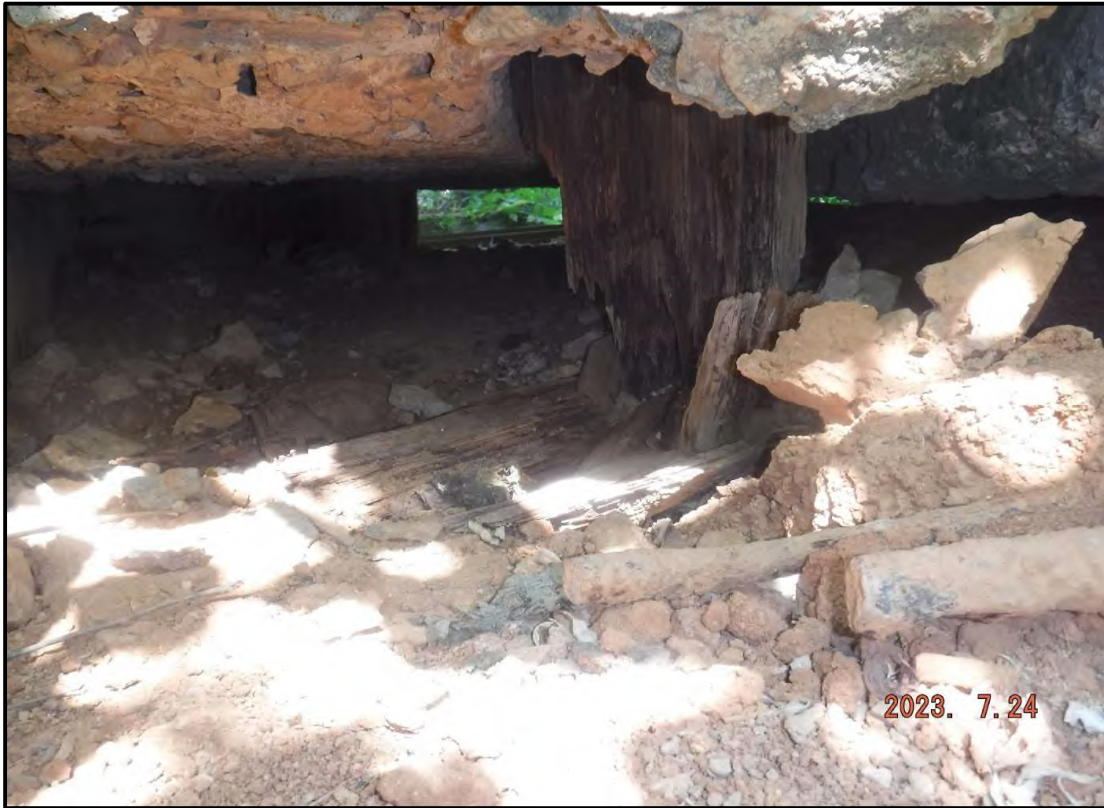
Photo 5: Undermined East Approach Ballast Trough

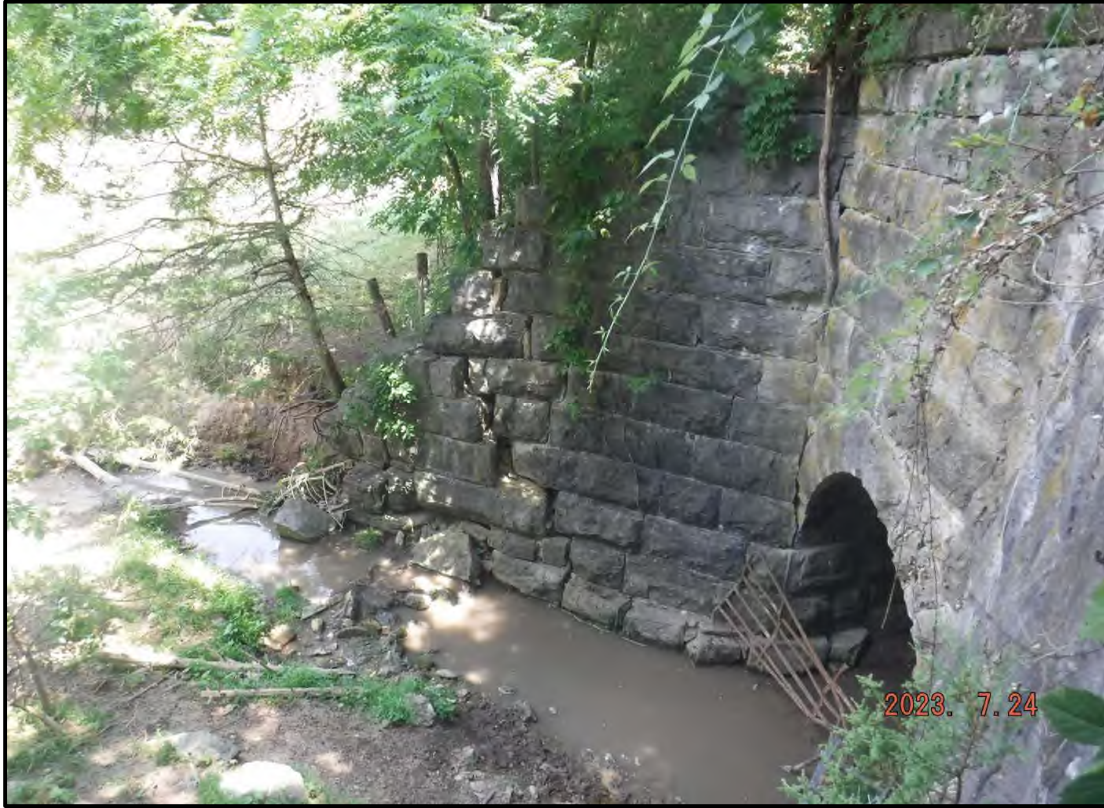
Photo 5: NE Wing with Free End Separation

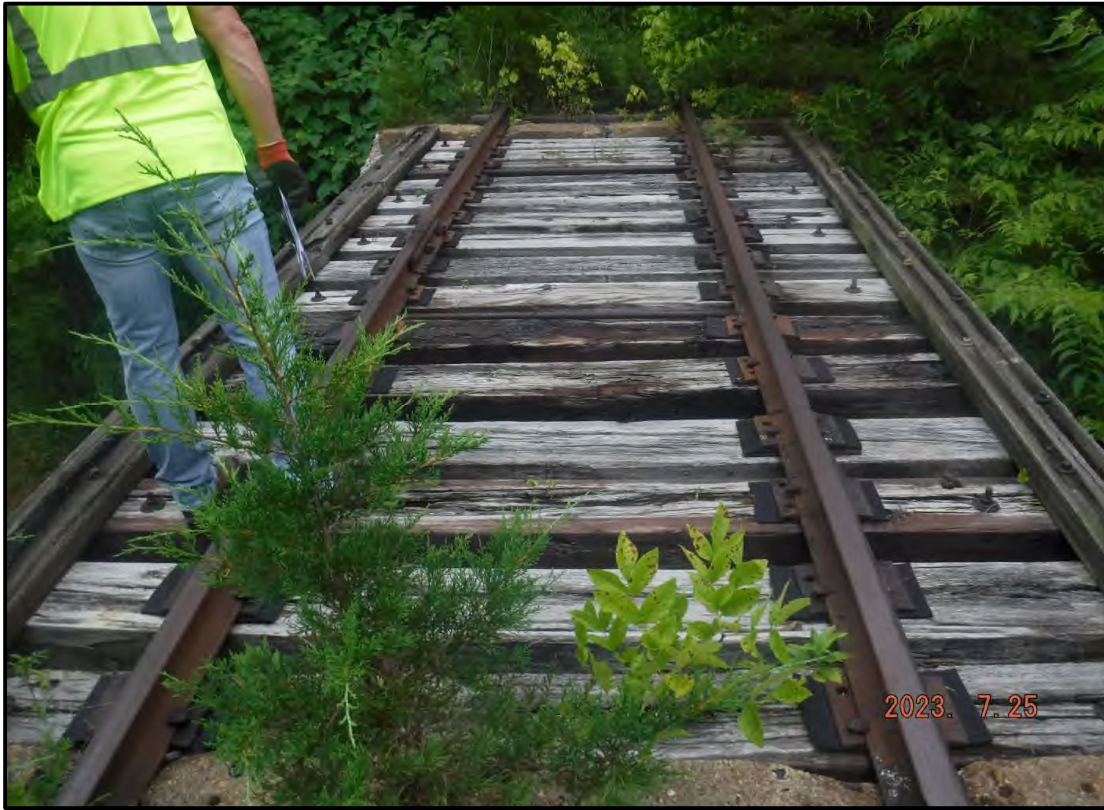
Photo 1: General Condition of Bridge Deck

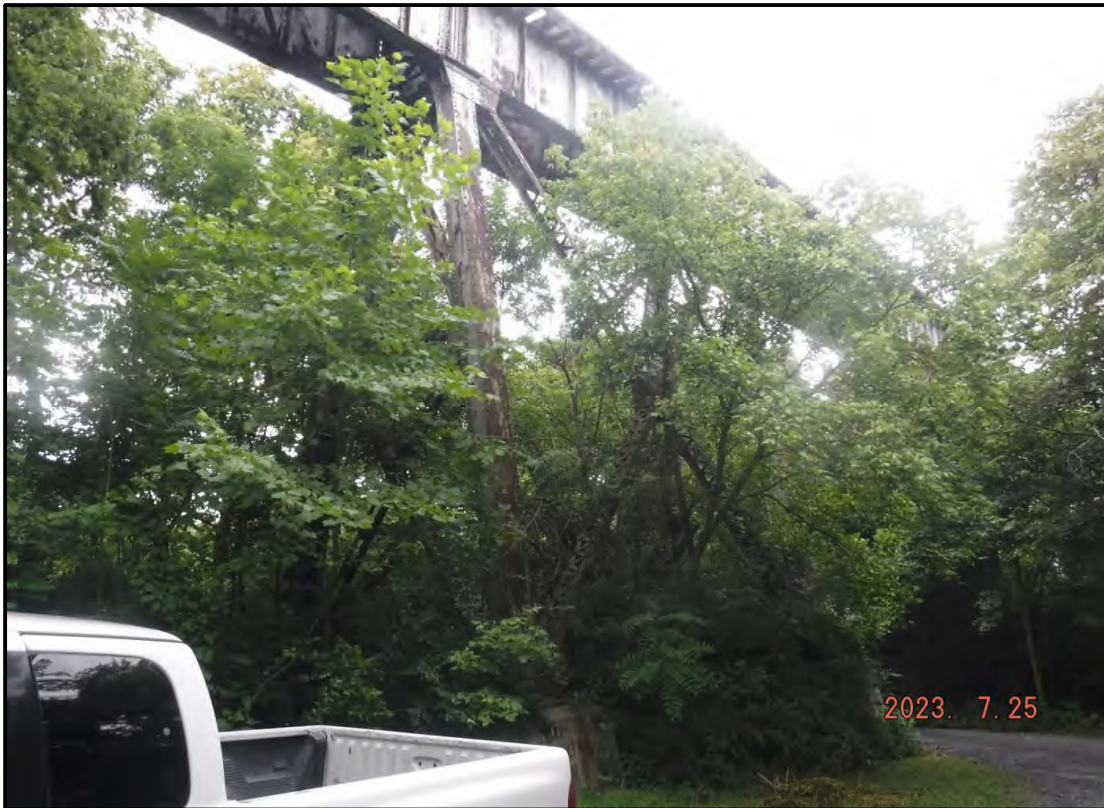
Photo 7: Typical Pier

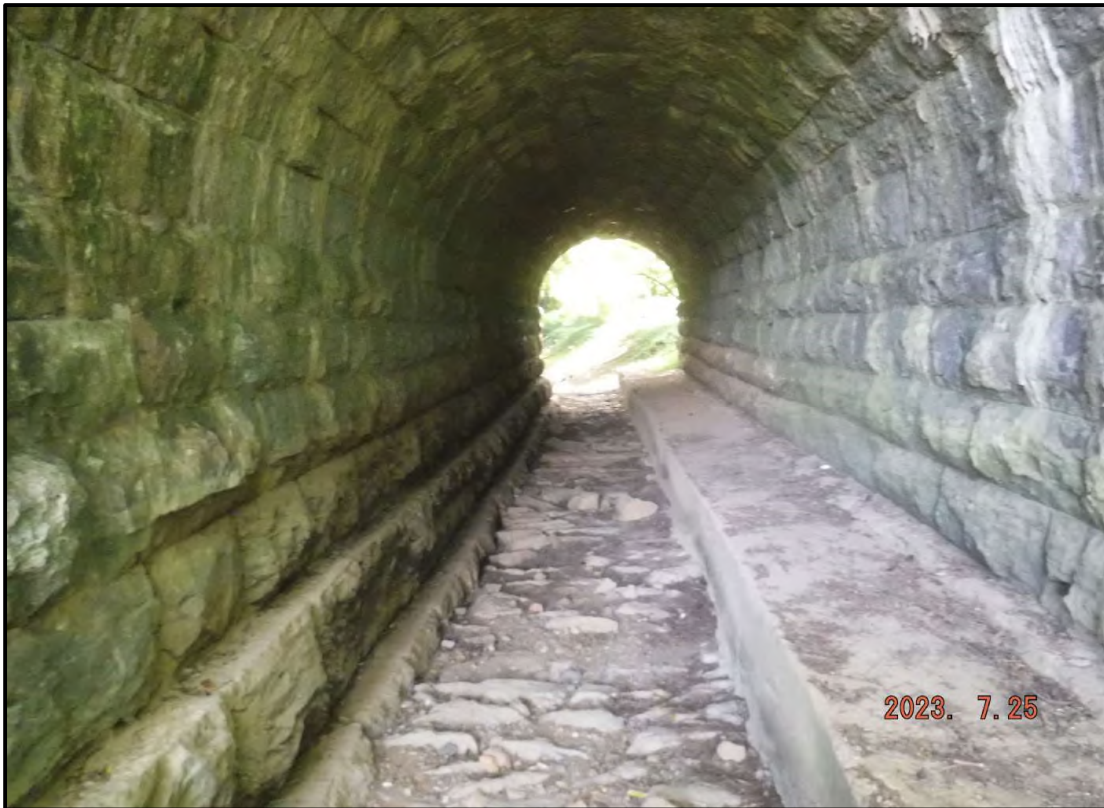
Photo 3: Arch Barrel (From North)

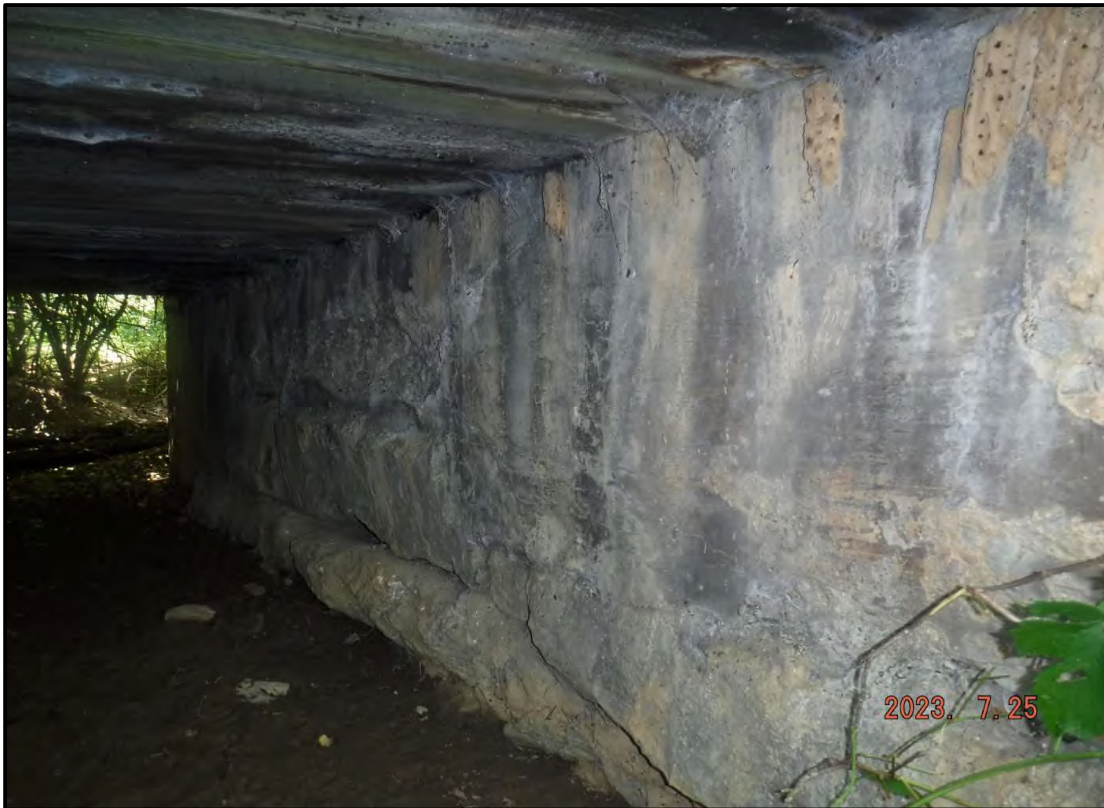
Photo 3: East Abutment (From South)

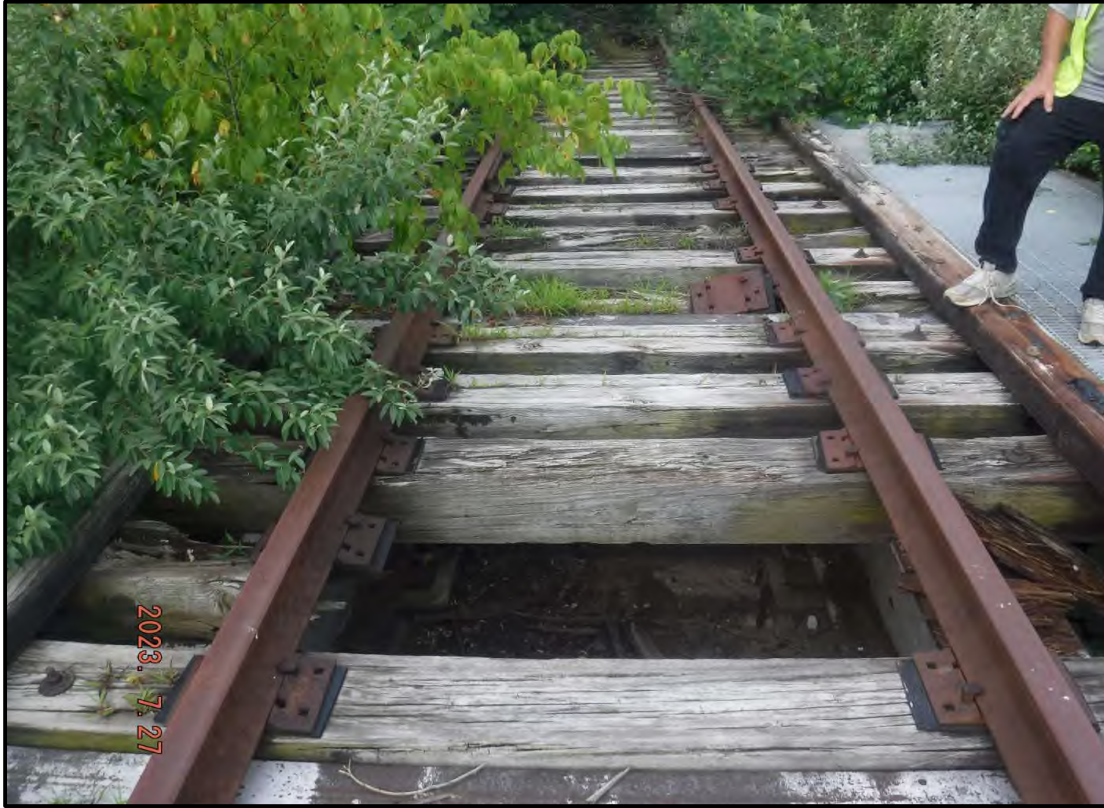
Photo 2: Missing Walkway Grate over Pier 3 of Main Spans

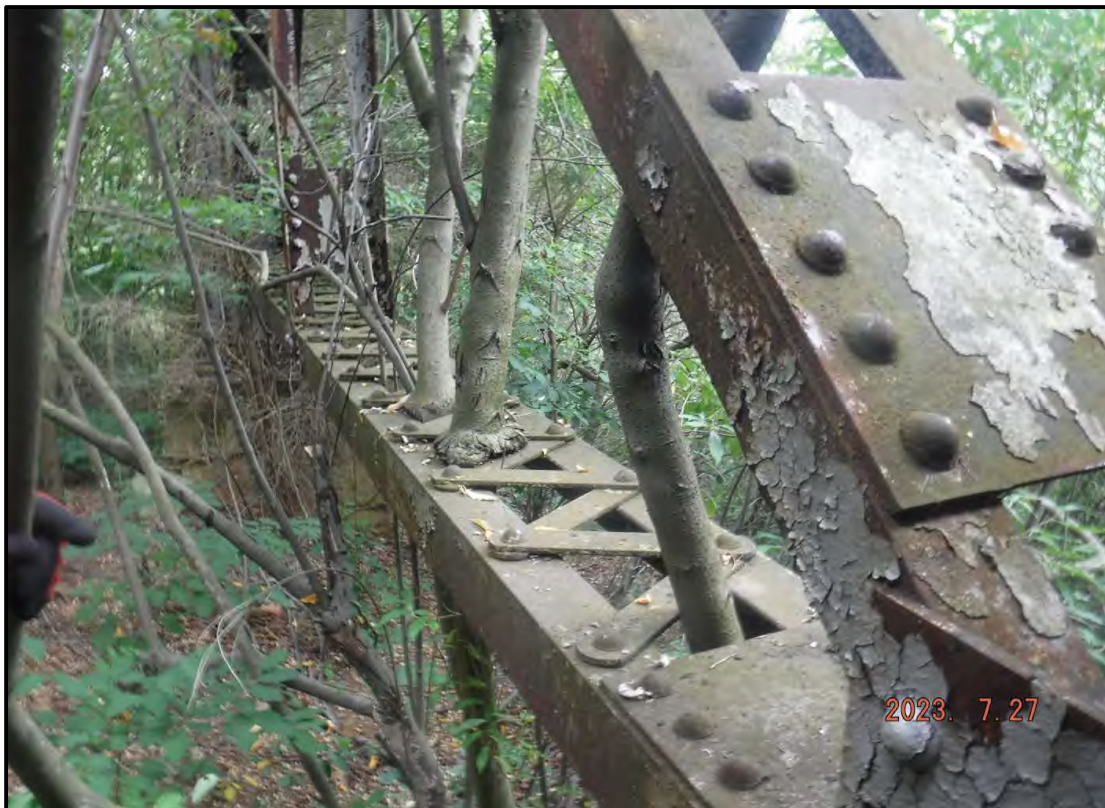
Photo 5: North Side of Main Spans (From East)

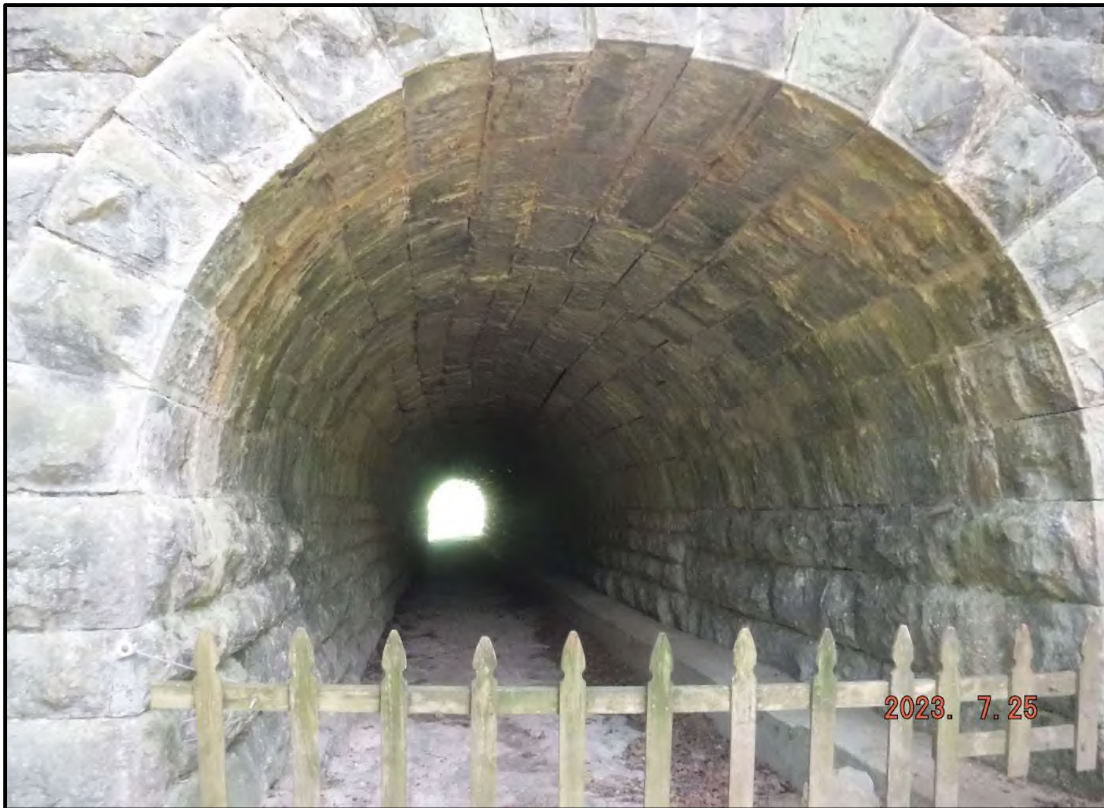
Photo 1: North Headwall

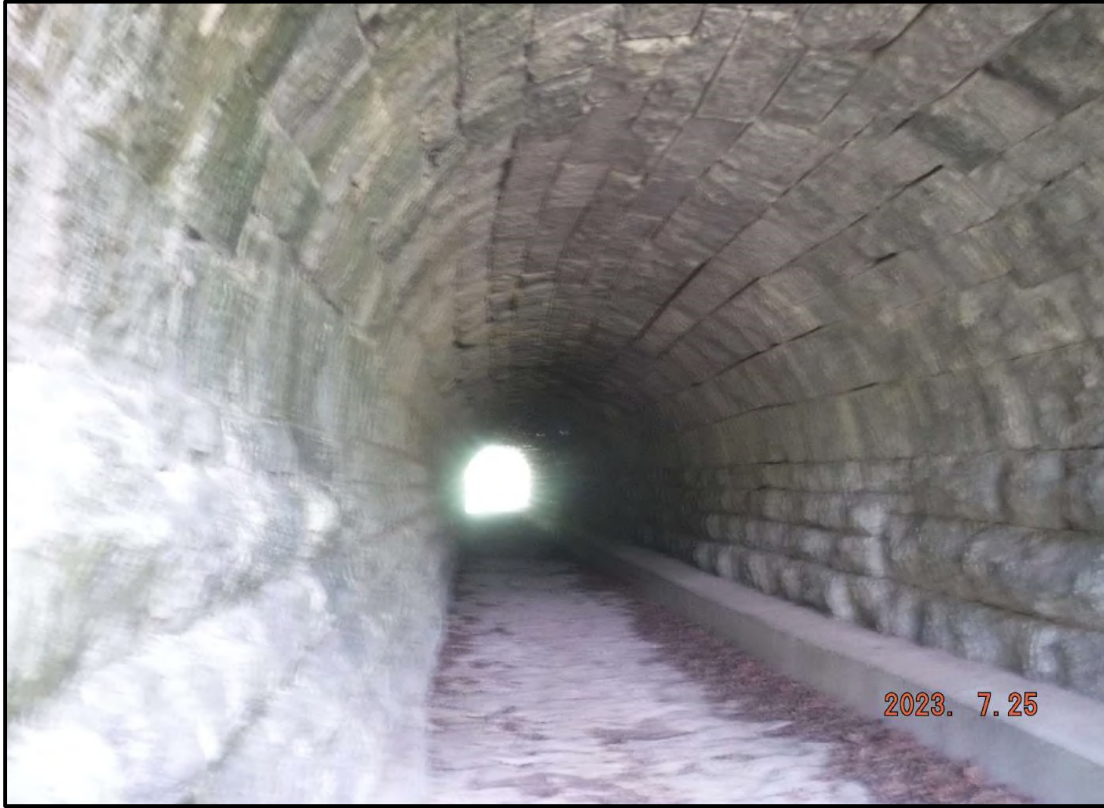
Photo 2: Through Stone Arch (From North)

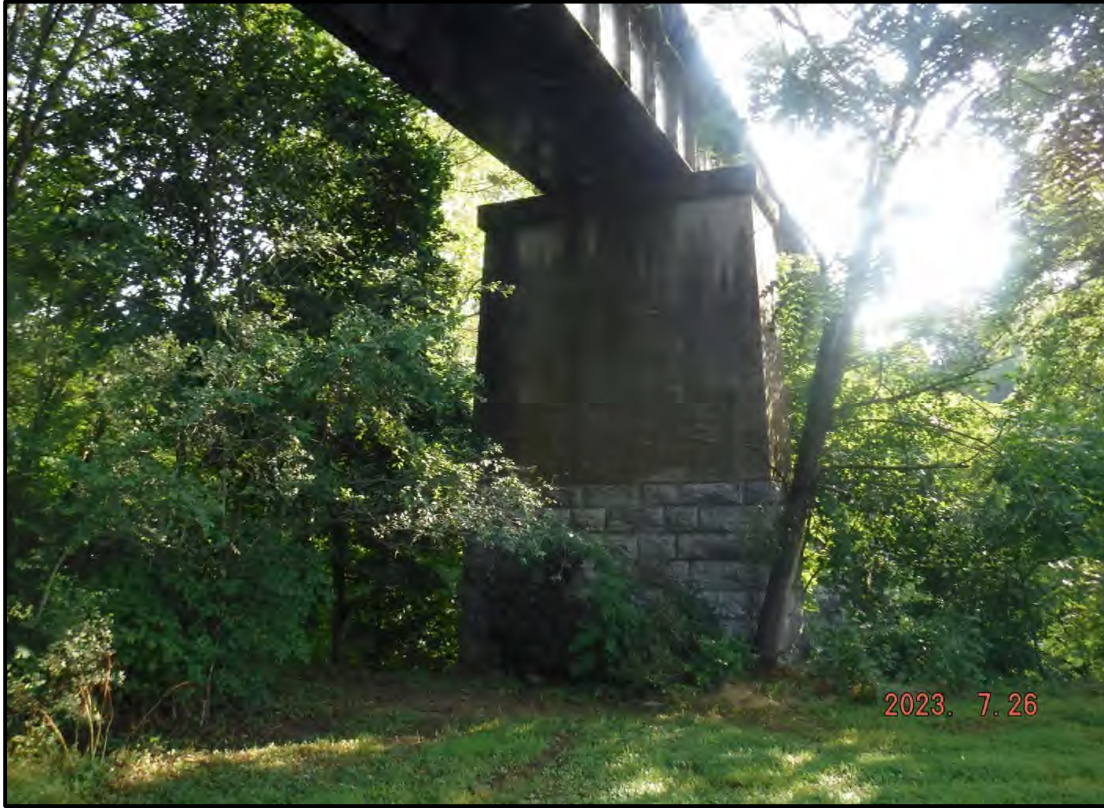
Photo 4: Typical Steel Bent (West Side of Bent 2 Shown)

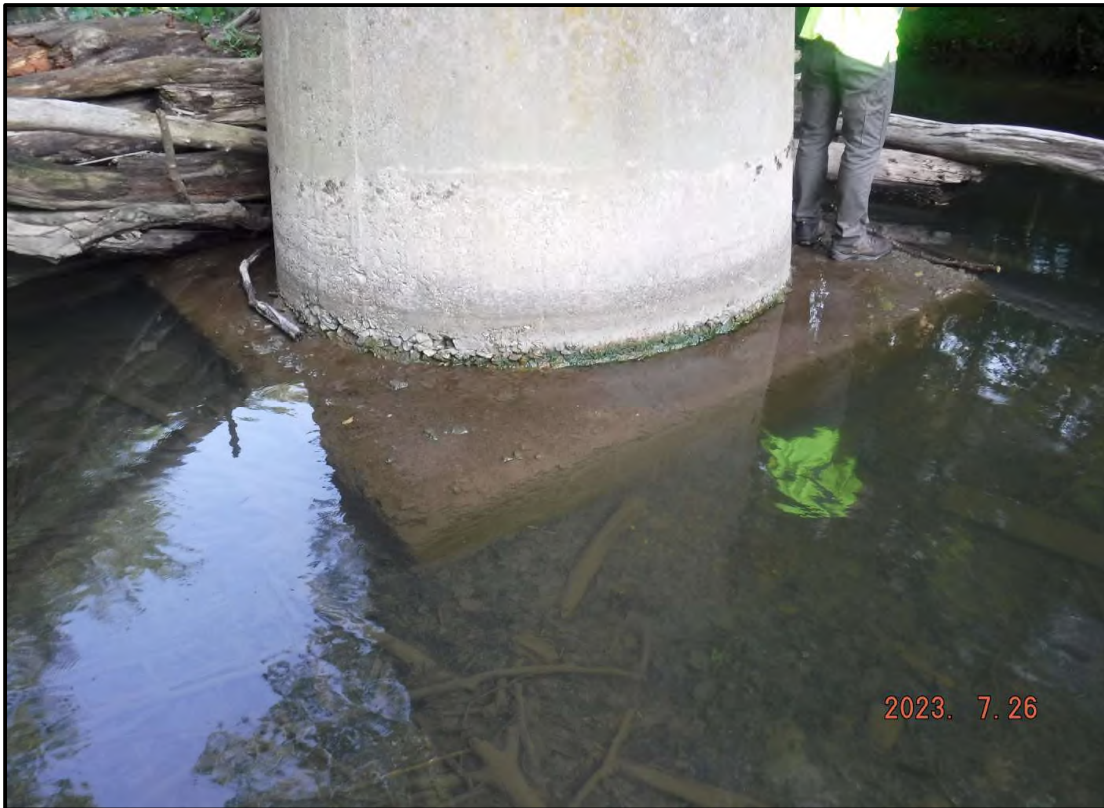
Photo 5: Typical Pier (West Side of Pier 2 Shown)

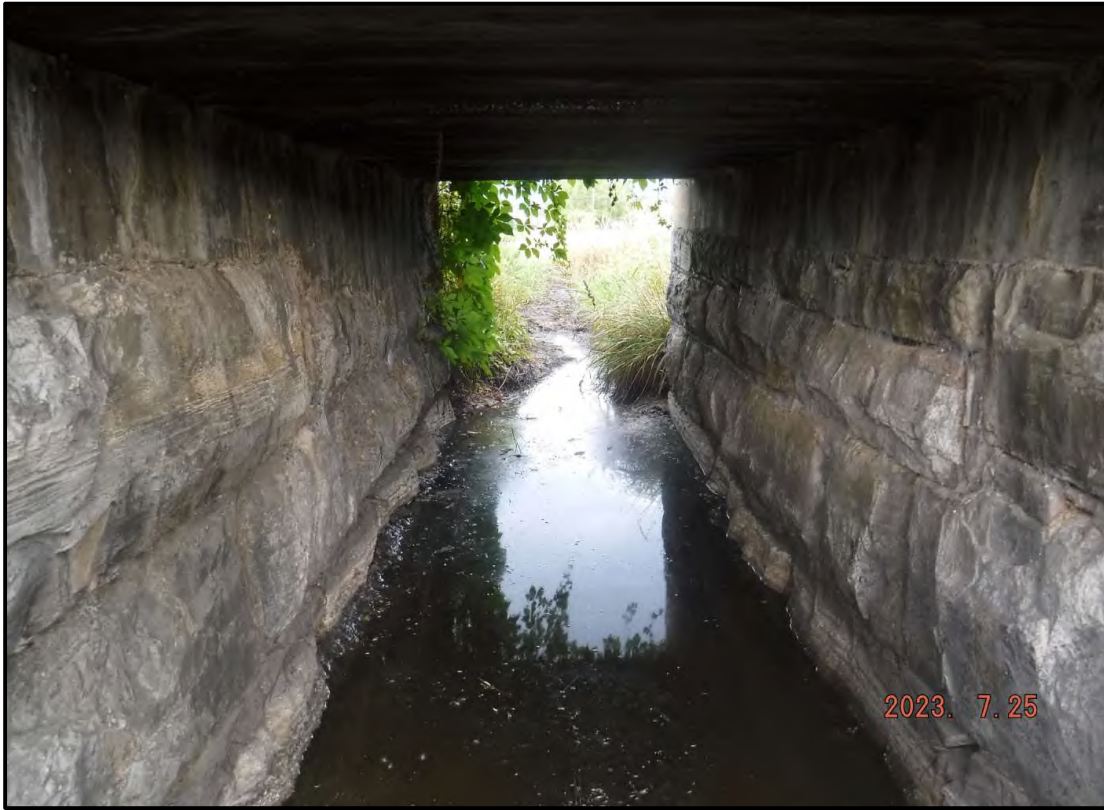
Photo 2: North Elevation

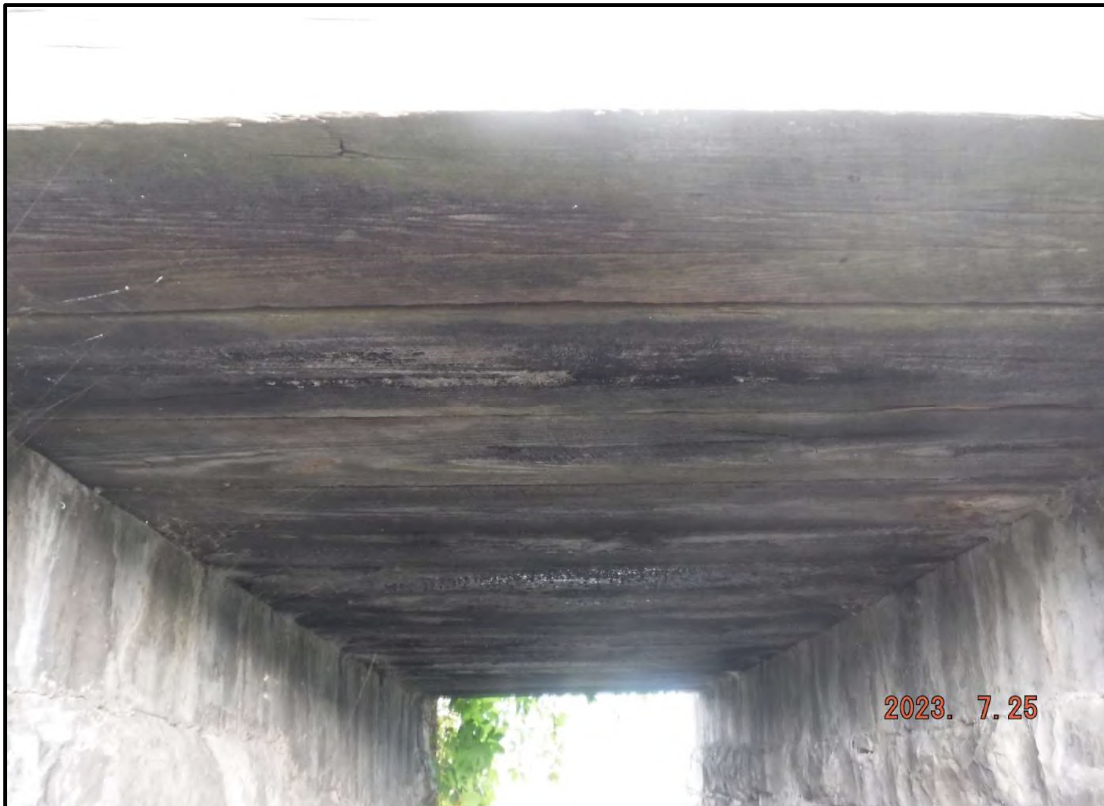
Photo 3: Through Structure (From North)

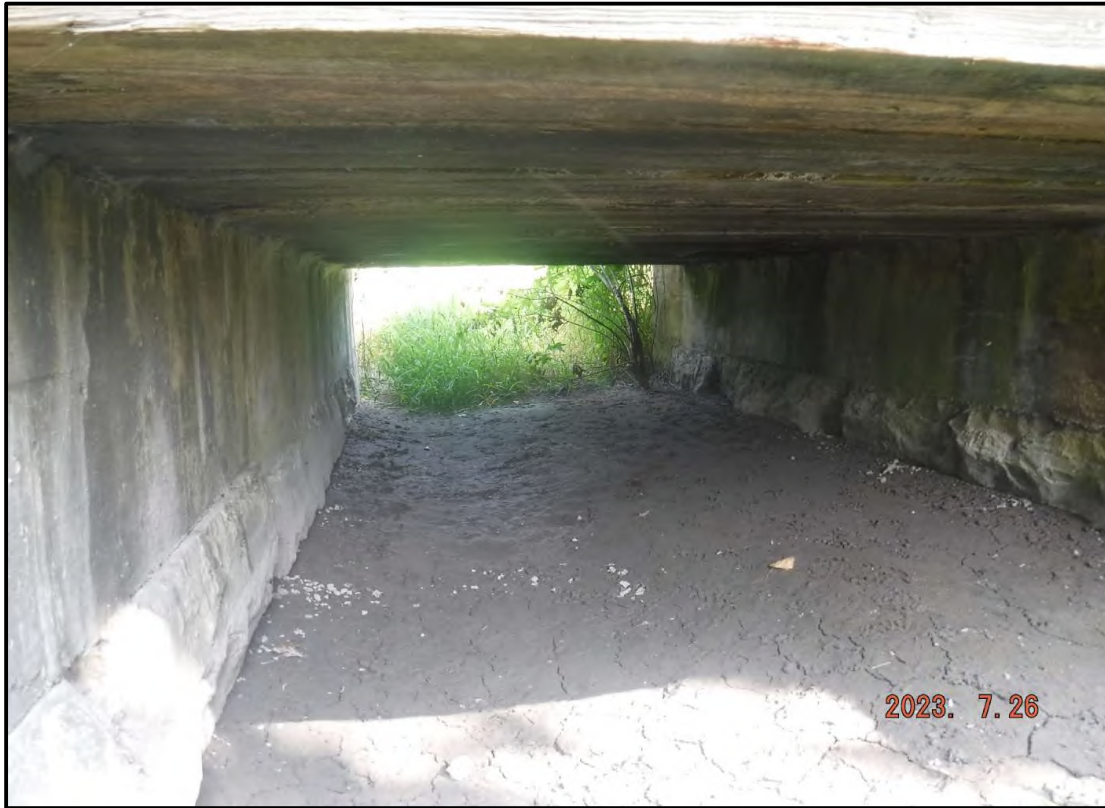
Photo 4: Underside of Timber Slab

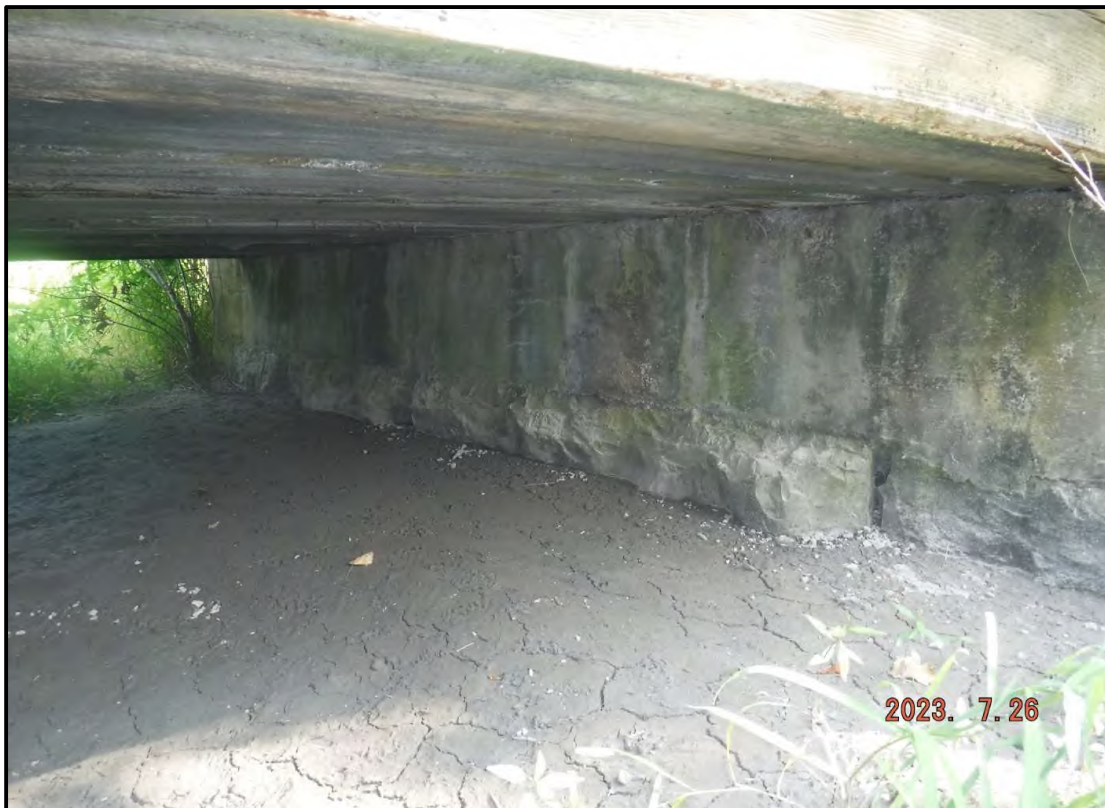
Photo 1: Through Structure (From North)

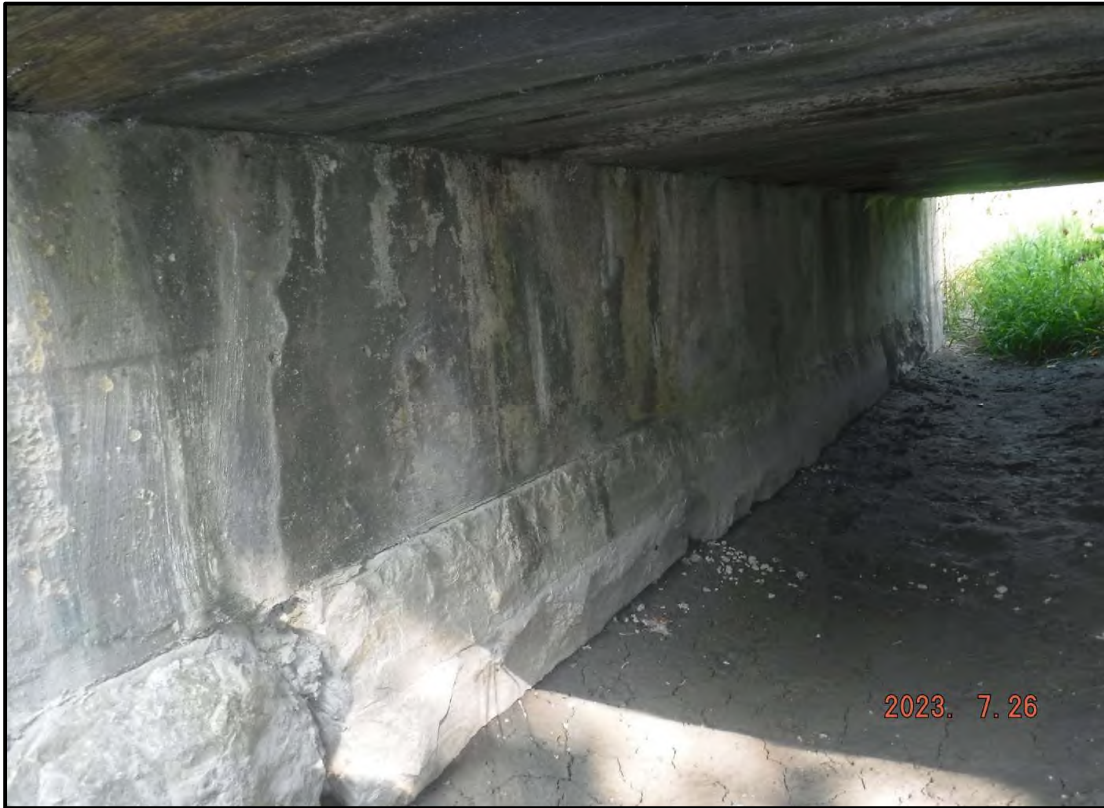
Photo 2: West Abutment (From North)

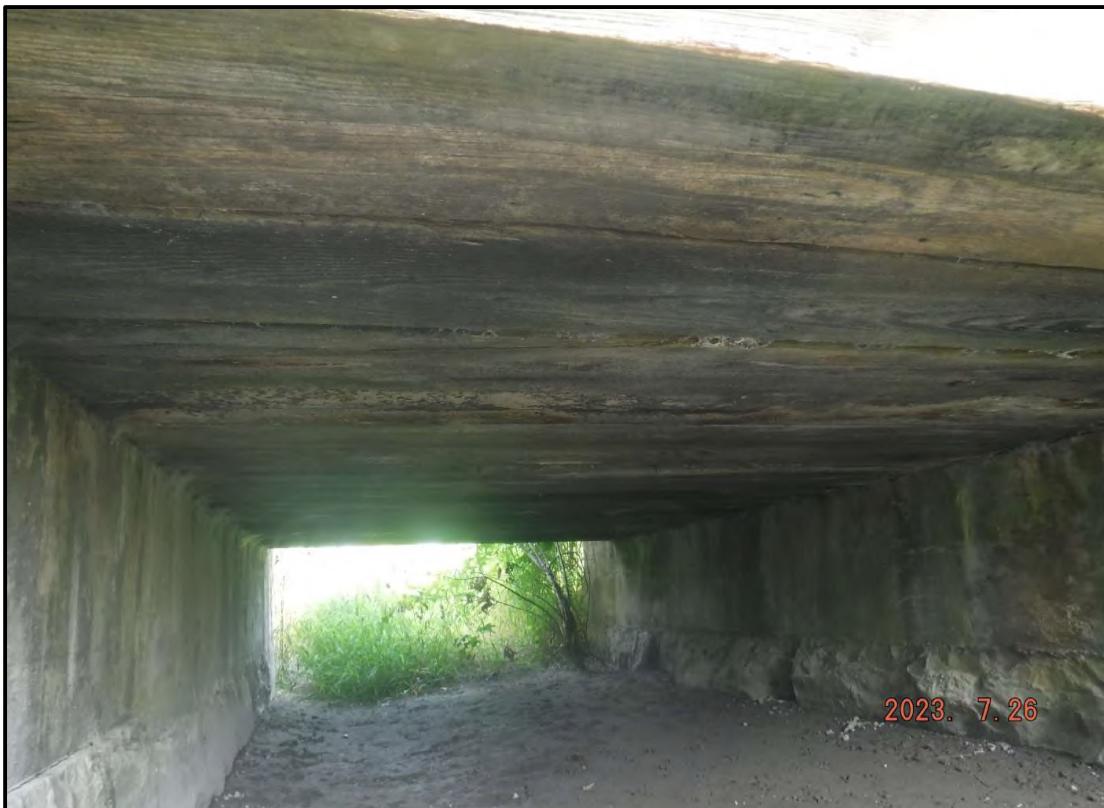
Photo 3: East Abutment (From North)

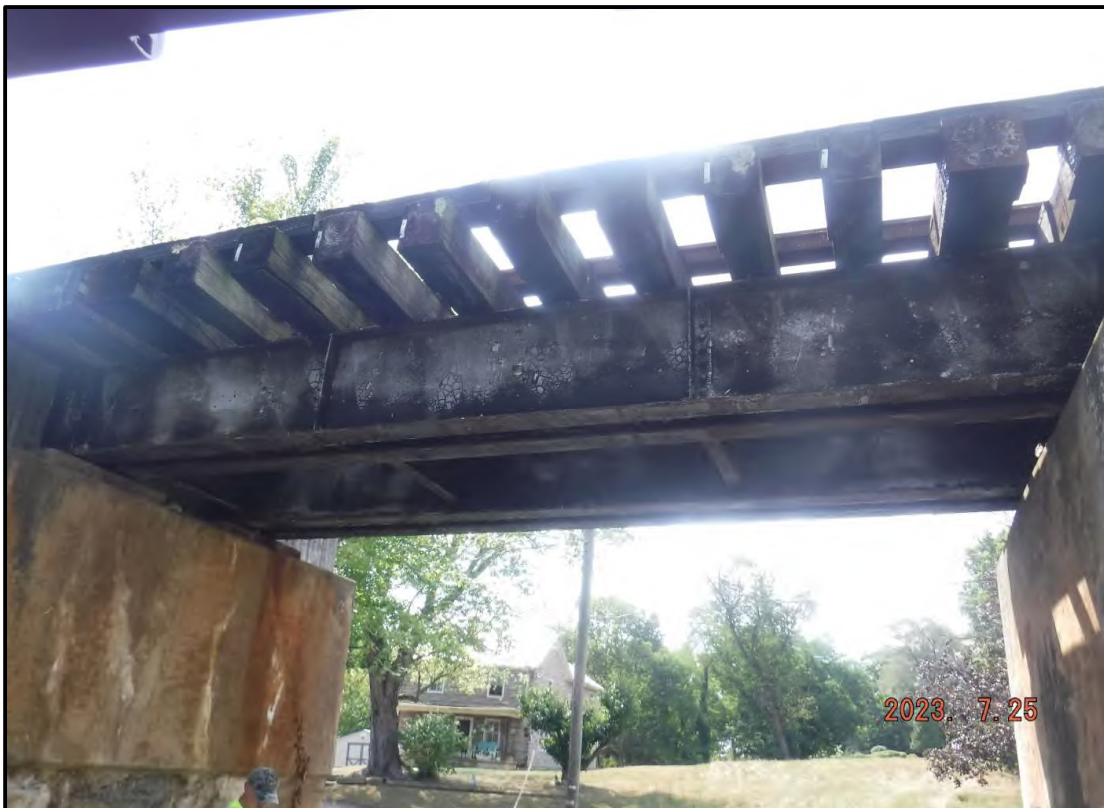
Photo 1: North Elevation of Girders

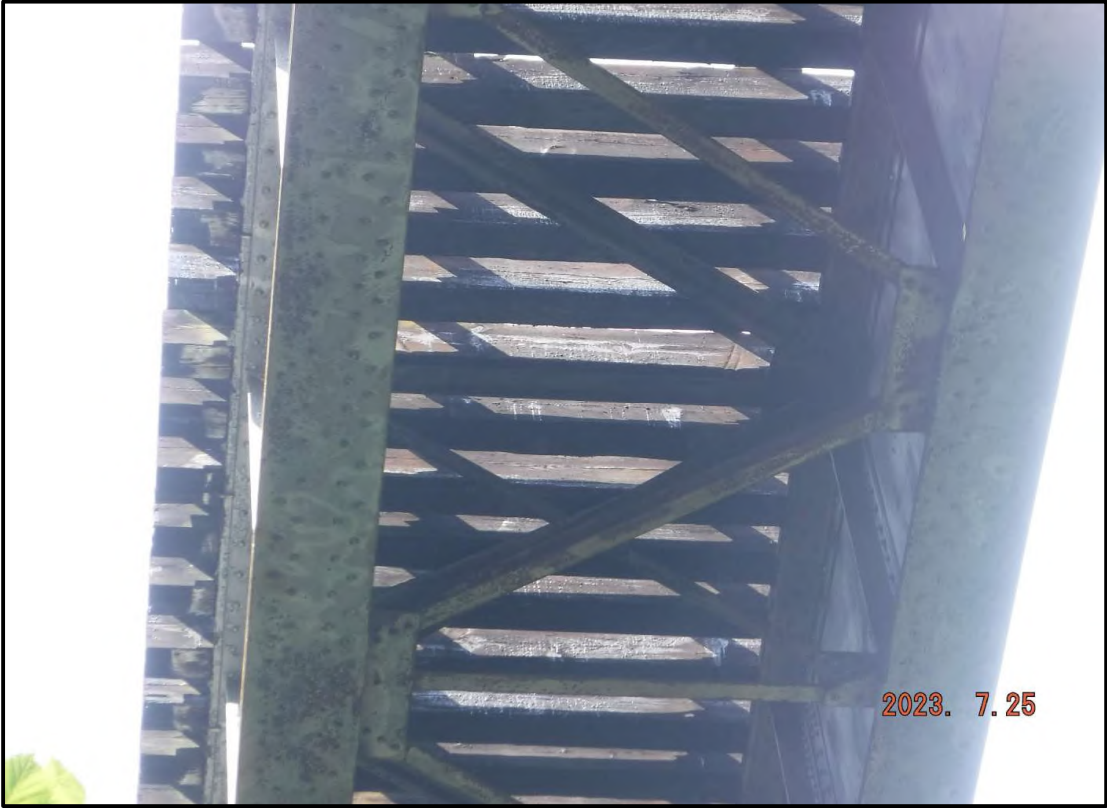
Photo 6: Underside of Span

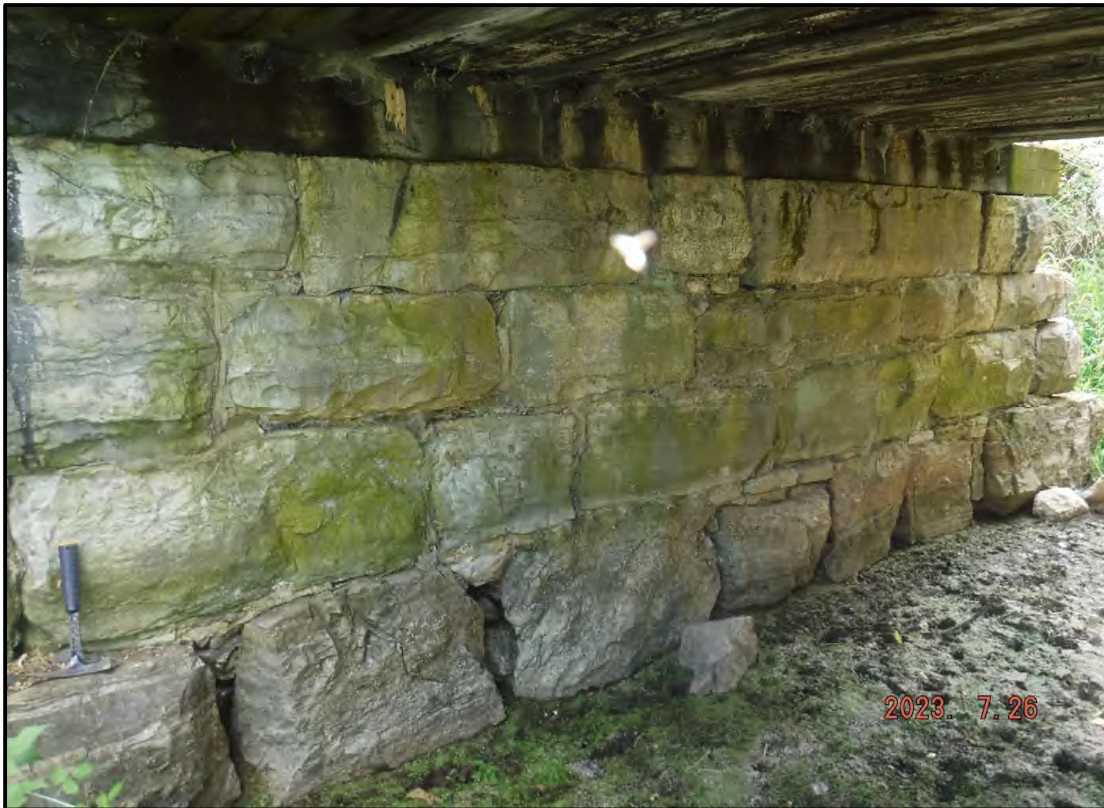
Photo 1: East Abutment (From South)

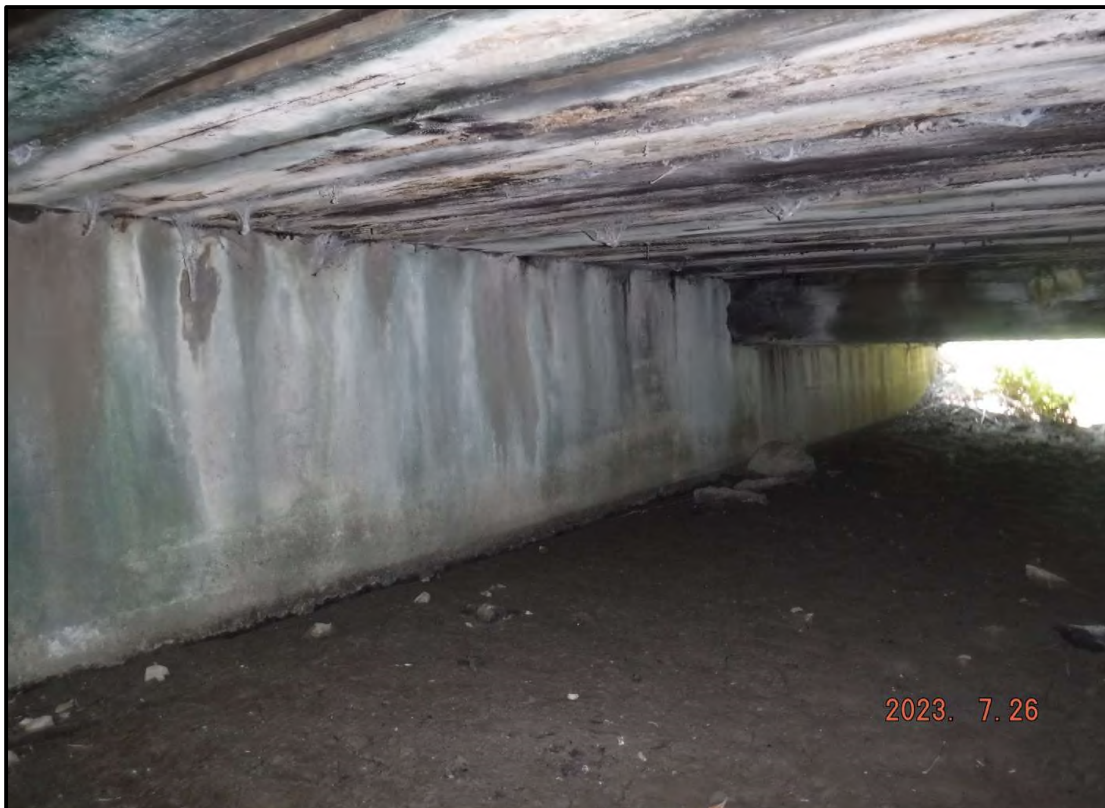
Photo 1: East Abutment (From South)

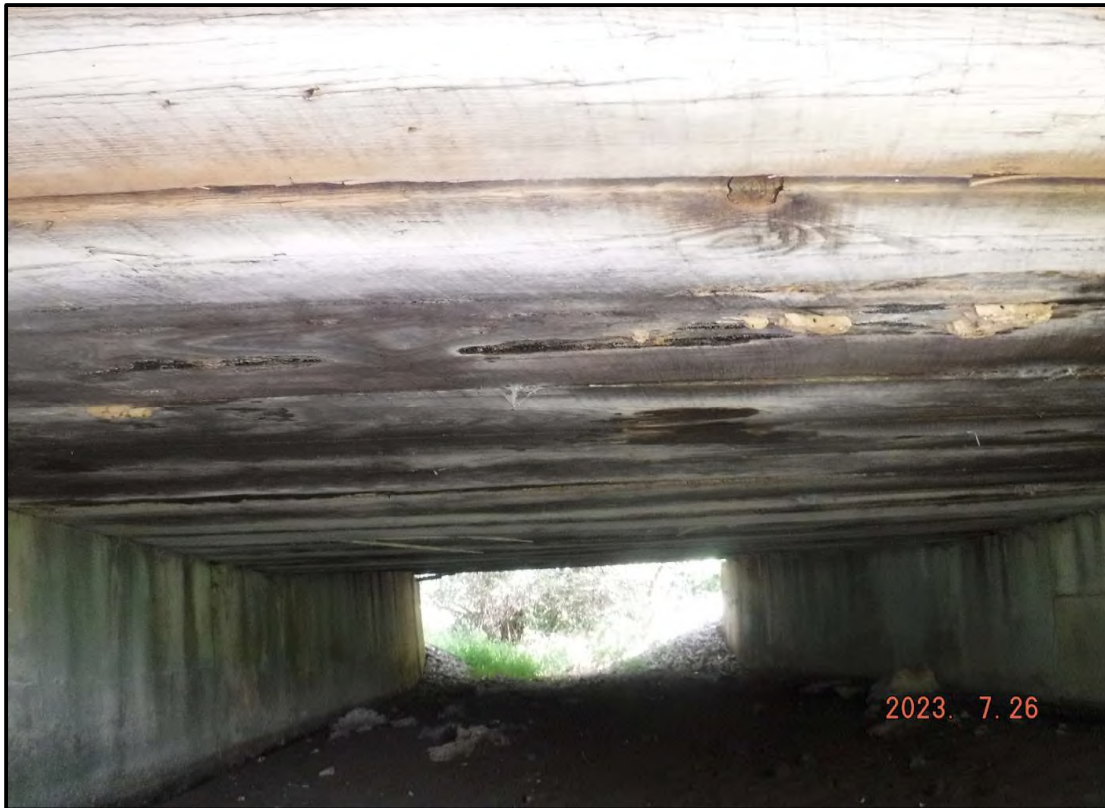
Photo 3: Typical Timber Slab (From South)
