**NORFOLK SOUTHERN
RAILWAY CO.
SHENANDOAH VALLEY RAIL
CORRIDOR
BRIDGE EVALUATION**

**STRASBURG, VIRGINIA
SHENANDOAH COUNTY**

**NORTHERN SHENANDOAH VALLEY
TRANSPORTATION PRESERVATION CORP.**

PROJECT NO. 23-1502.101
August 25, 2023
Revised August 31, 2023

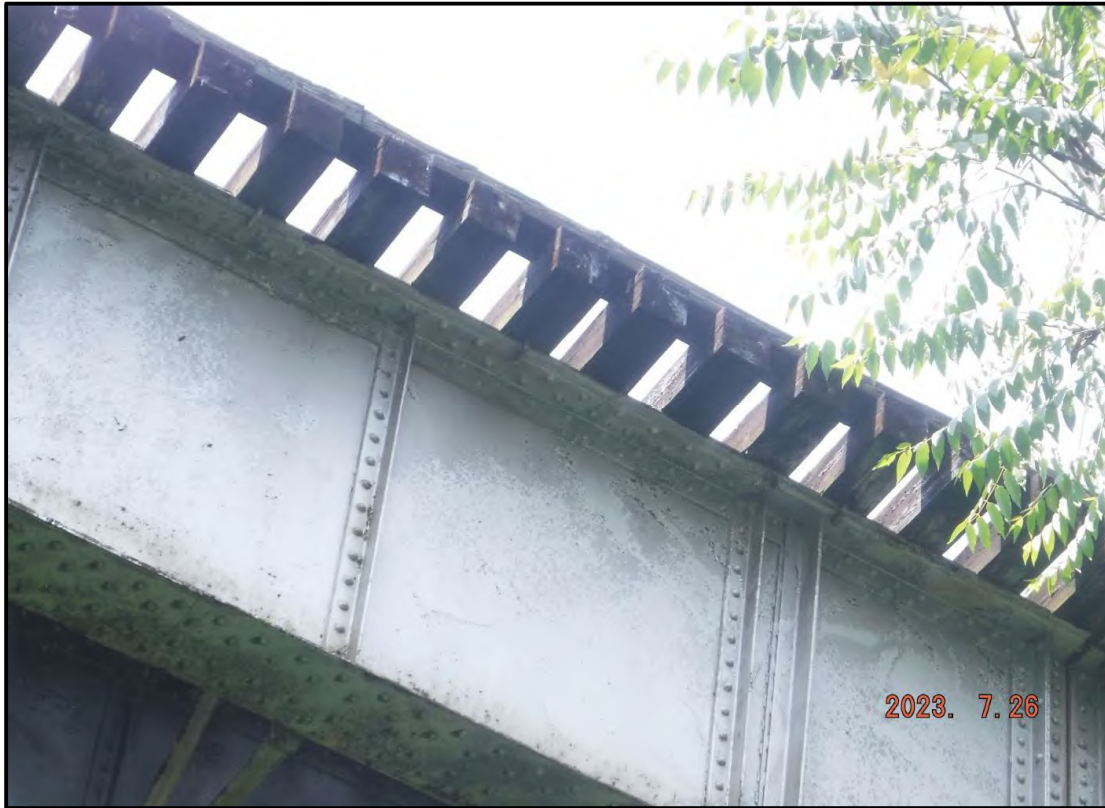
Photo 4: Typical Timber Slab (From North)

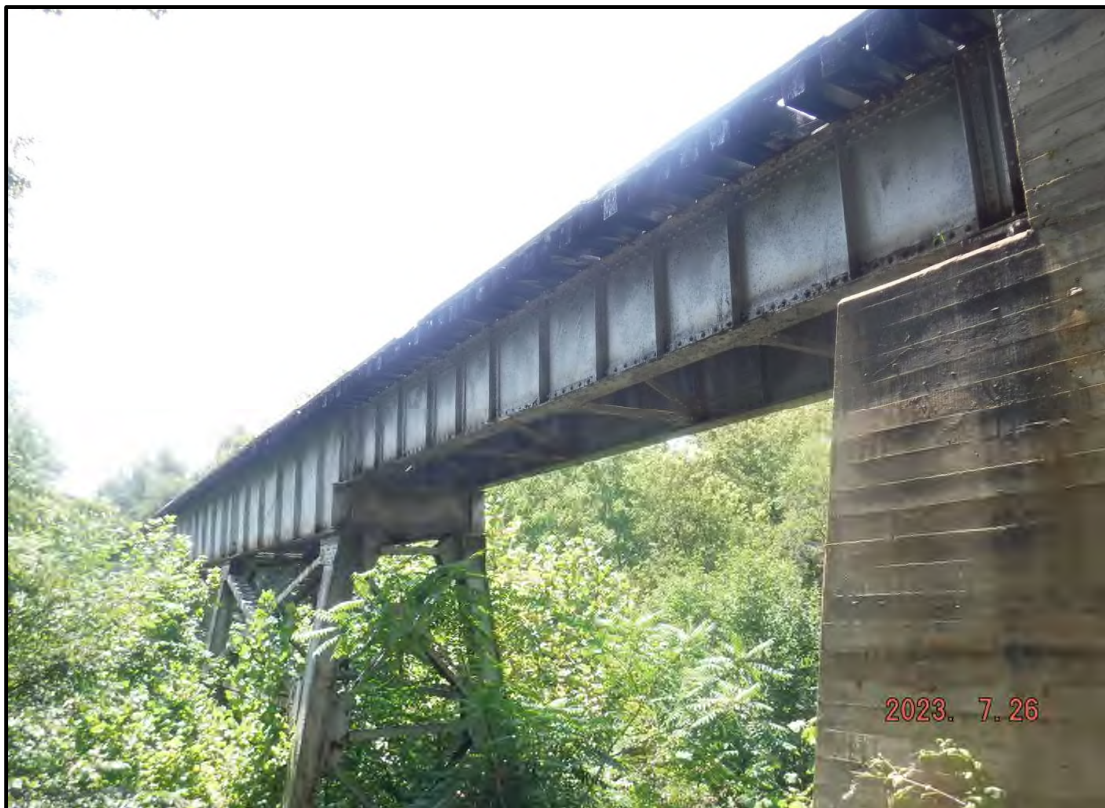
Photo 1: General Condition of Timber Tie Deck

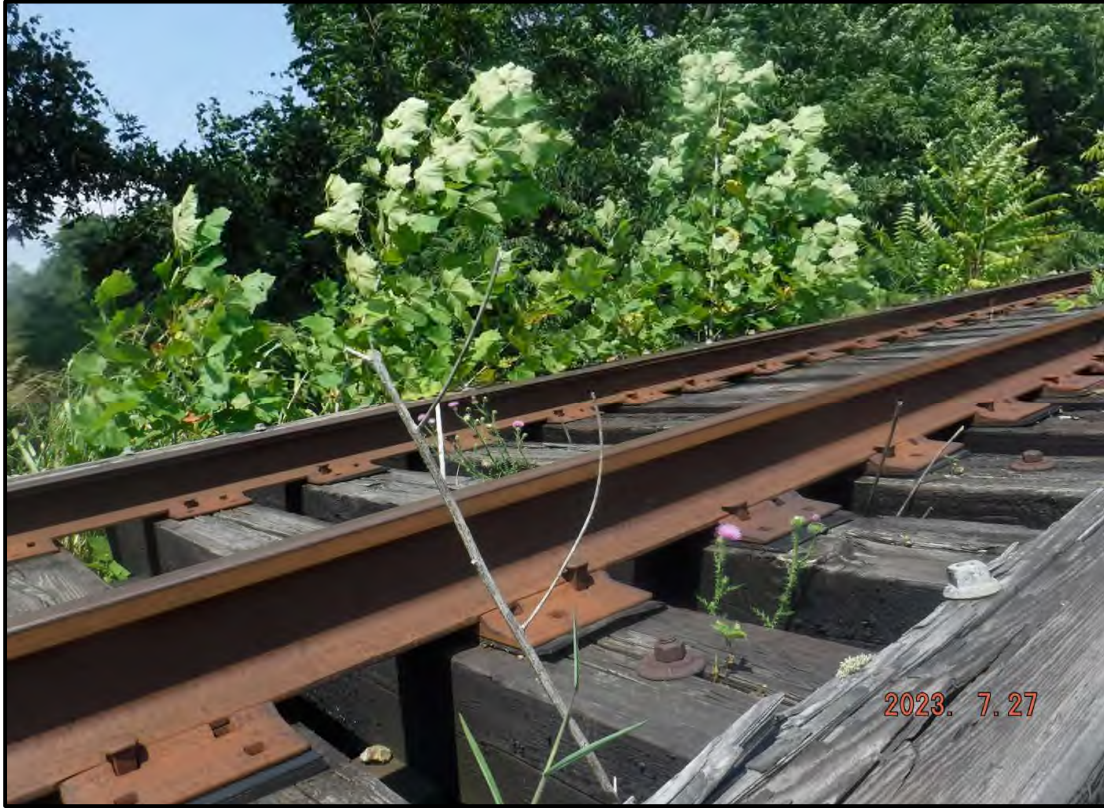
Photo 6: East Approach Trough Structure Behind East Abutment

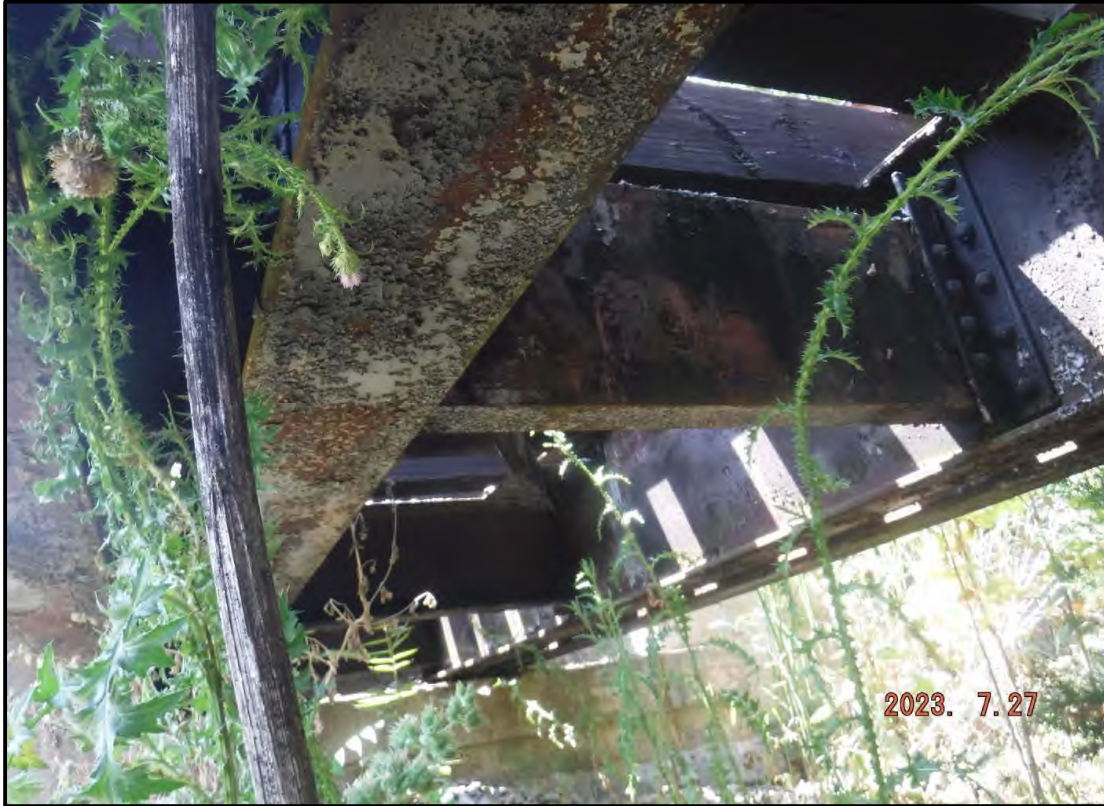
Photo 4: West Abutment

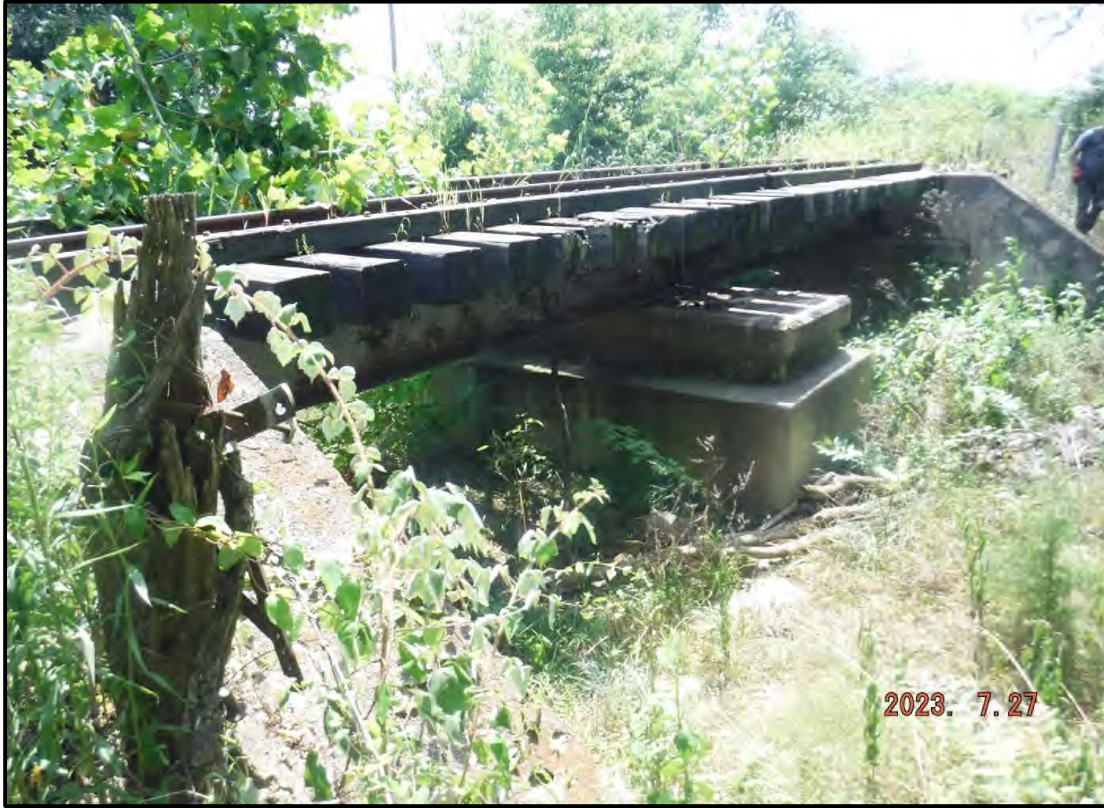
Photo 6: Typical Spalled Bridge Seat (Outside of Bearings)

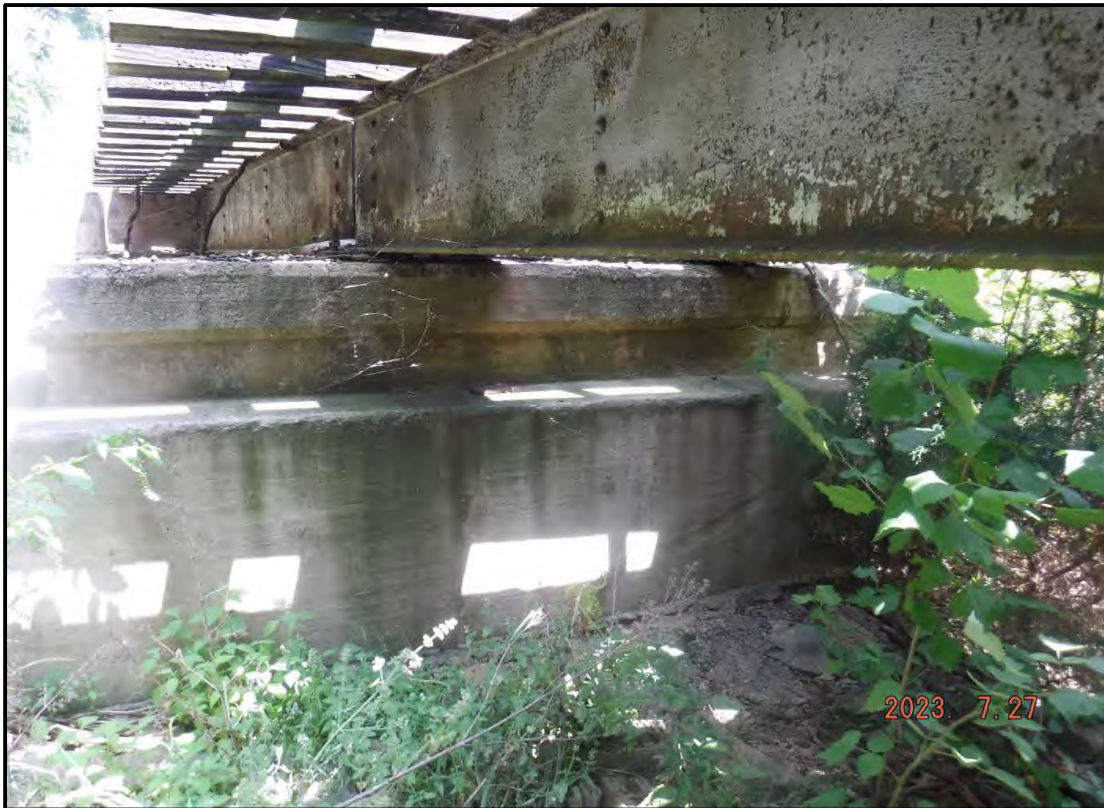
Photo 3: East Abutment

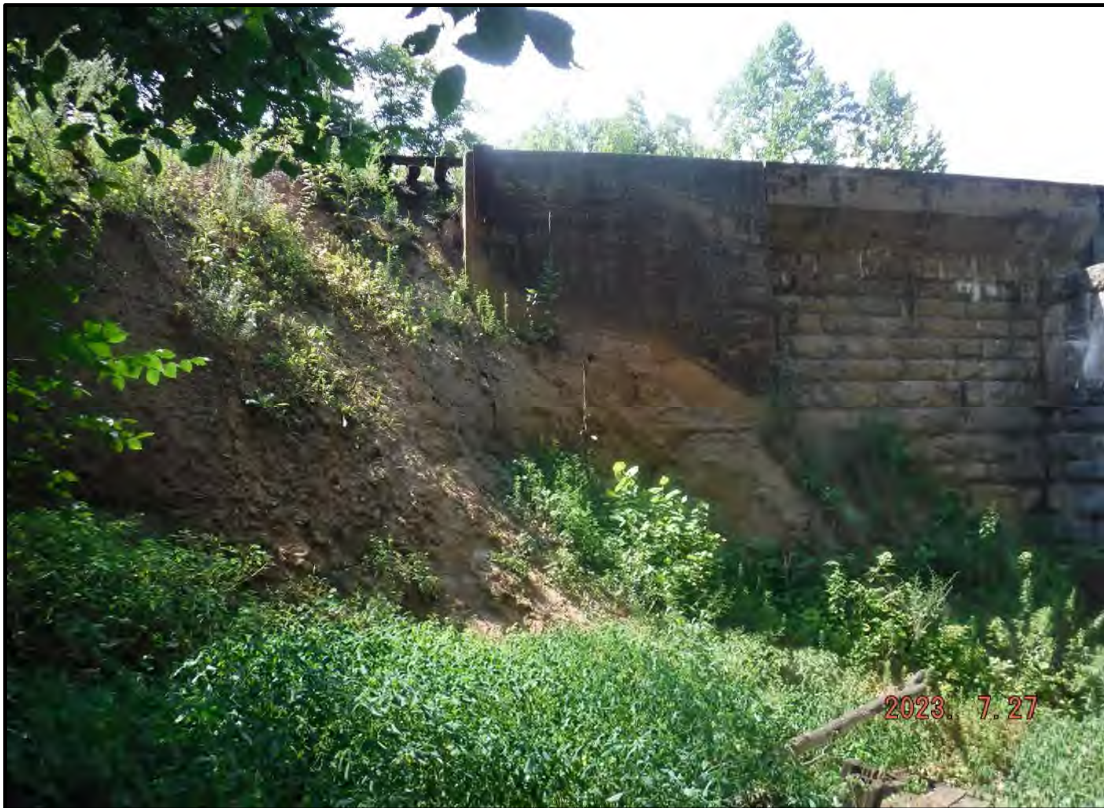
Photo 1: Erosion/Washout at SW Corner of Structure

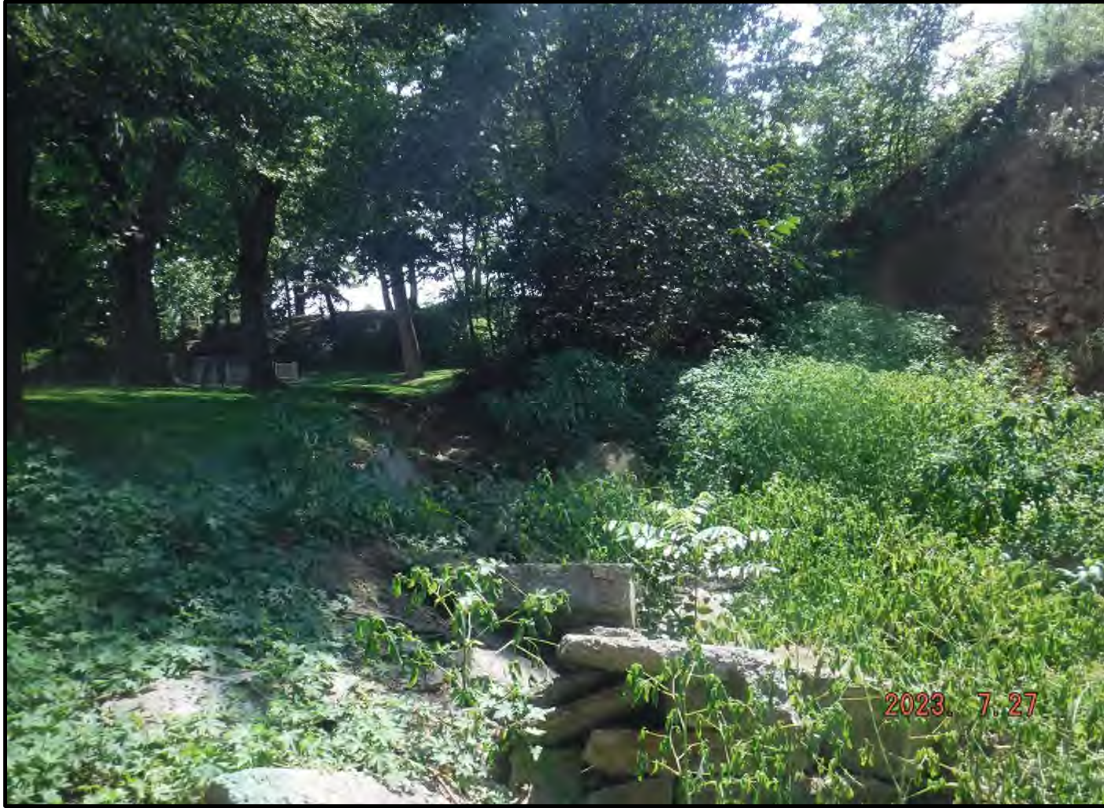
Photo 2: Erosion/Washout at SW Corner of Structure

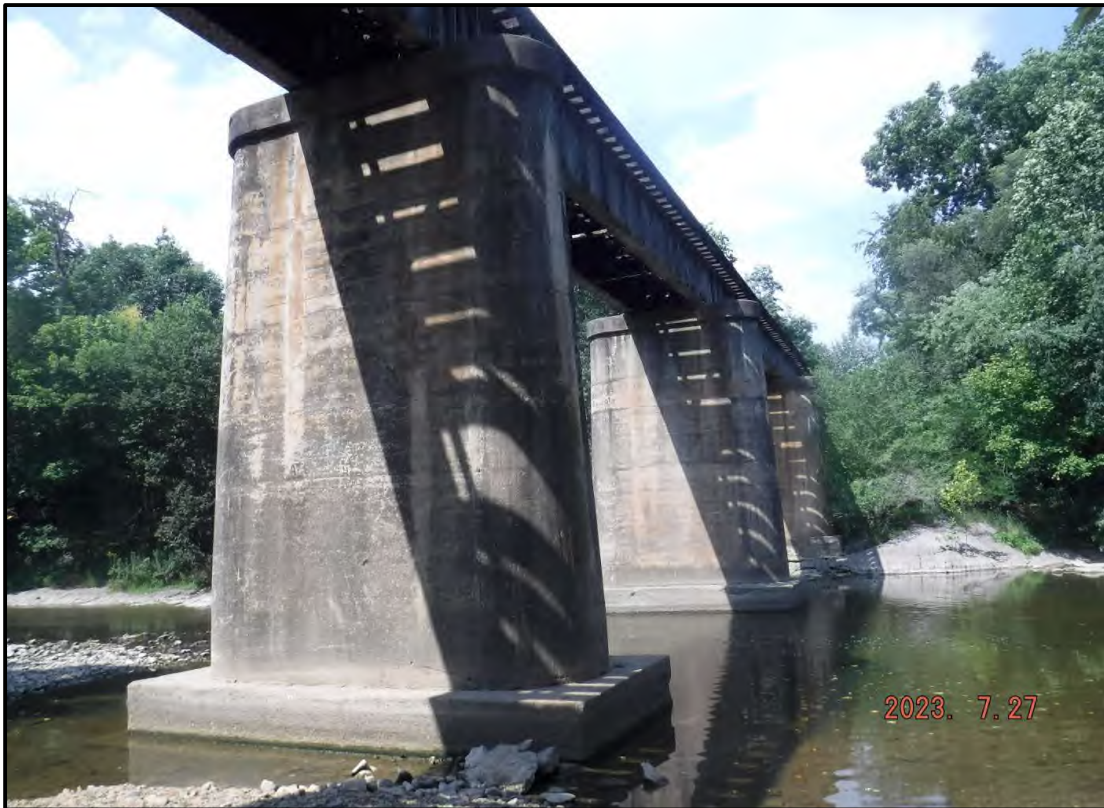
Photo 3: Looking West Up Drainage Ditch at SW Corner of Structure
