**NORFOLK SOUTHERN
RAILWAY CO.
SHENANDOAH VALLEY RAIL
CORRIDOR
BRIDGE EVALUATION**

**STRASBURG, VIRGINIA
SHENANDOAH COUNTY**

**NORTHERN SHENANDOAH VALLEY
TRANSPORTATION PRESERVATION CORP.**

PROJECT NO. 23-1502.101
August 25, 2023
Revised August 31, 2023

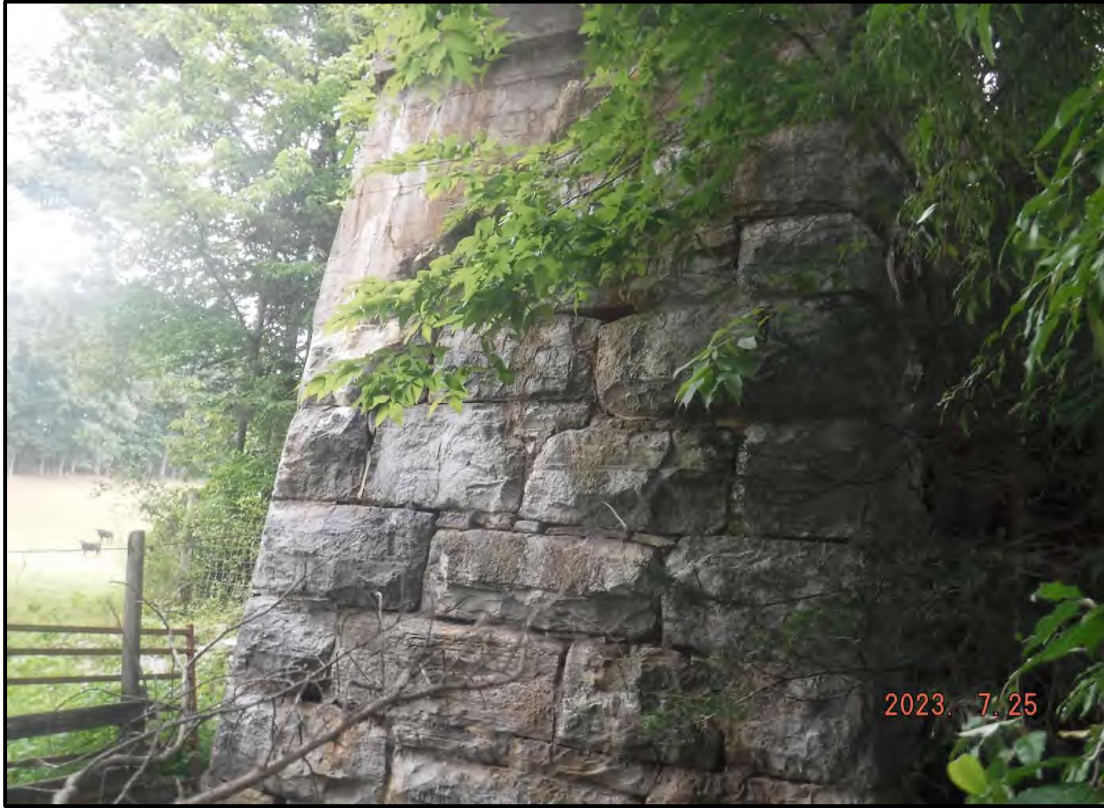
Photo 2: West Abutment

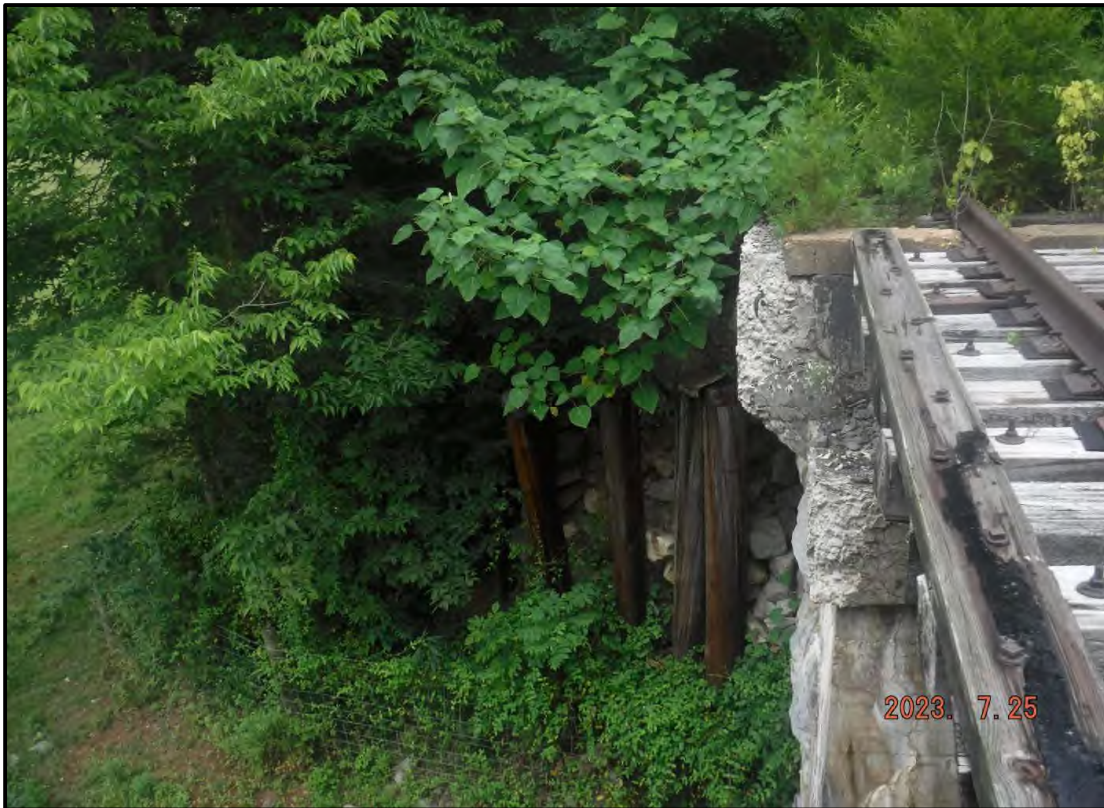
Photo 3: East Abutment

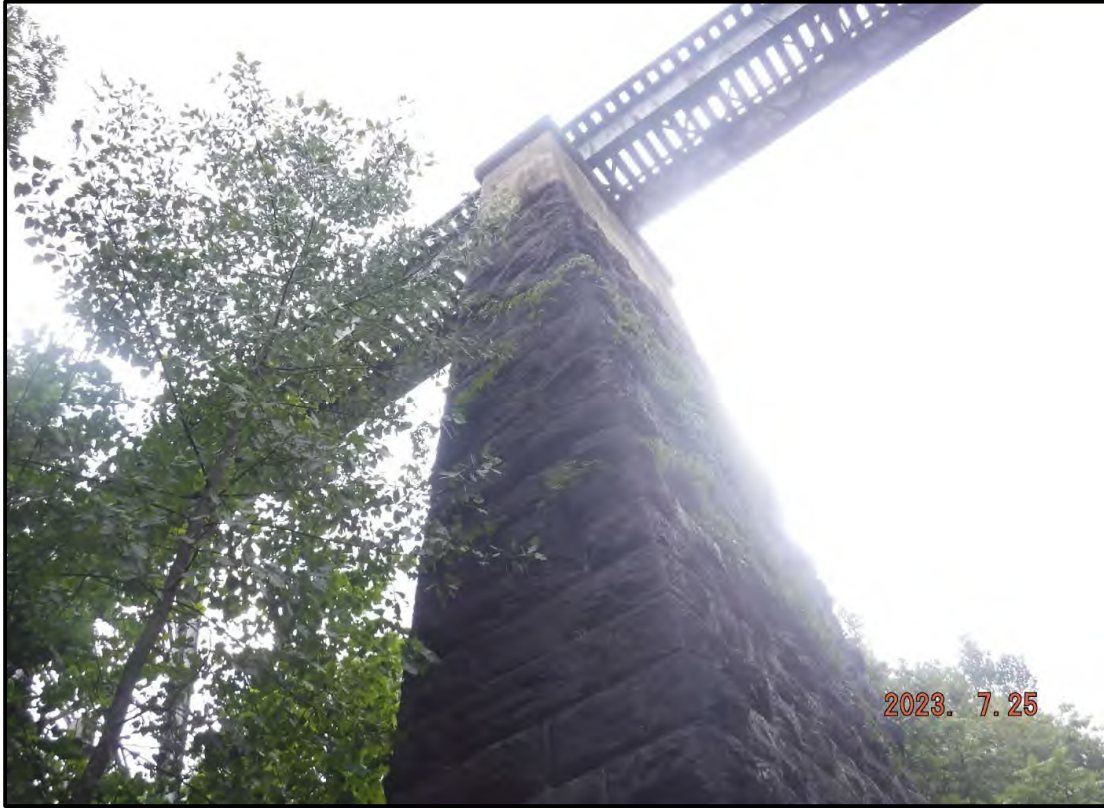
Photo 6: East Abutment

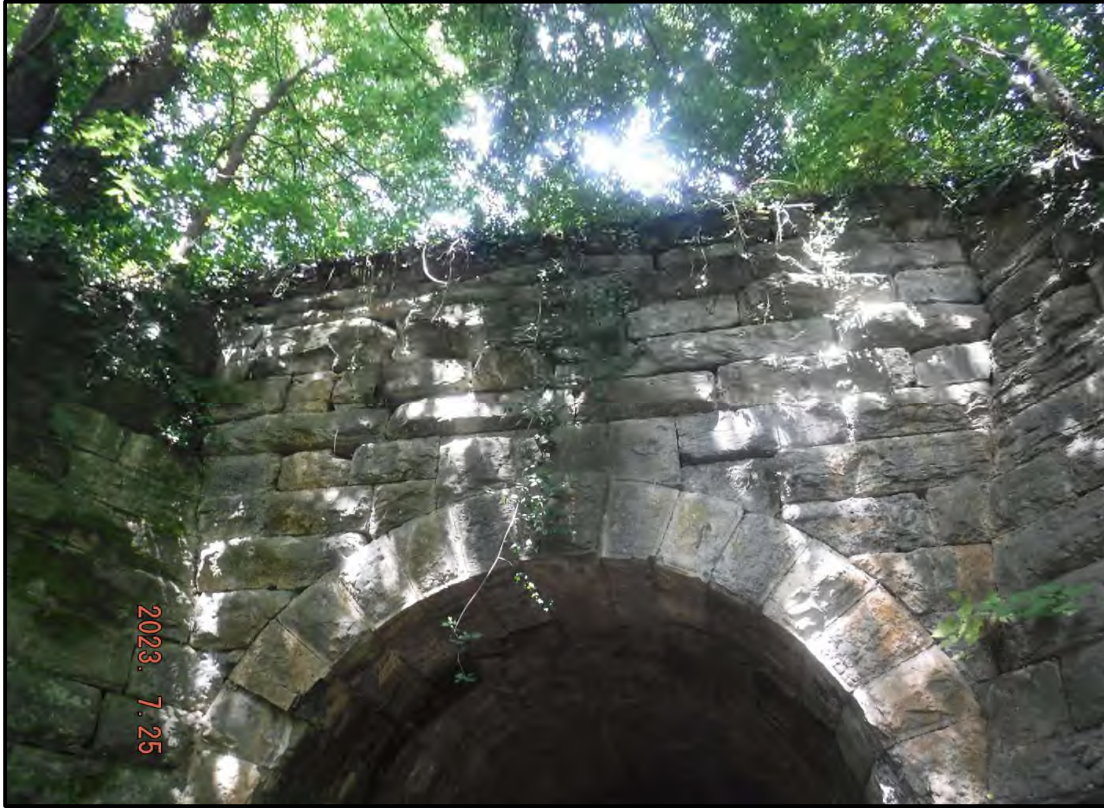
Photo 4: Through Stone Arch (From North)

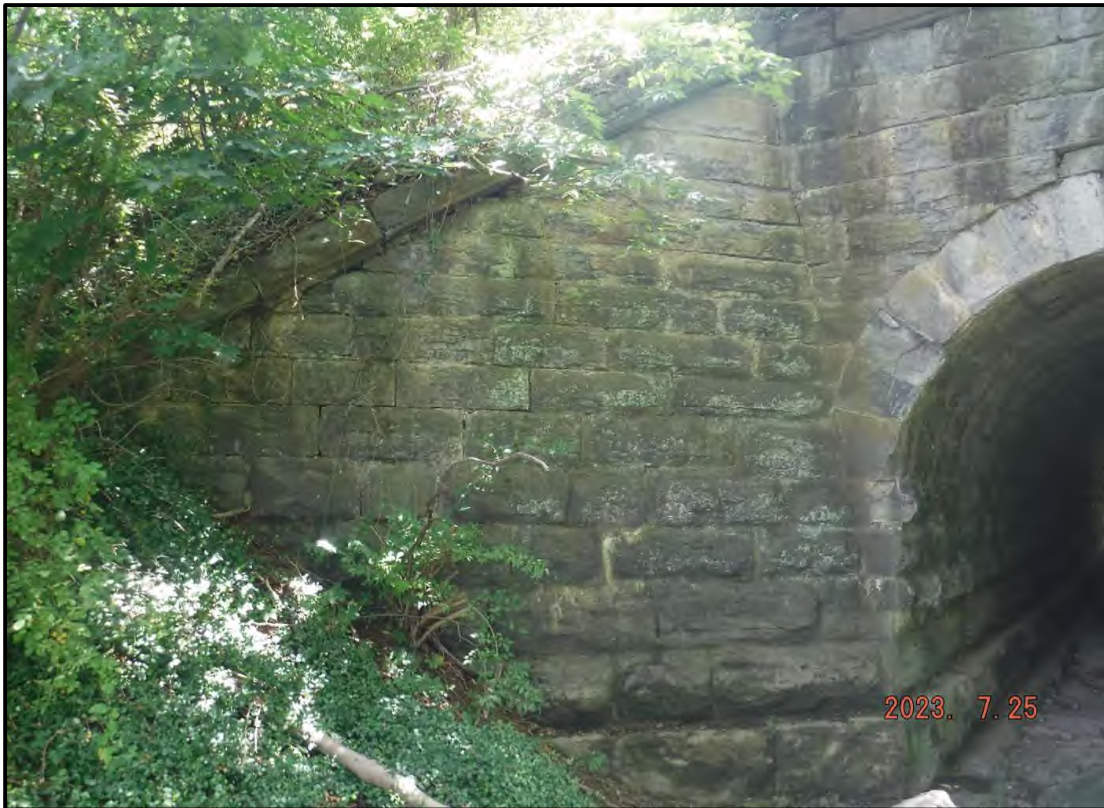
Photo 5: South Headwall

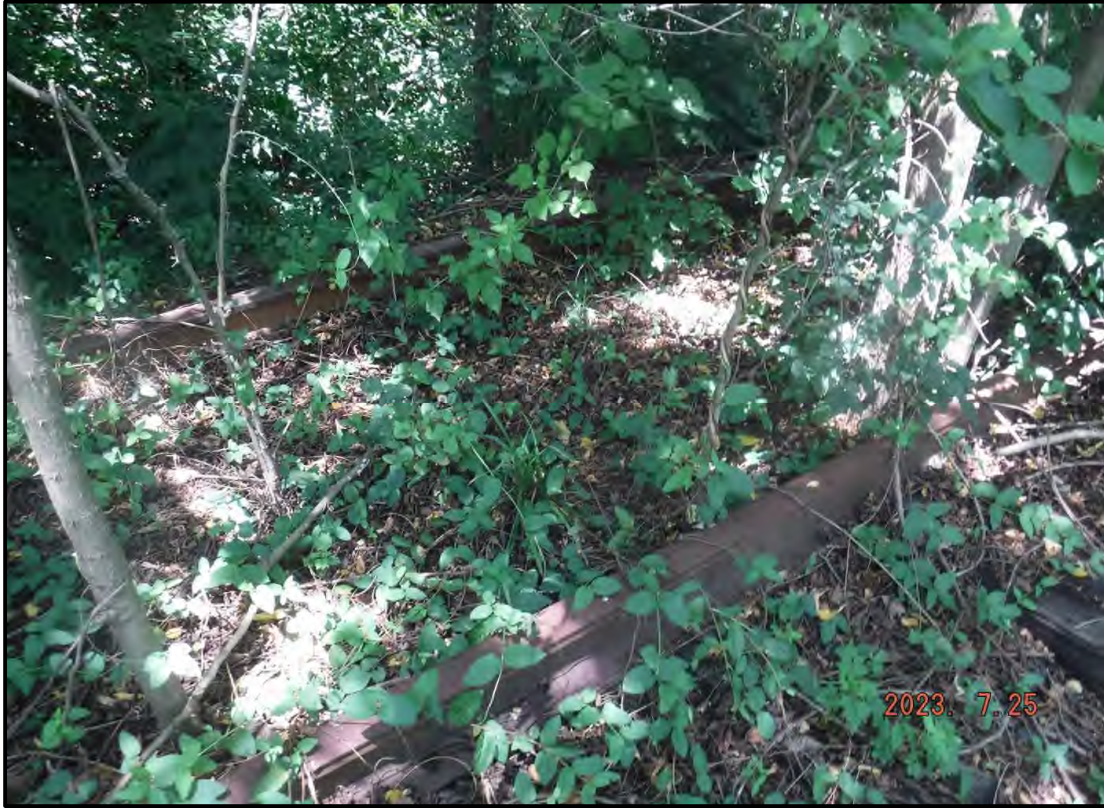
Photo 6: Typical Wingwall (NE Wing Shown)

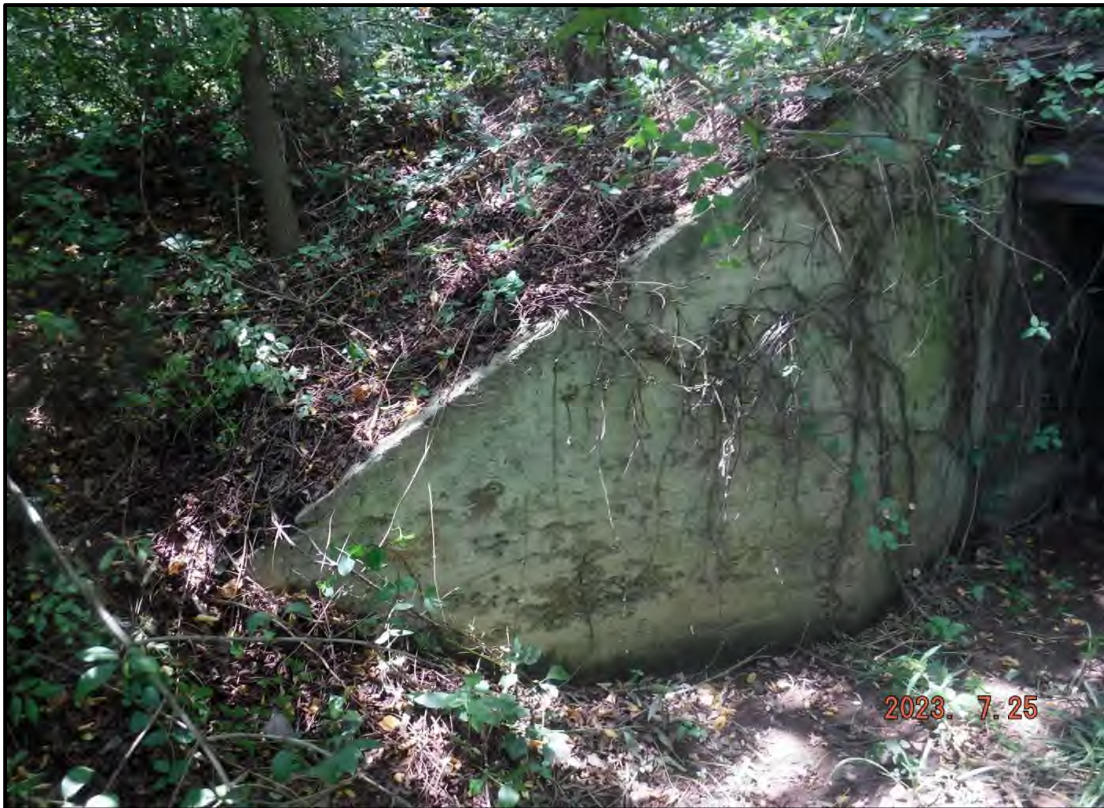
Photo 1: Track on Structure

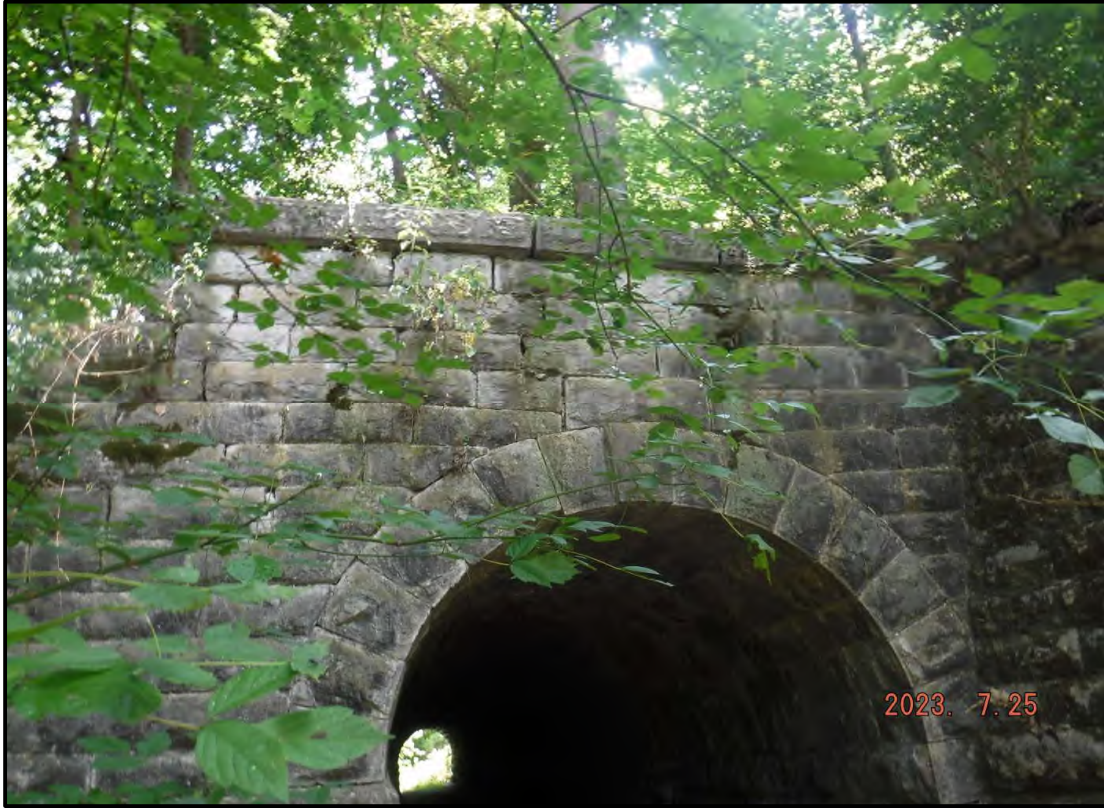
Photo 8: Spalled Concrete on Main Span Bent 2 North Pedestal

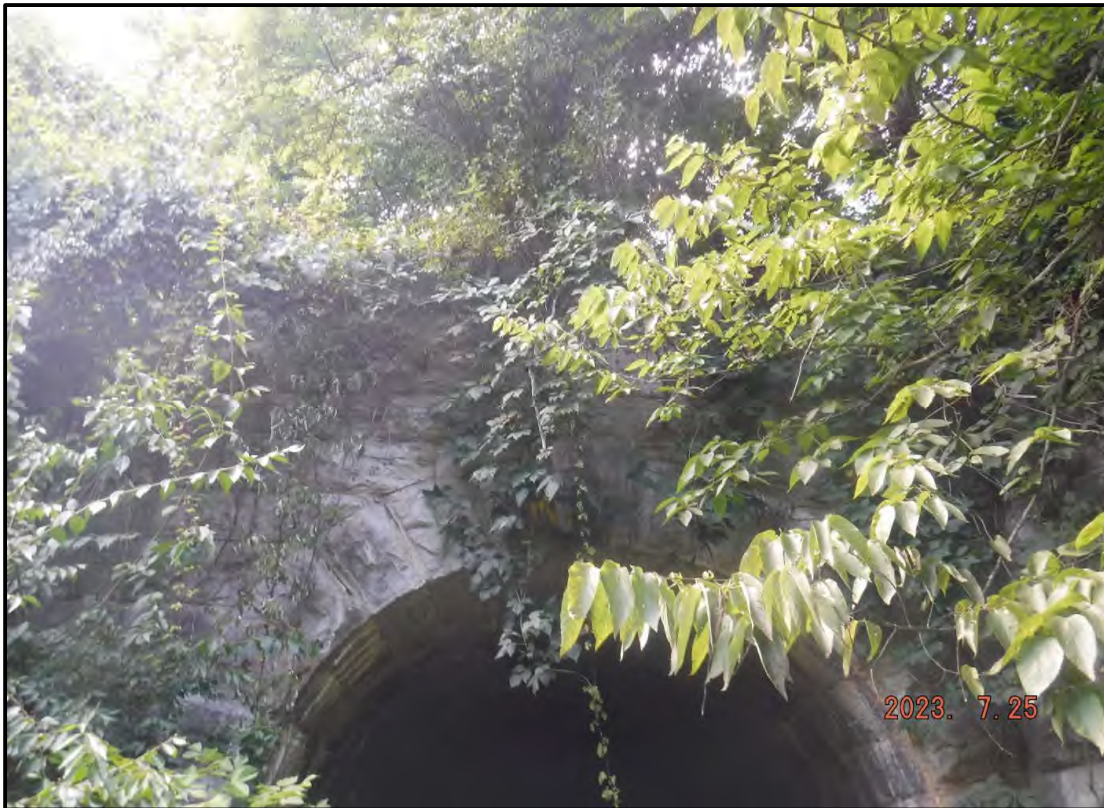
Photo 3: Through Stone Arch (From South)

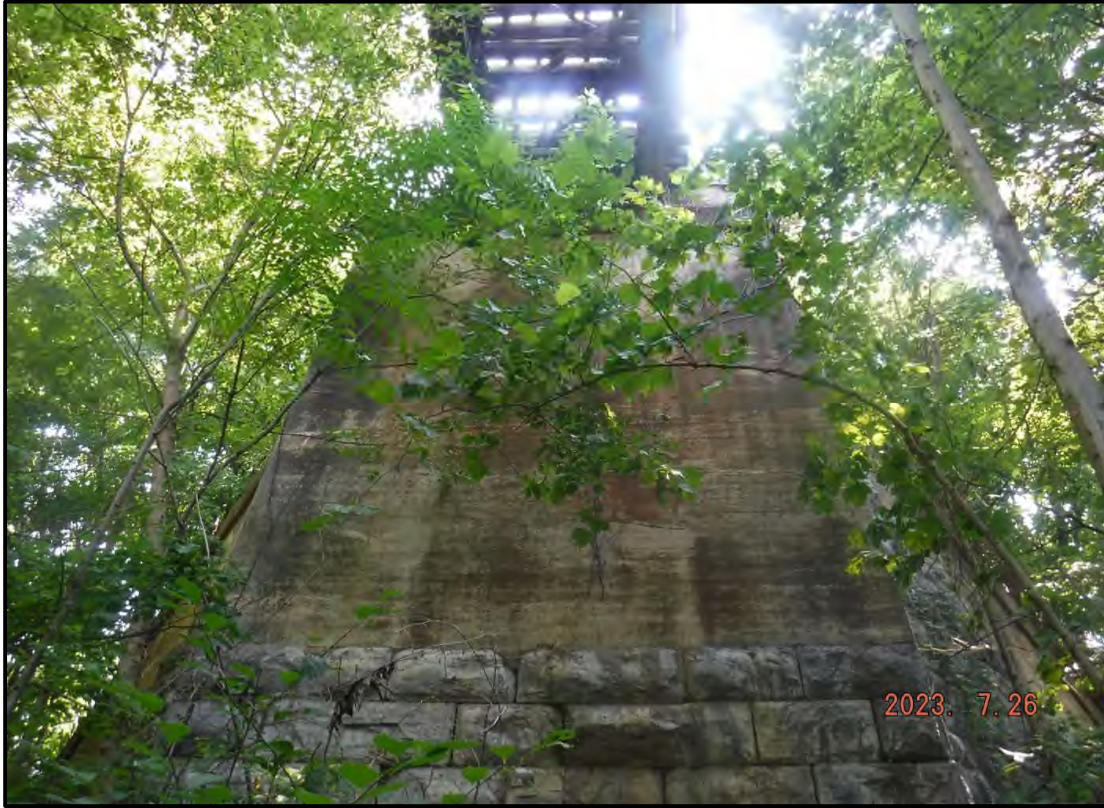
Photo 6: Typical Exposed Footing (Steel Bent Tower)

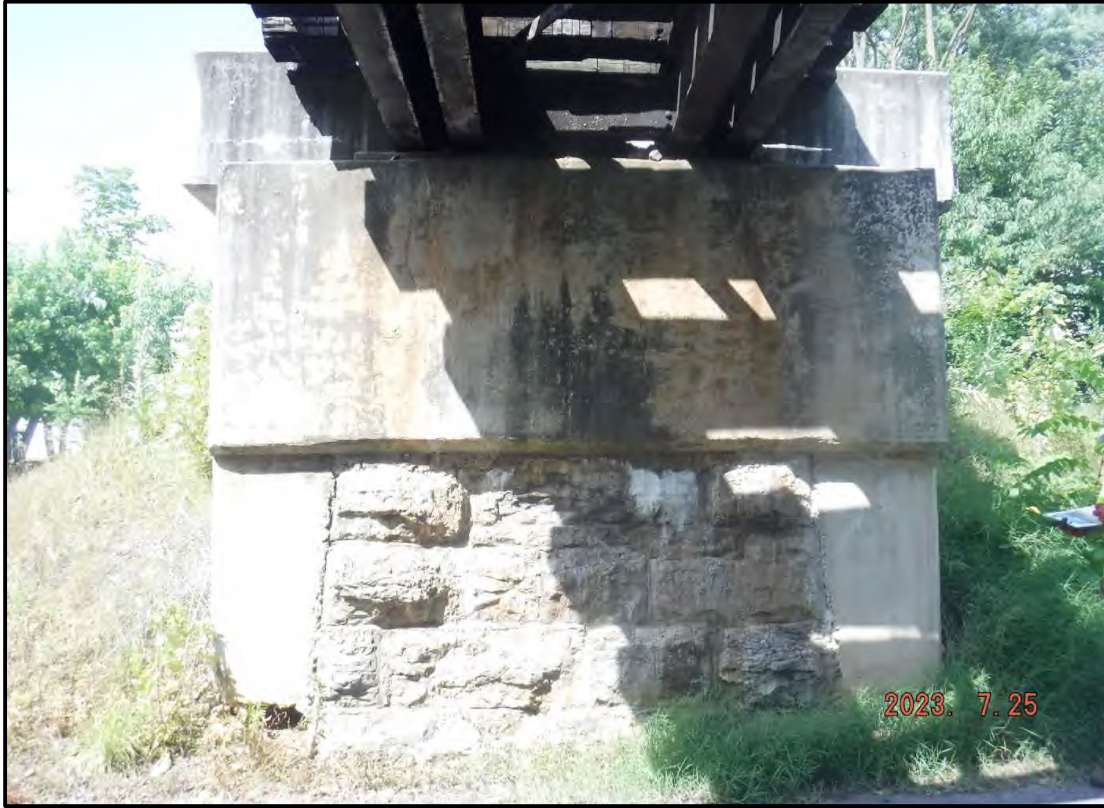
Photo 4: West Abutment

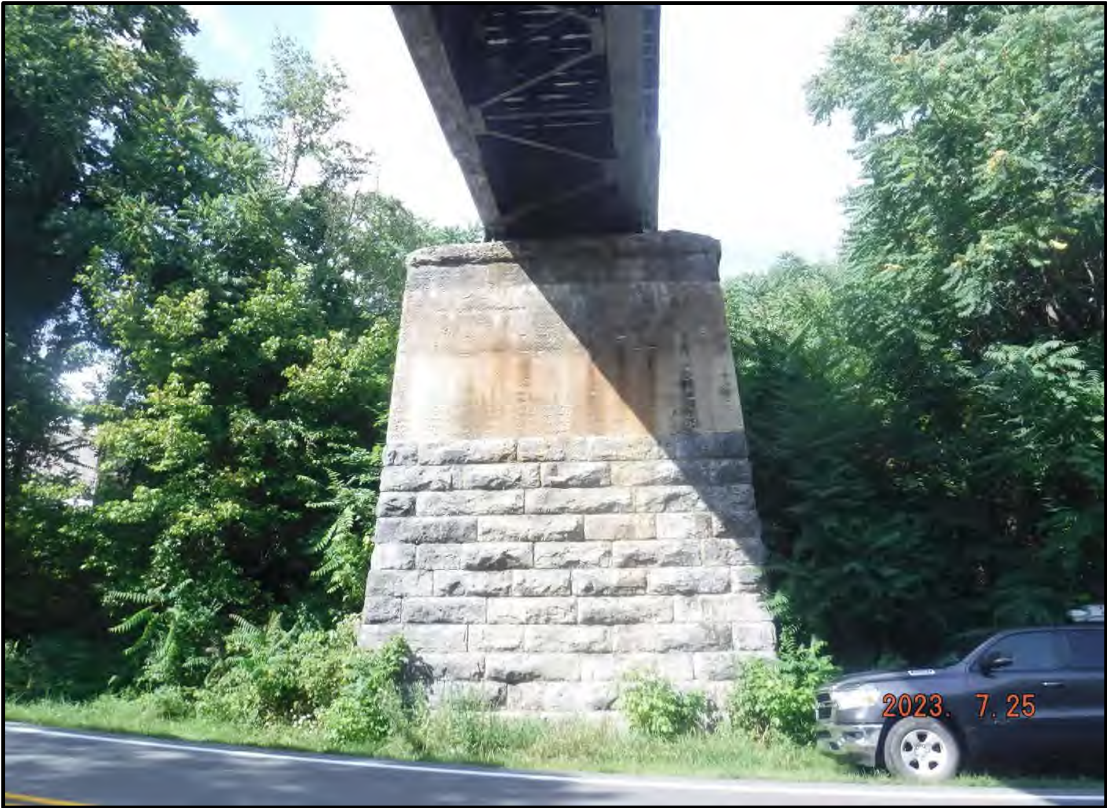
Photo 1: General Condition of Timber Tie Deck

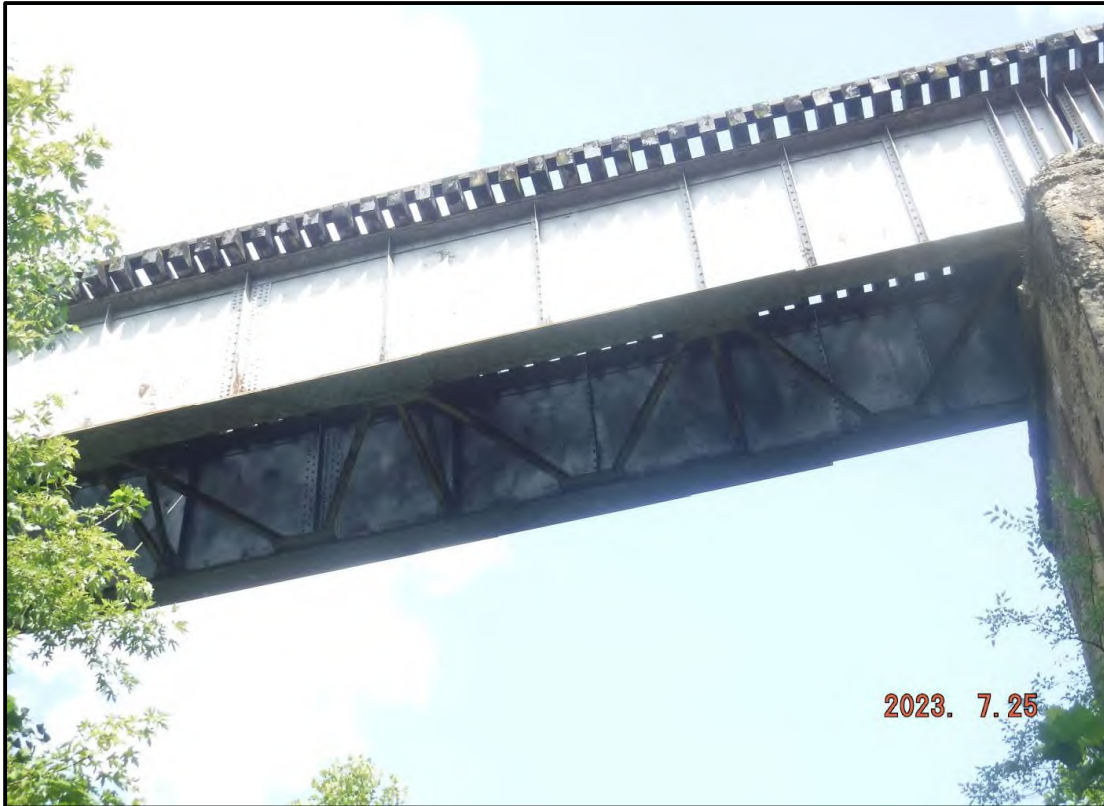
Photo 5: Typical Underside of Span

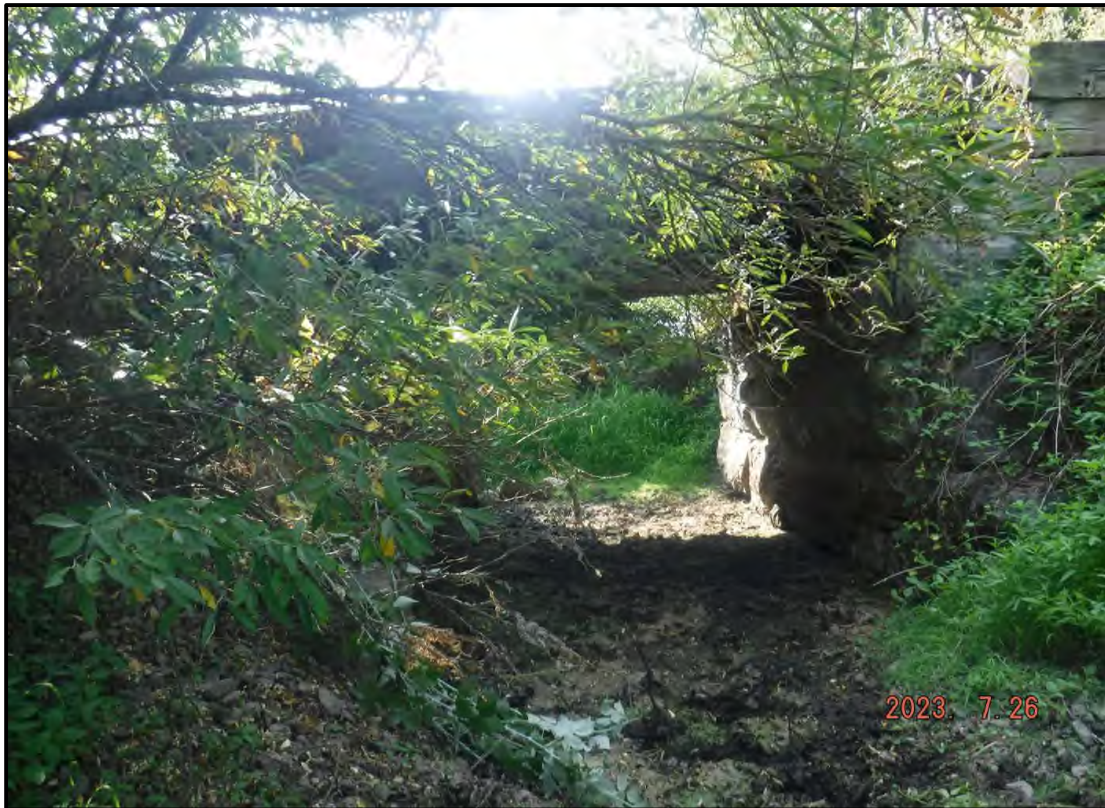
Photo 3: Typical Timber Slab

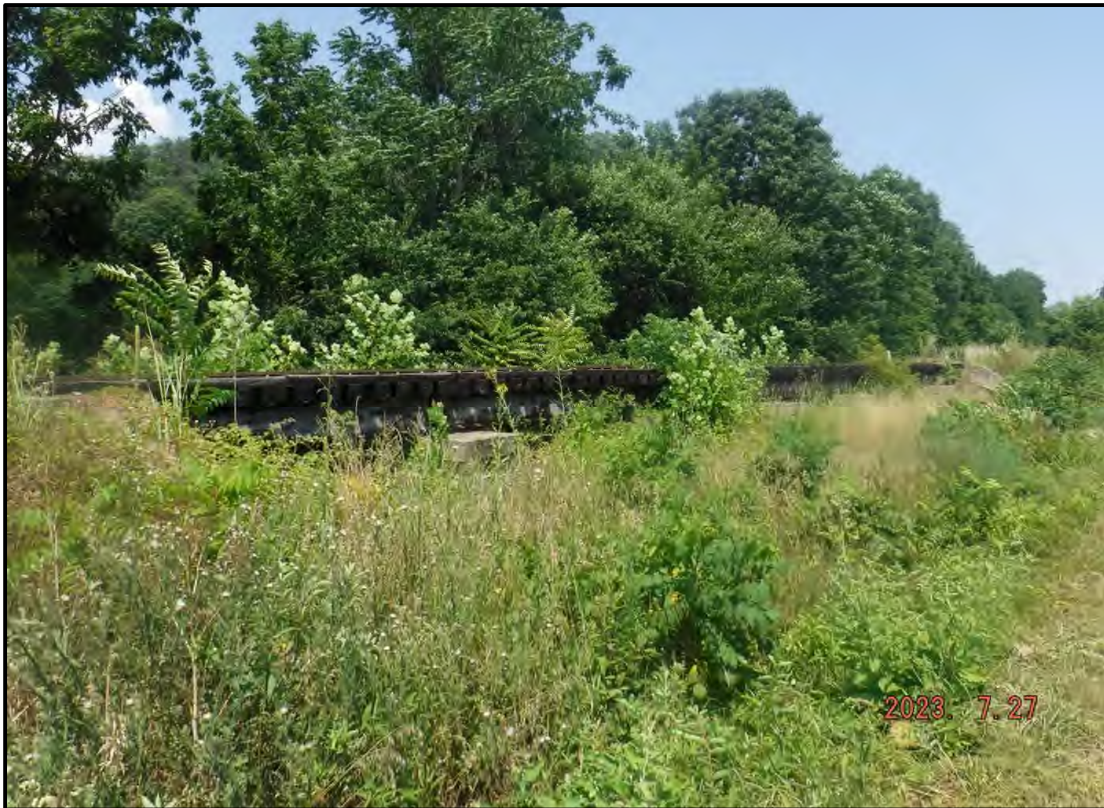
Photo 1: General Condition of Timber Tie Deck

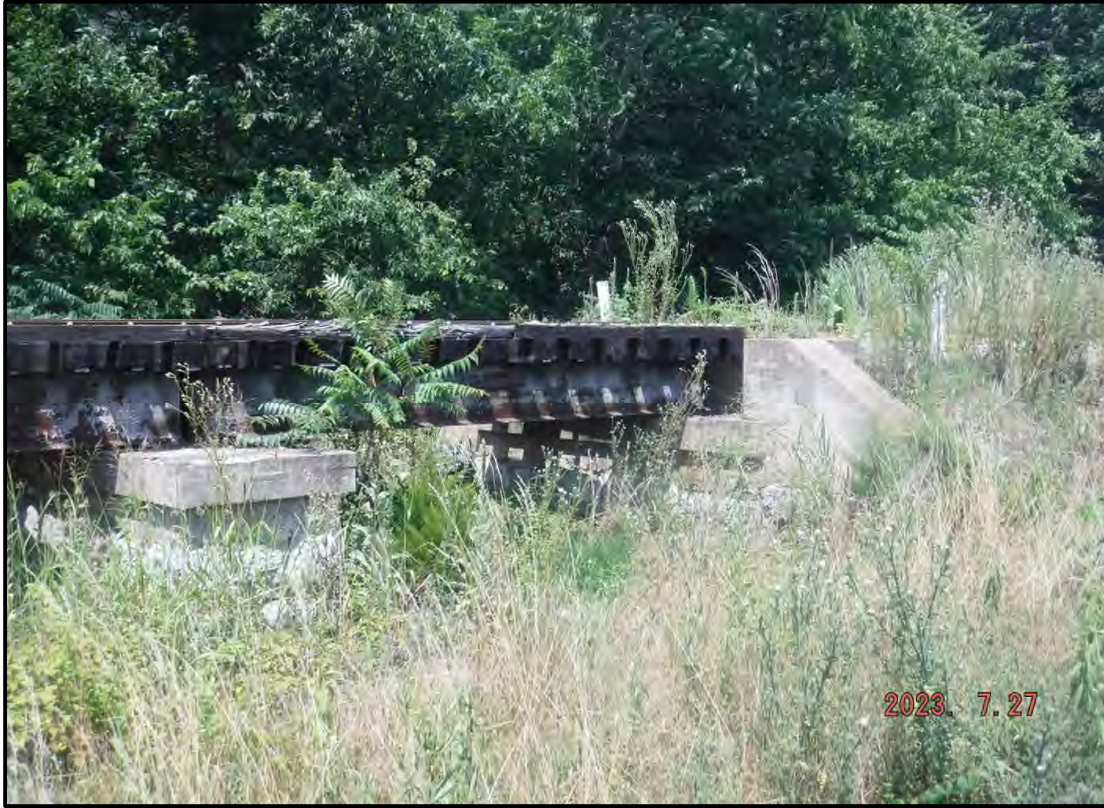
Photo 2: South Elevation

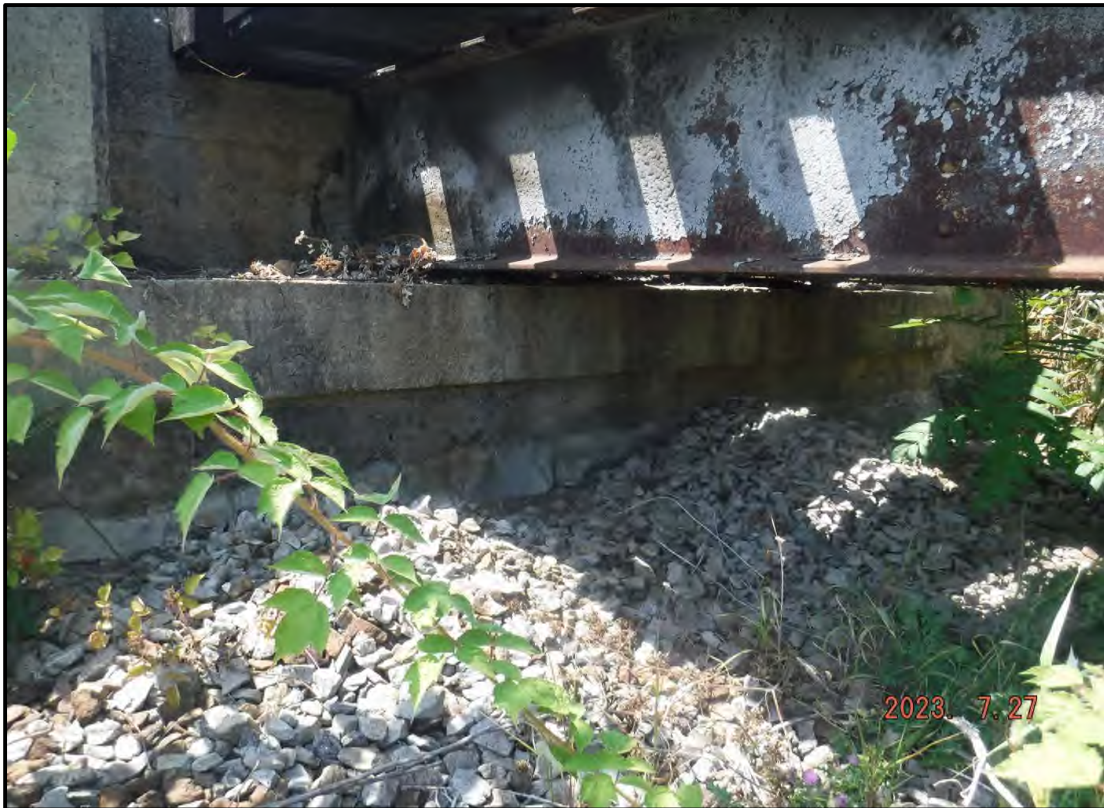
Photo 3: East Abutment

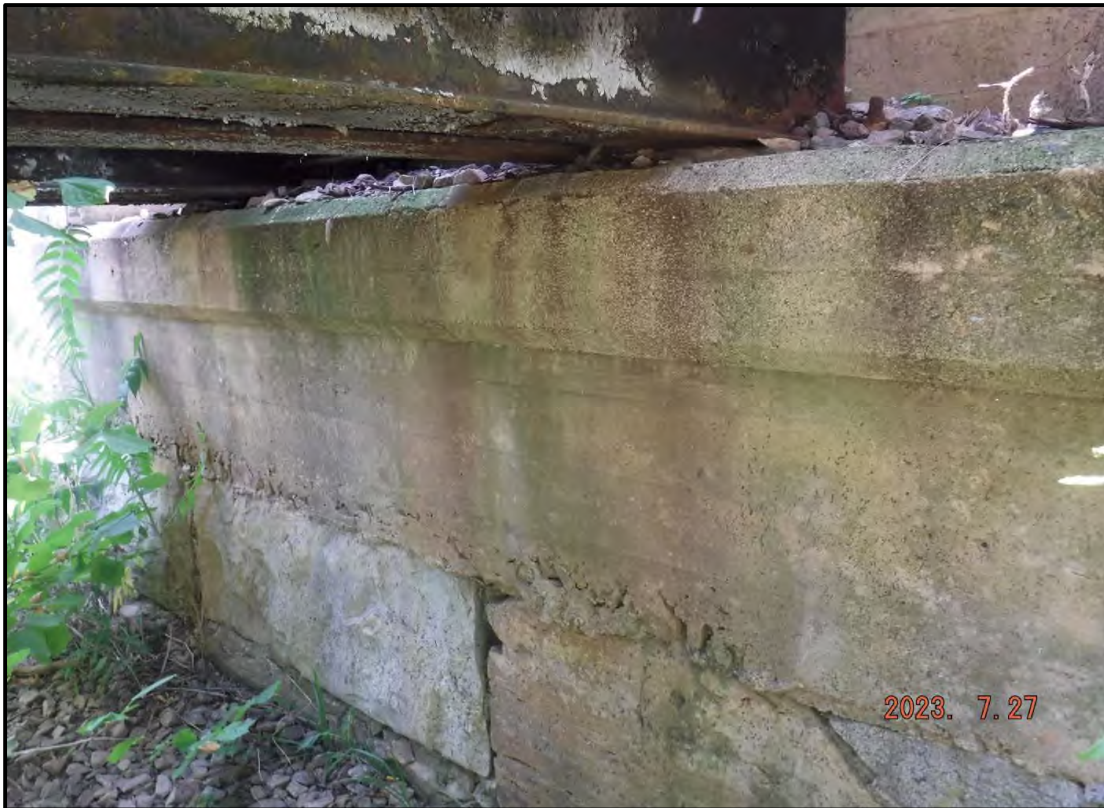
Photo 1: General Condition of Timber Tie Deck

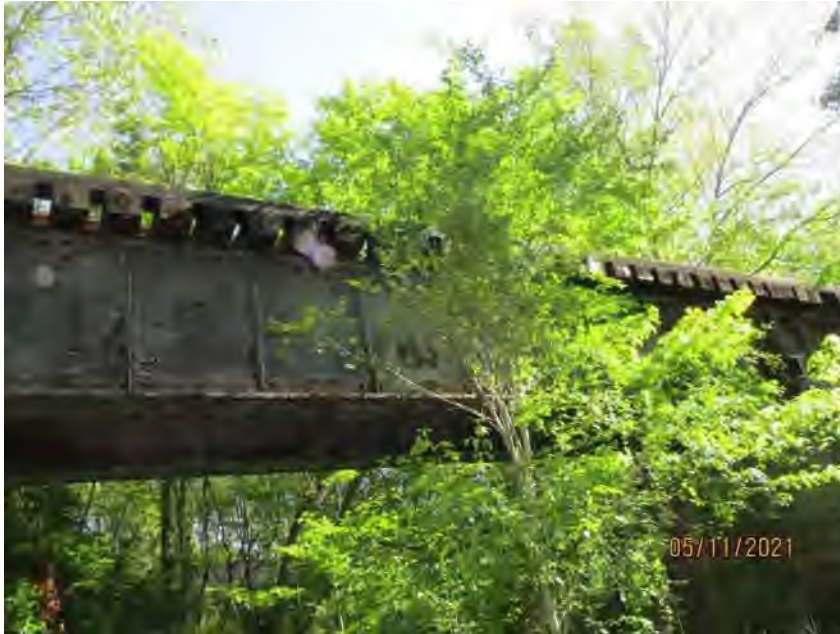
Photo #3

Looking at downstream side of Span 1.

Dense vegetation growth in span encroaching structure.

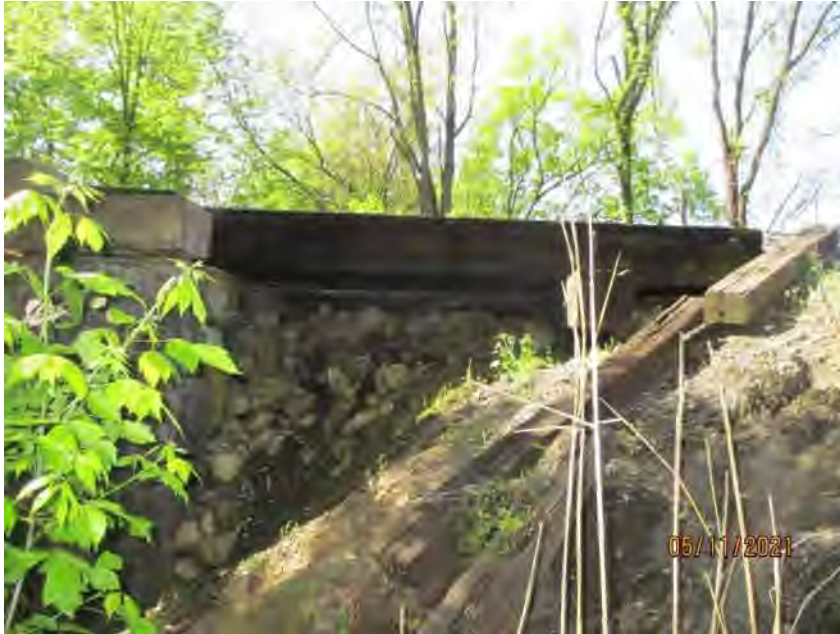
Photo #5

Abutment A upstream side.

Behind abutment at approach slab (longitudinal railroad ties) area of erosion and undermining on both the upstream and downstream sides.

Area of erosion:
7' long x 3' wide x 10' high.

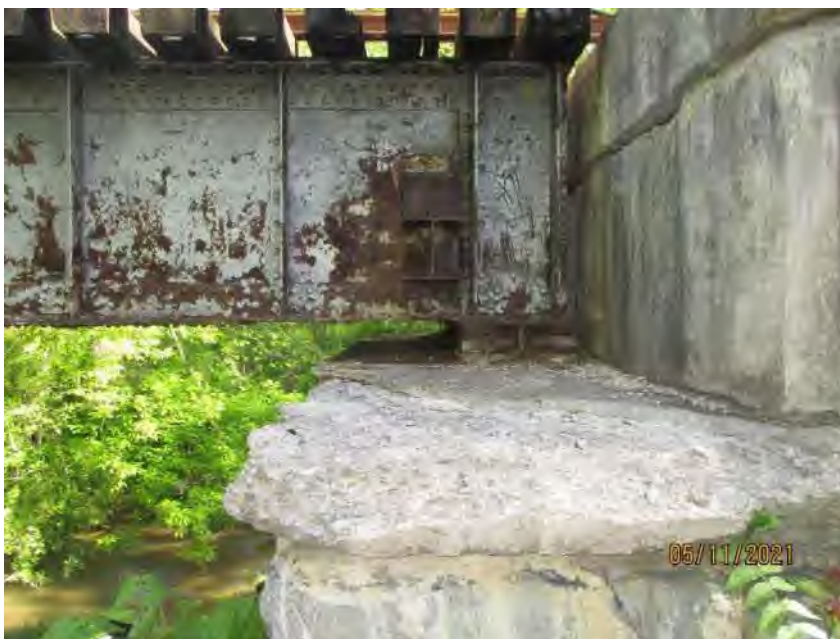
Photo #10

Looking at Abutment B top of pedestal downstream side.

Area of spall:
4' long x 9" high x 6" deep.

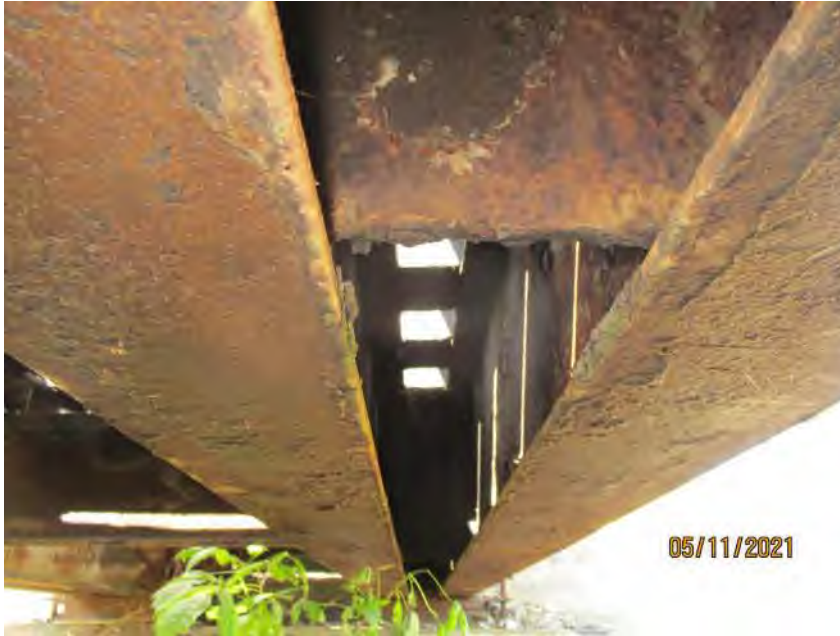
Photo #3

Looking at G3 and G4

Mild vegetation growth encroaching beams.

Beams exhibit surface rust with no measurable section loss.

- Remove railroad ties and install new timber deck planks.
- Repair/seal cracks in abutments.
- Repair spalls in abutments.
- Install a suitable transition from the gravel railroad bed at both ends of the structure, including grade transitions and installation of a safety guardrail at the transition to the structure.
- Install a pedestrian railing that meets current safety standards.
- Preparation and painting of the entire superstructure is recommended.
- Clean bearing areas.

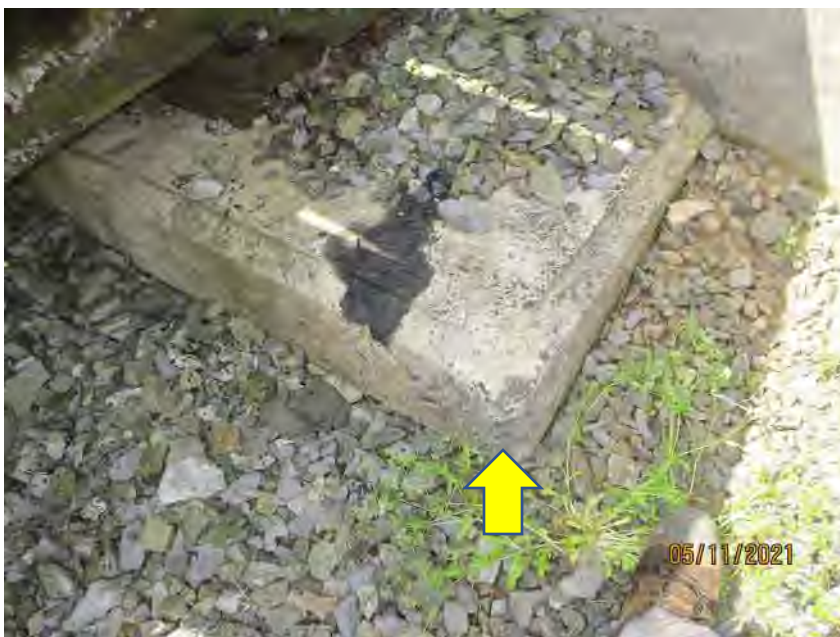
Photo #4

Abutment A is in good condition. Spall near G1 on upstream side 3" long x 3" wide x 2" deep. See Photo #4.

Looking at Abutment A.

Spall 3" long x 3" wide x 2" deep.

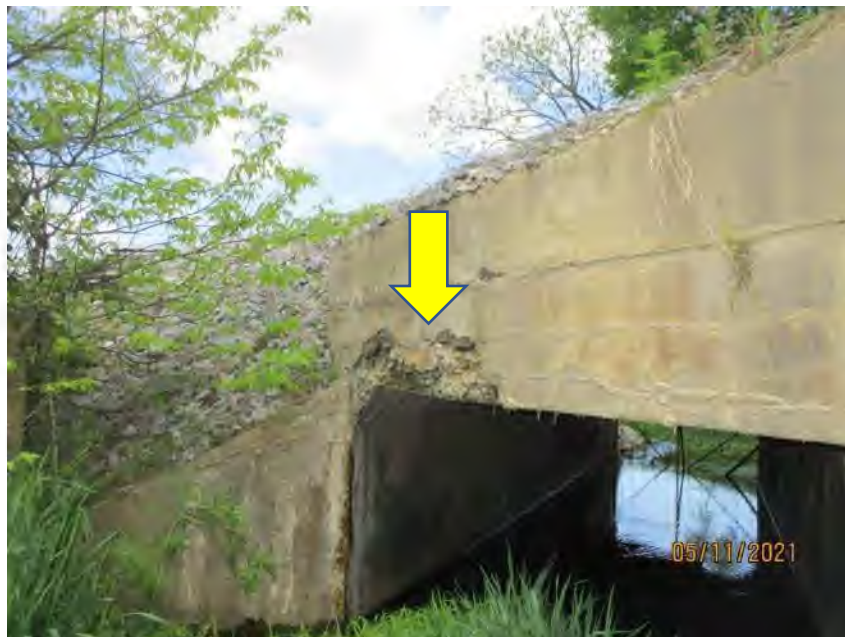
Photo #2

Headwalls are in fair condition. The downstream headwall has a spall 5' long x 1.5' high x up to 10" deep and cracking 4' long x 1/16" wide. The upstream headwall has a spall 5' long x 9.5" high x 3" deep on. See Photos #2-#4.

Downstream headwall at southwest corner.

Area of spall:
5' long x 1.5' high x up to 10" deep

- Remove railroad ties.
- Repair/seal cracks in wingwalls and barrel.
- Repair spalls in wingwalls and headwalls.
- Install a pedestrian railing integrated into the existing culvert along the opening that meets current safety standards.

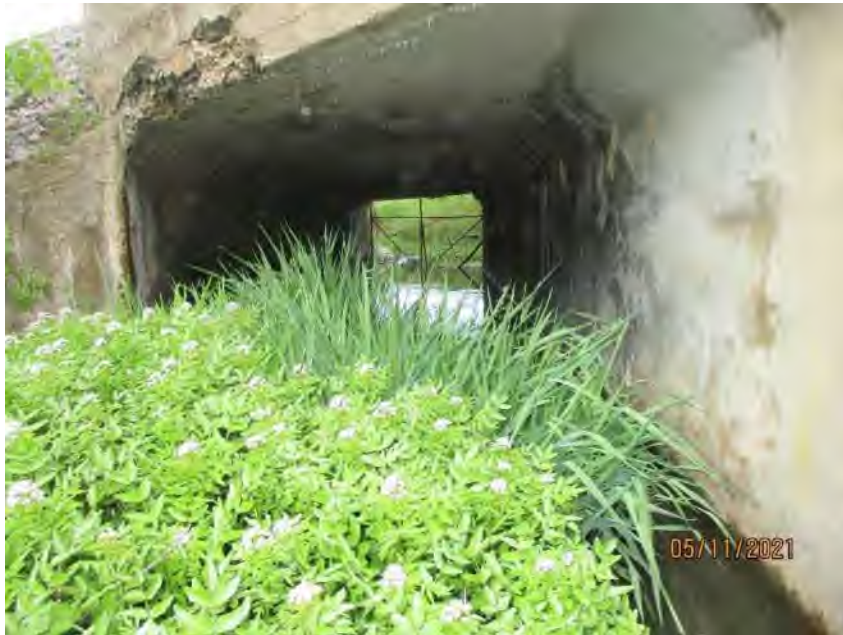
Photo #5

The barrel is in good condition. There are hairline full height vertical cracks throughout. See Photo #5.

Looking into barrel from downstream end.

Inside barrel full height hairline vertical cracks in random locations.

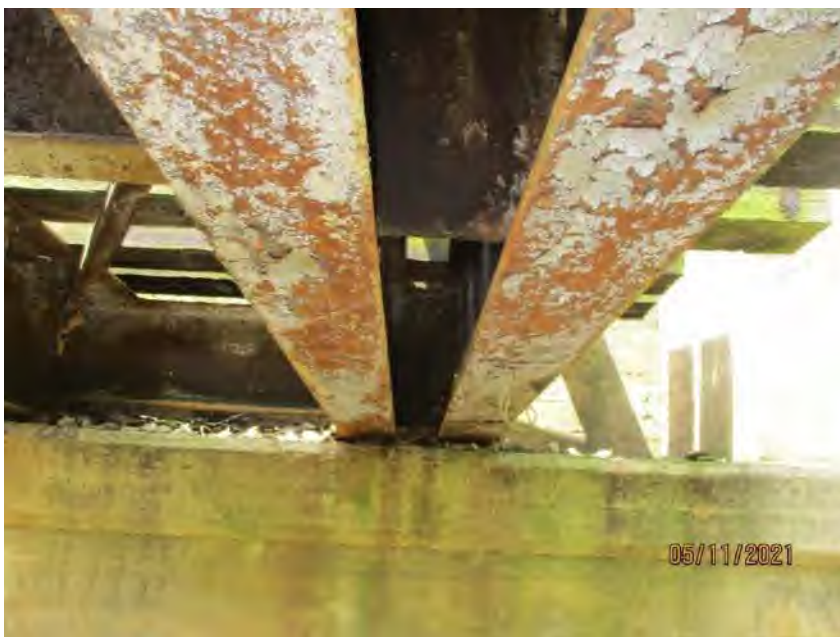
Photo #2

In general, the condition of the steel superstructure elements is in good condition. Surface rust exists on all steel members. The superstructure exhibits trace evidence of paint with no protective value remaining. At time of inspection no measurable section loss was observed to members. See Photos #2-#3.

Span 1, double girder unit G1 and G2 at Abutment A.

Surface rust on girders and superstructure elements with failed coating.

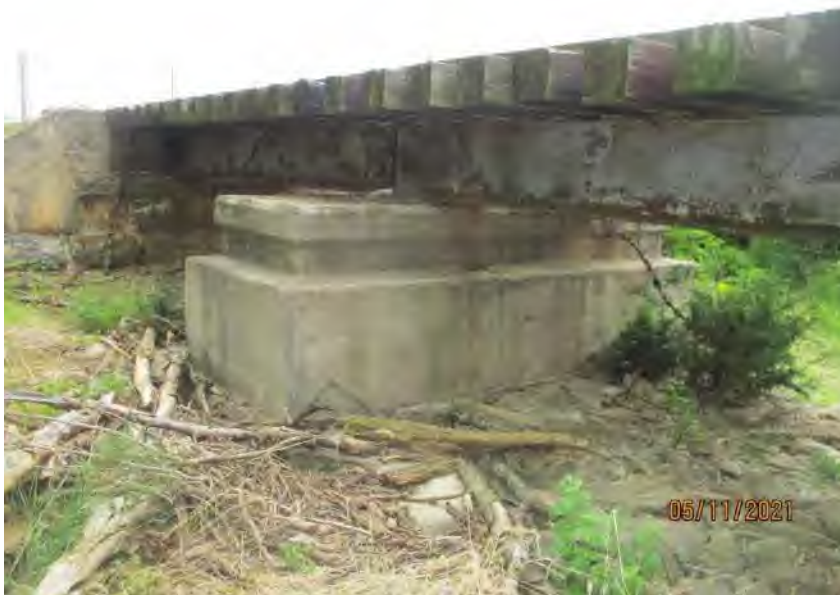
Photo #4

The concrete abutments are in fair condition with minor cracking, some with efflorescence. Abutment A has minor cracking at both wingwalls. There is also accumulation of debris on top of the bearing seat. Abutment B has spalling and delamination full width x up to 6' high x 3" deep. See Photos #5-#6. Stone portions of the abutments are in fair condition with minor loss of mortar. The pier is in fair condition with minor cracking and some minor spalls. Accumulation of debris on upstream side of the pier is present. See Photo #4.

Looking at Pier on upstream side.

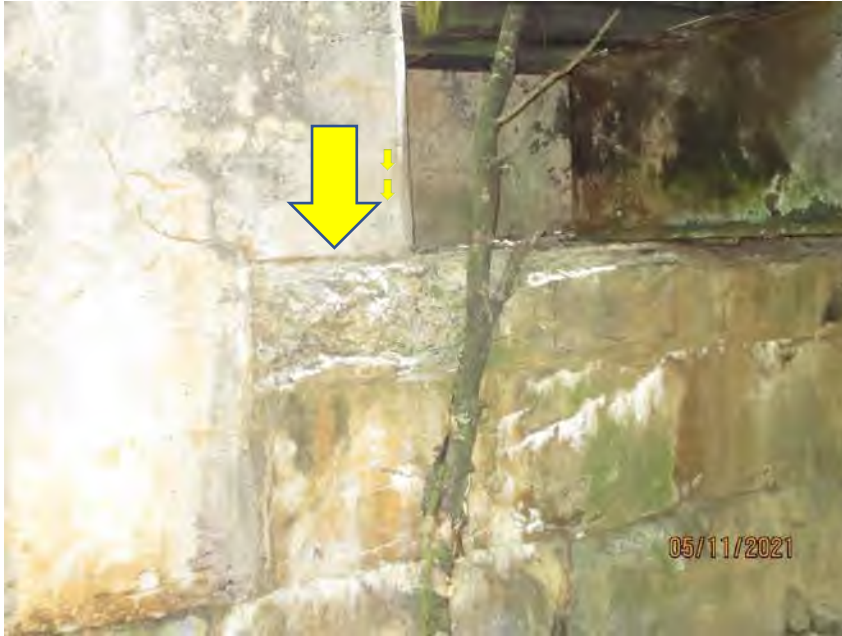
Photo #5

Abutment B upstream side.

Concrete spall:
2' long x 1' high x 2" deep.

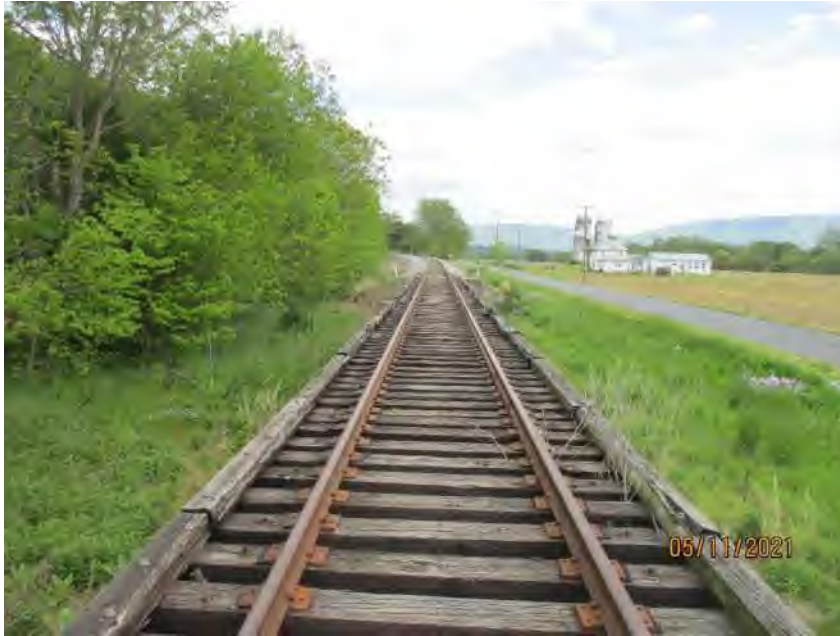
Photo #1

Looking west at top of structure toward Abutment A.

Timber railroad ties deteriorated.
