**NORFOLK SOUTHERN
RAILWAY CO.
SHENANDOAH VALLEY RAIL
CORRIDOR
BRIDGE EVALUATION**

**STRASBURG, VIRGINIA
SHENANDOAH COUNTY**

**NORTHERN SHENANDOAH VALLEY
TRANSPORTATION PRESERVATION CORP.**

PROJECT NO. 23-1502.101
August 25, 2023
Revised August 31, 2023

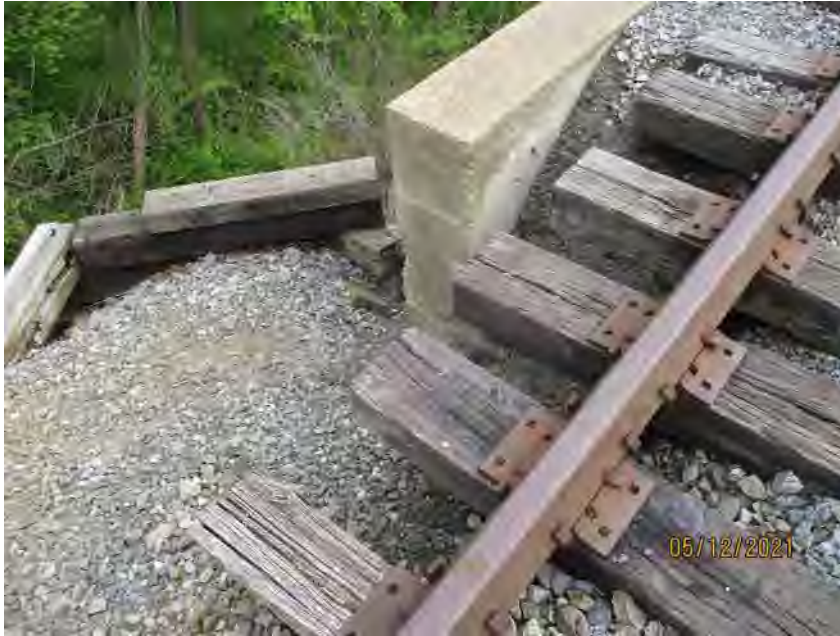
Photo #5

Abutment A upstream side

Area of erosion:
4'-8" deep x 9' long x 3' wide

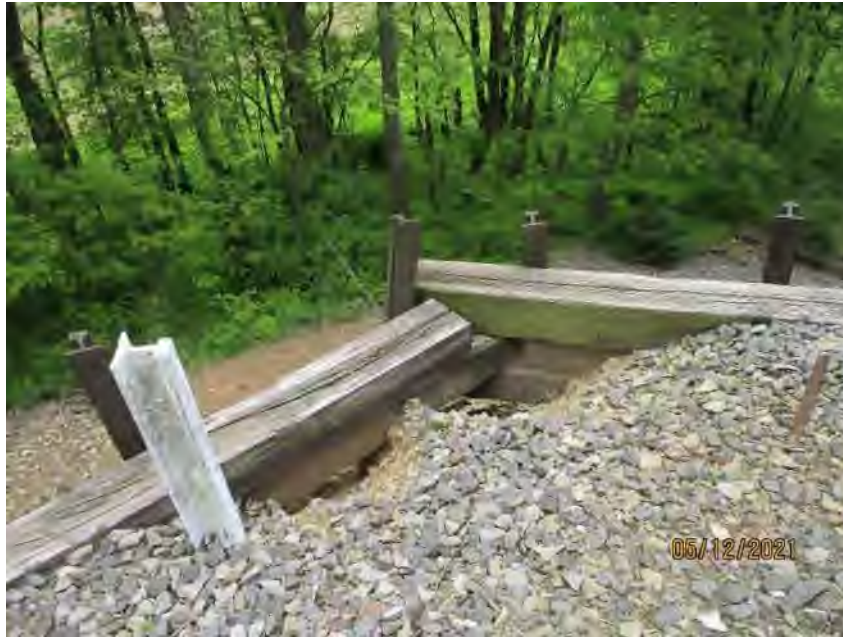
Photo #9

Abutment B erosion behind wingwall downstream side

Area of erosion:
6' deep x 2' long x 2' wide

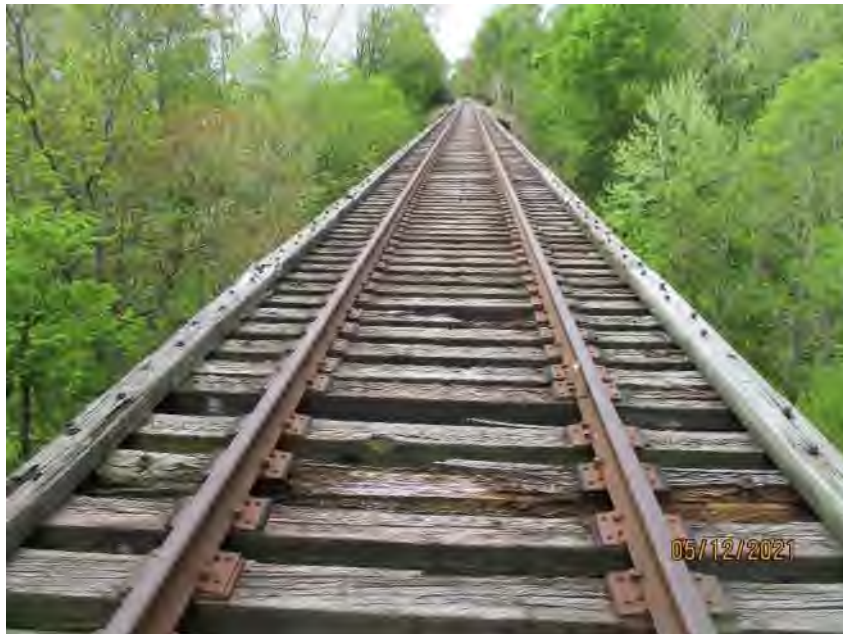
Photo #10

Condition of timber railroad ties
from Abutment B end

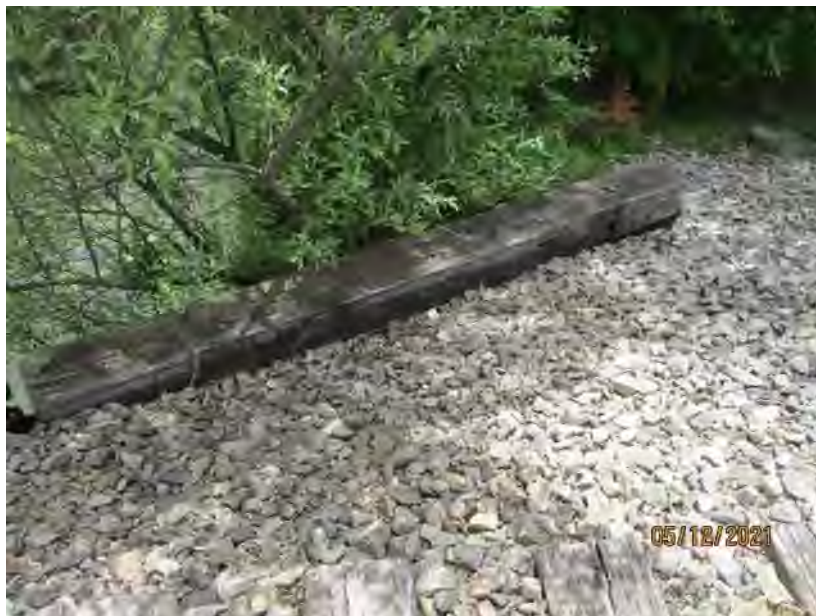
Photo #2

Wingwalls are in fair condition. Minor area of erosion behind southwest upstream wingwall, 4' long x 2' wide x up to 6" deep. Area of erosion at southeast downstream wingwall, 4' long x 1' wide x up to 3" deep. See Photos #1-#2.

Southeast downstream wingwall

- Remove railroad ties.
- Repair erosion behind wingwalls.
- Install a pedestrian railing that meets current safety standards along culvert opening.

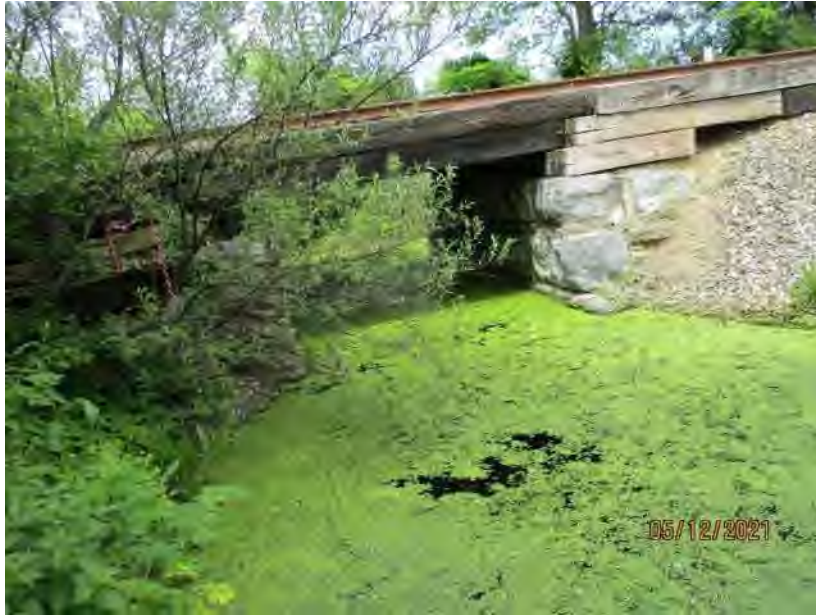
Photo #3

Timber members are in good condition. See Photos #3.

Looking at downstream elevation.

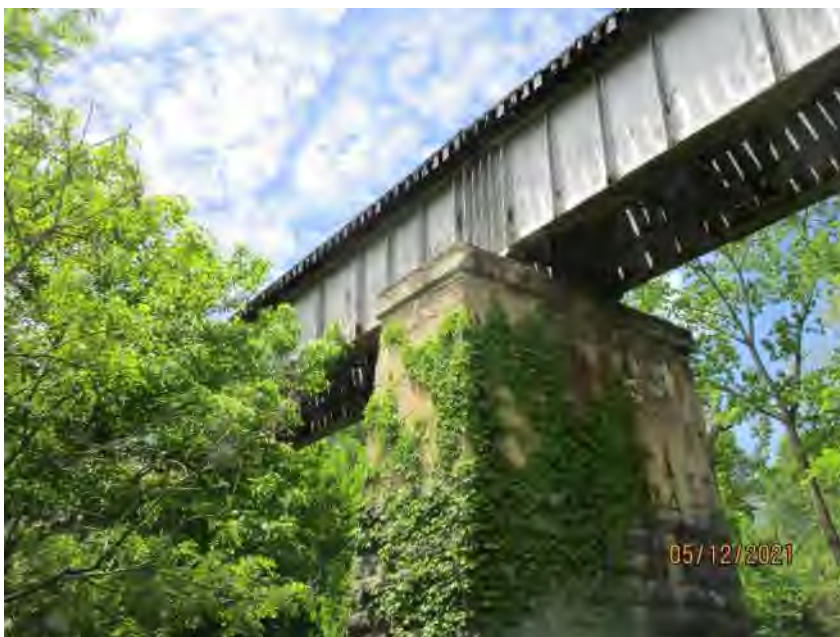
Photo #4

Piers are in fair condition. Both piers have minor to moderate vegetation growth. Pier 1 top of cap has surface spalling all the way around. Pier 2 exhibits corner surface spalling on Span 3 side of cap. See Photos #3-#4.

Pier 2, Span 3 side, downstream end.

On top of cap surface concrete spall on downstream corner edge.

- Remove railroad ties and install new timber deck planks.
- Repair/seal cracks in abutments and piers and regrout stone portions of abutment.
- Repair spalls in abutments and piers.
- Install a suitable transition from the gravel railroad bed at both ends of the structure, including grade transitions and installation of a safety guardrail at the transition to the structure.
- Install a pedestrian railing that meets current safety standards.
- Prepare and paint superstructure.

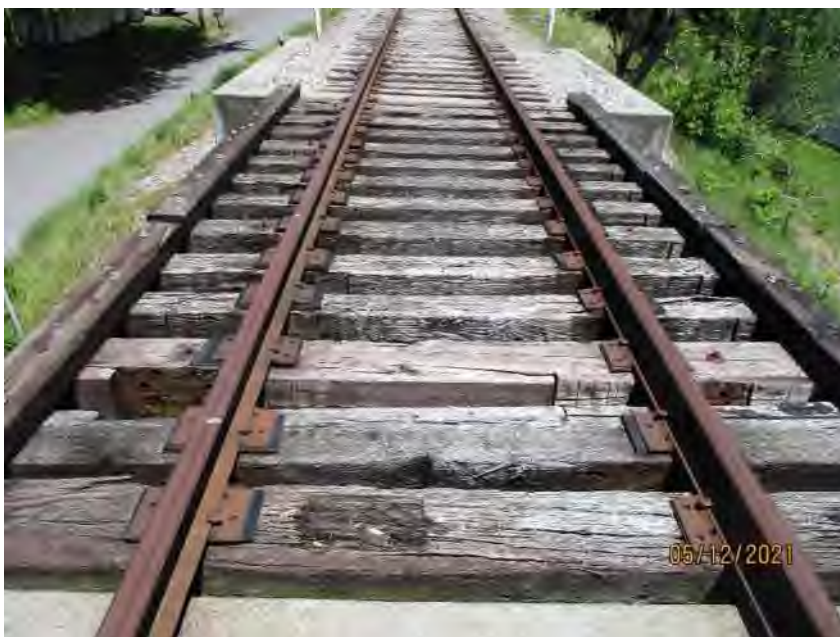
Photo #2

The conditions of the timber railroad ties vary from highly deteriorated (with some missing portions) to mildly deteriorated. See Photos #1-#2.

Timber railroad ties exhibit minor to severe section loss.

Timber railroad tie shown is heavily deteriorated.

- Remove deteriorated railroad ties and install new timber deck planks.
- Repair/seal cracks in abutments and regrout stone portions of abutment.
- Install a suitable transition from the gravel railroad bed at both ends of the structure, including grade transitions and installation of a safety guardrail at the transition to the structure.
- Install a pedestrian railing that meets current safety standards.
- Prepare and paint the superstructure.

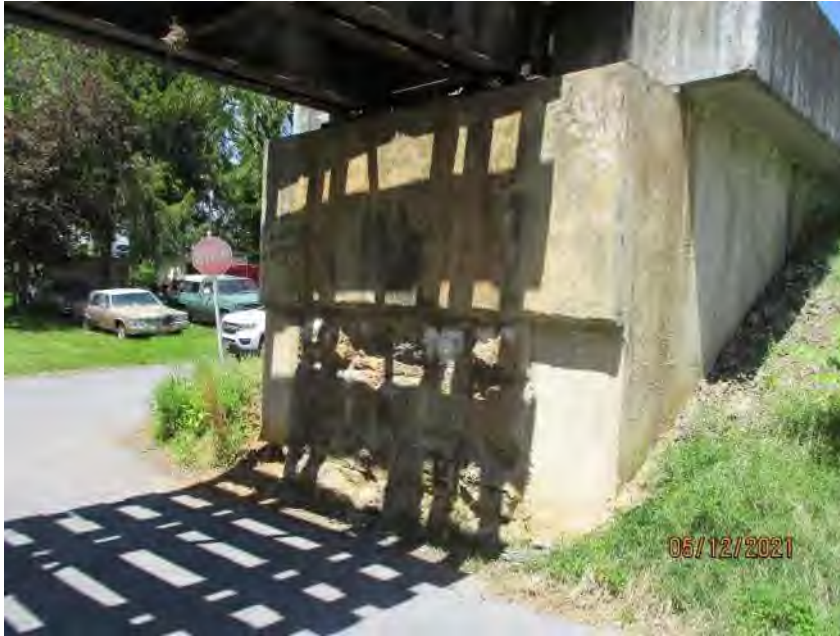
Photo #5

Abutment B has cracking throughout with efflorescence. See Photo #5-#6.

Abutment B.

Minor cracking throughout face with efflorescence.

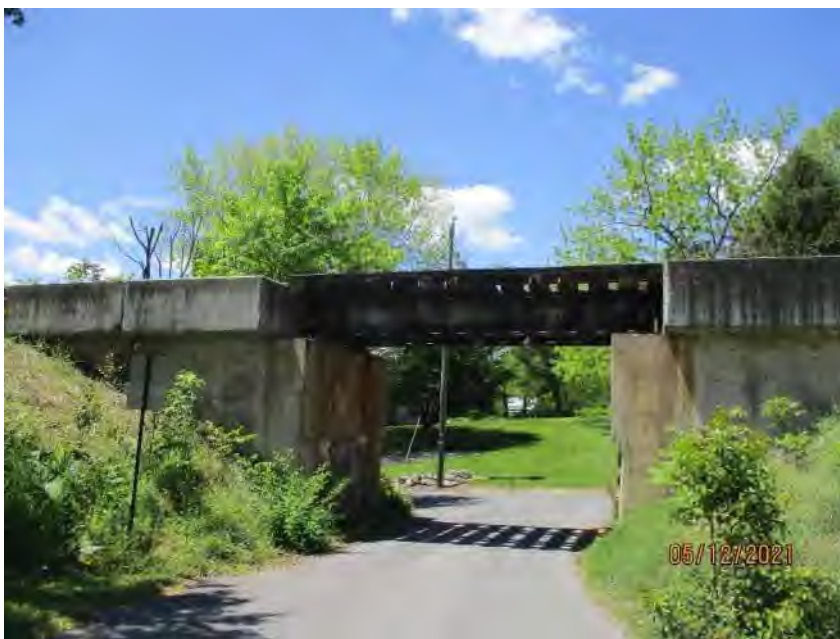
Photo #6

Abutment A has vertical cracking throughout with efflorescence. See Photos #4 & #6.

Span looking toward Clifford Street.

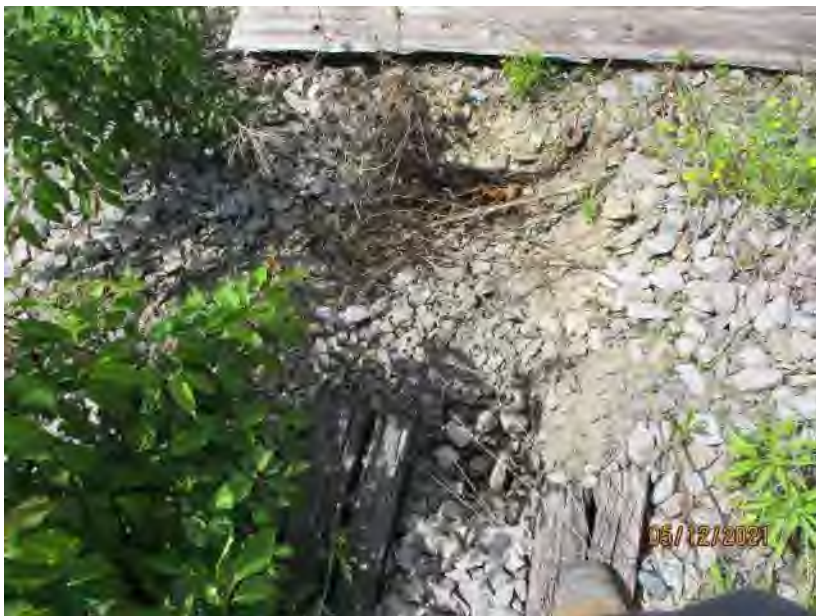
Photo #2

At upstream headwall.

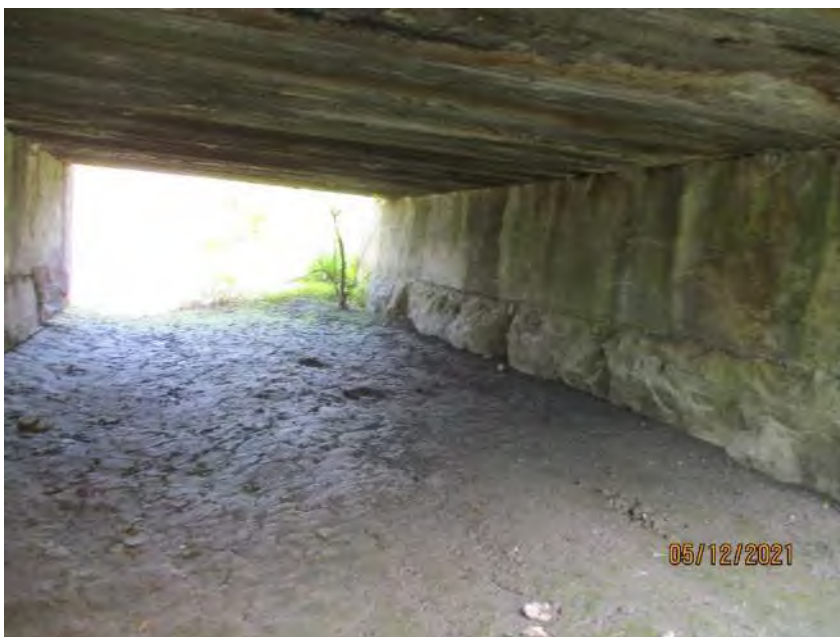
Photo #4

Looking into barrel from the upstream side.

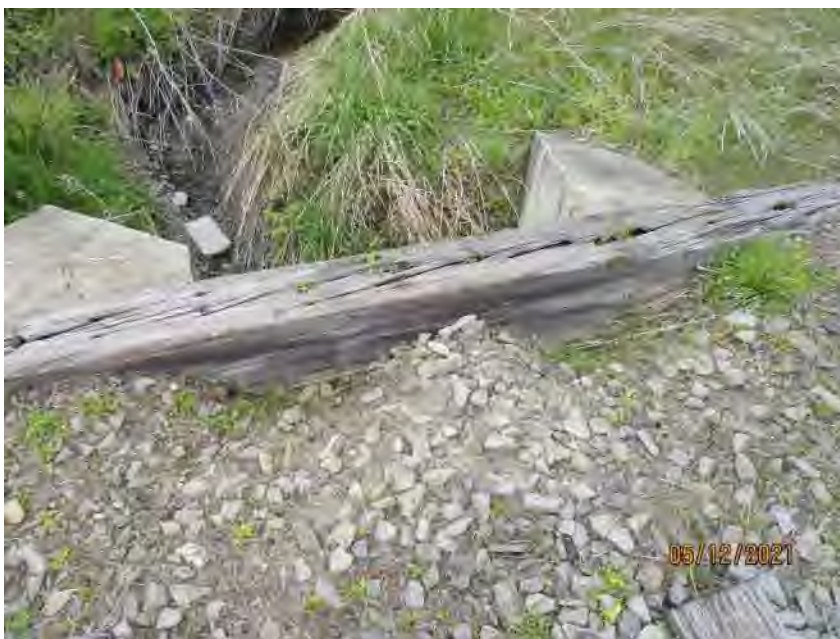
Photo #2

At upstream headwall.

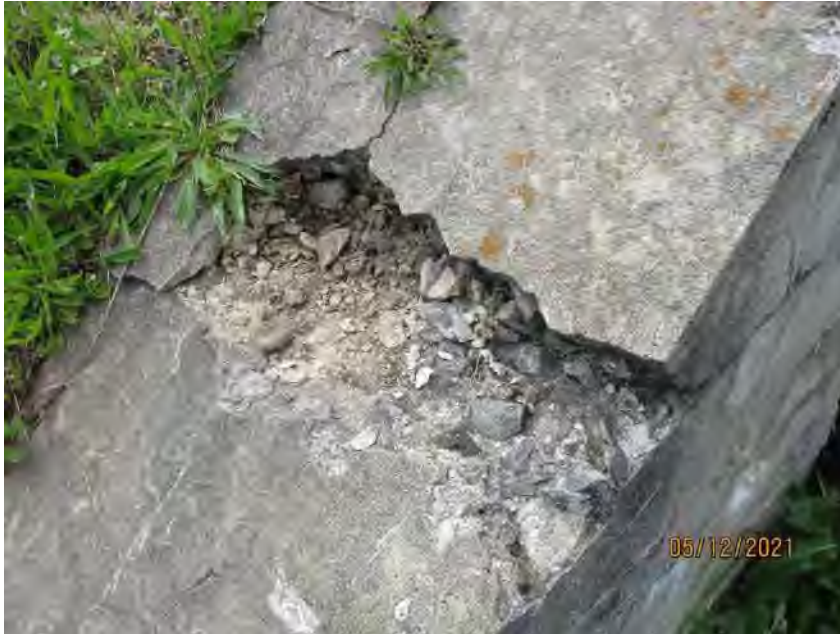
Photo #3

Downstream south wingwall

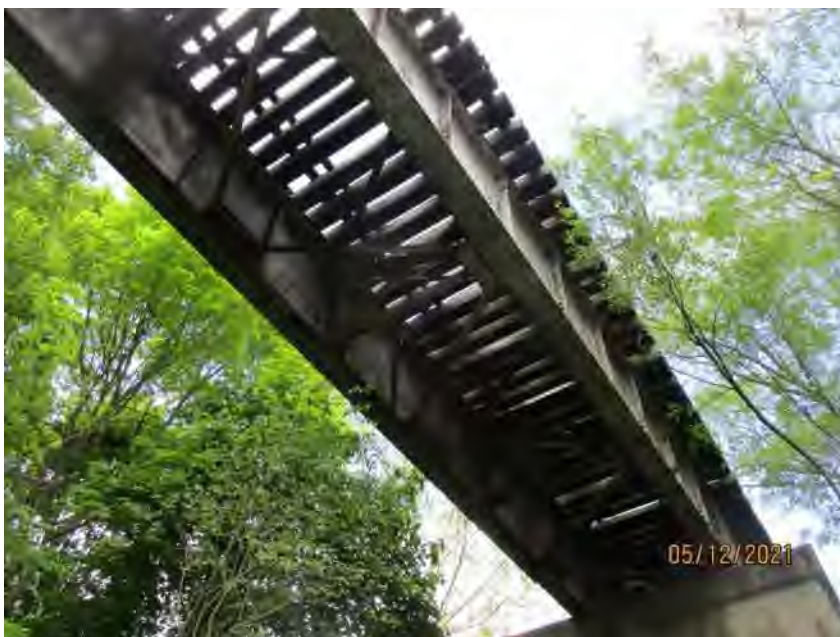
Photo #2

In general, the steel superstructure elements are in fair condition. Surface rust exists on all steel members. The superstructure exhibits flaking and peeling paint. At time of inspection no measurable section loss was observed to members. See Photos #2 & #4.

Span 2, typical underside of structure.

Surface rust on girders and superstructure elements with failed coating.

- Remove railroad ties and install new timber deck planks.
- Repair/seal cracks in abutments and piers and regrout stone portions of abutment.
- Repair spalls in abutments.
- Install a suitable transition from the gravel railroad bed at both ends of the structure, including grade transitions and installation of a safety guardrail at the transition to the structure.
- Install a pedestrian railing that meets current safety standards.
- Prepare and paint superstructure.

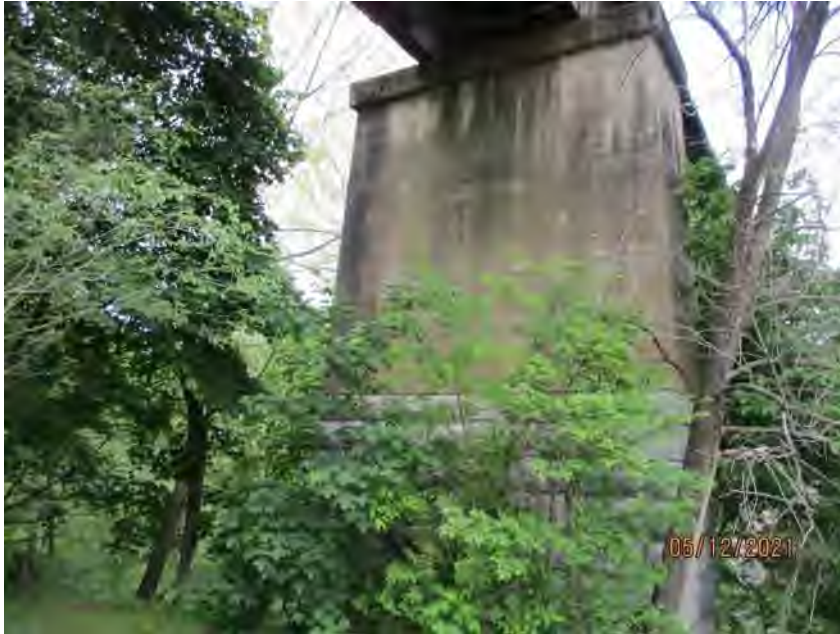
Photo #3

Piers are in fair condition. Both concrete piers have minor to moderate vegetation growth. Concrete piers exhibit minor cracking, some with effloresce. Metal piers have peeling paint with minor surface rust. Vegetation growth is encroaching on piers. See Photos #3-#5.

Pier 2, Span 2 side.

Moderate vegetation growth.

Concrete piers exhibit minor cracking some with effloresce.

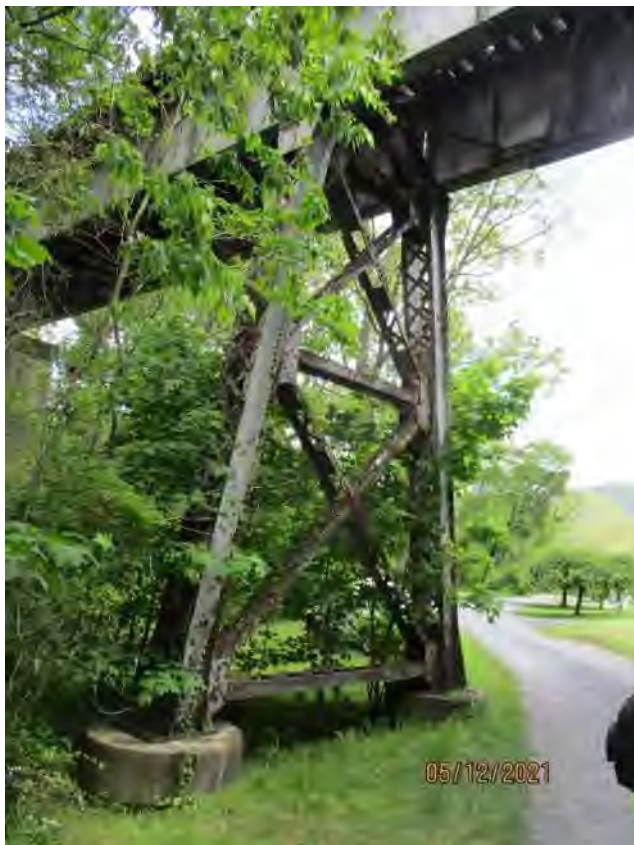
Photo #4

Pier 1, Span 1 side.

Surface rust on pier with failed coating.

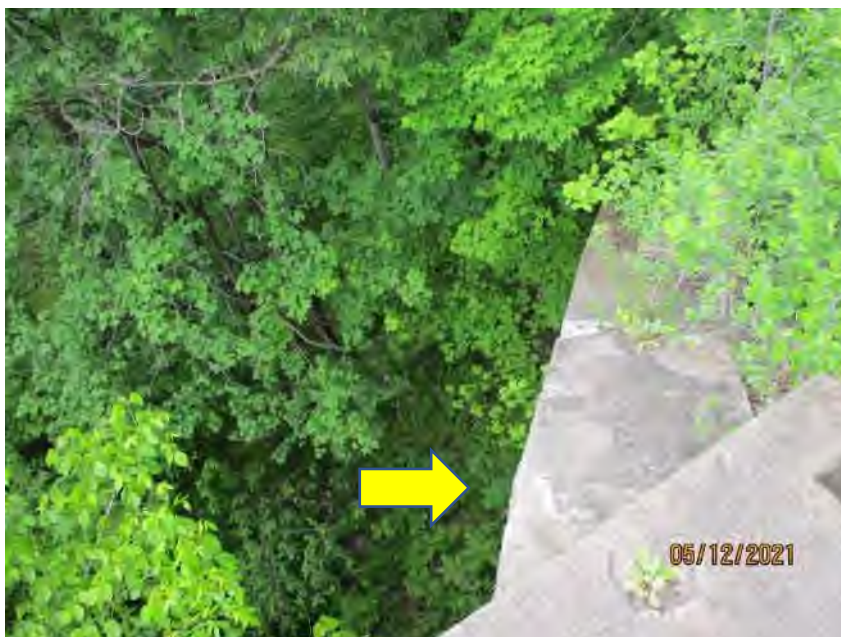
Photo #6

Abutment B is in fair condition with minor cracking with efflorescence. Minor spall on upstream wingwall 1' long x 1' wide x 3" deep. On top of deck heavy vegetations growth. See Photos #6-#7.

Abutment B, upstream wing wall.

Area of concrete spall:
1' long x 1' wide x 3" deep.

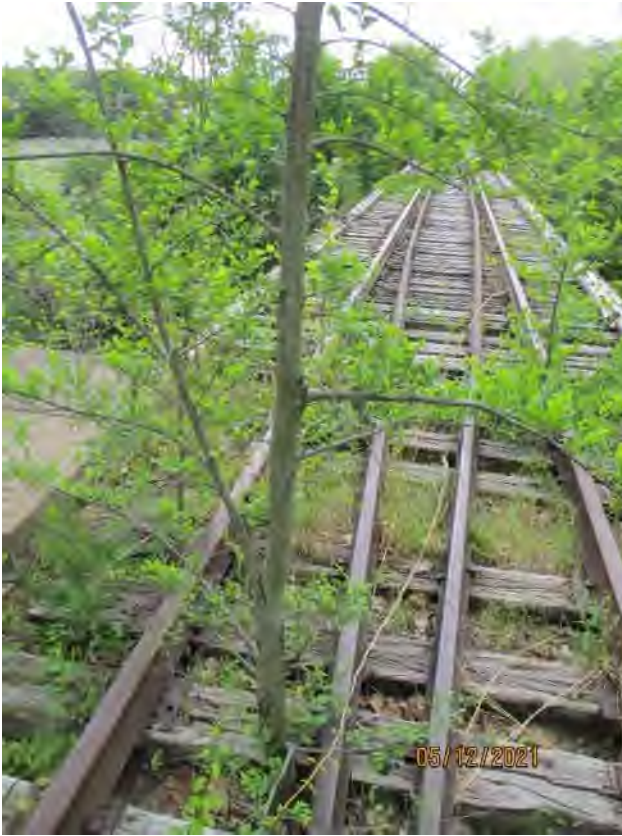
Photo #7

Top of deck looking from Abutment B.

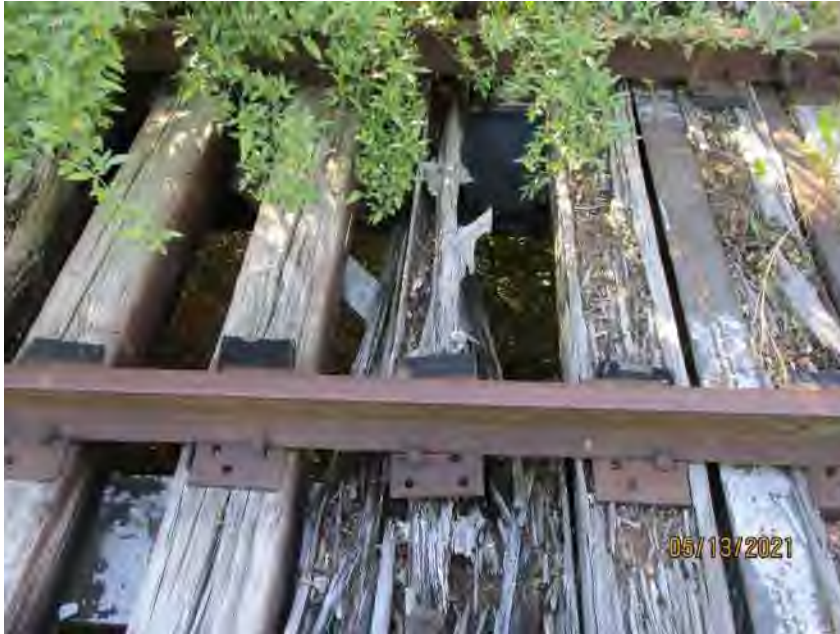
Photo #1

The conditions of the timber railroad ties vary from highly deteriorated to mildly deteriorated. See Photos #1 and the Title Page Photo.

Timber railroad ties shown are heavily deteriorated.

- Remove railroad ties and install new timber deck planks.
- Perform detailed site assessment and repair/seal any cracks found in abutments and piers and re-grout stone portions of abutments and pier as needed.
- Install a suitable transition from the gravel railroad bed at both ends of the structure, including grade transitions and installation of a safety guardrail at the transition to the structure.
- Install a pedestrian railing that meets current safety standards.
- Preparation and painting of the entire superstructure and steel substructure is recommended.
- Repair erosion areas and encroaching vegetation at abutments.

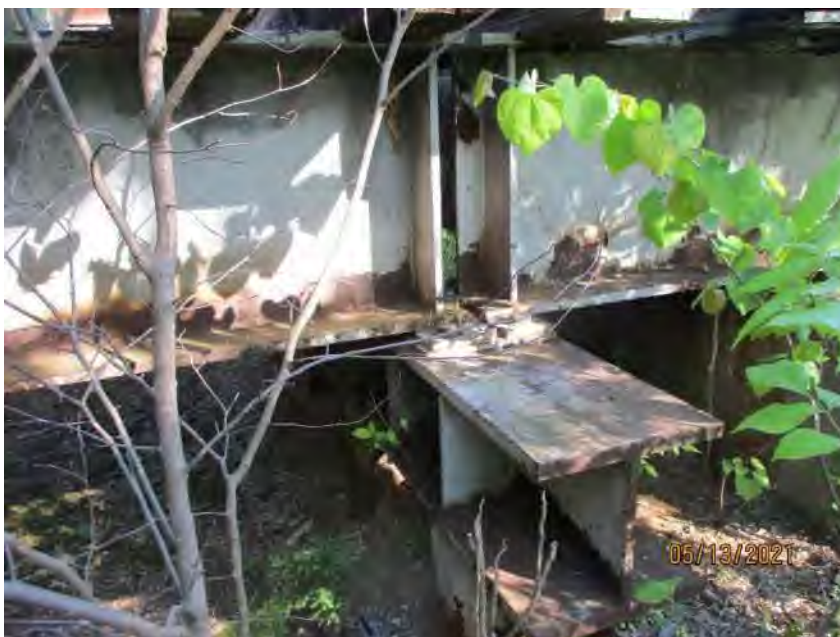
Photo #2

Pier 1 is in good condition with surface rust throughout. See Photo #2.

Pier 1 downstream side

Typical girder configuration for Spans 1&2 with failed protective coating and minor surface rust throughout.

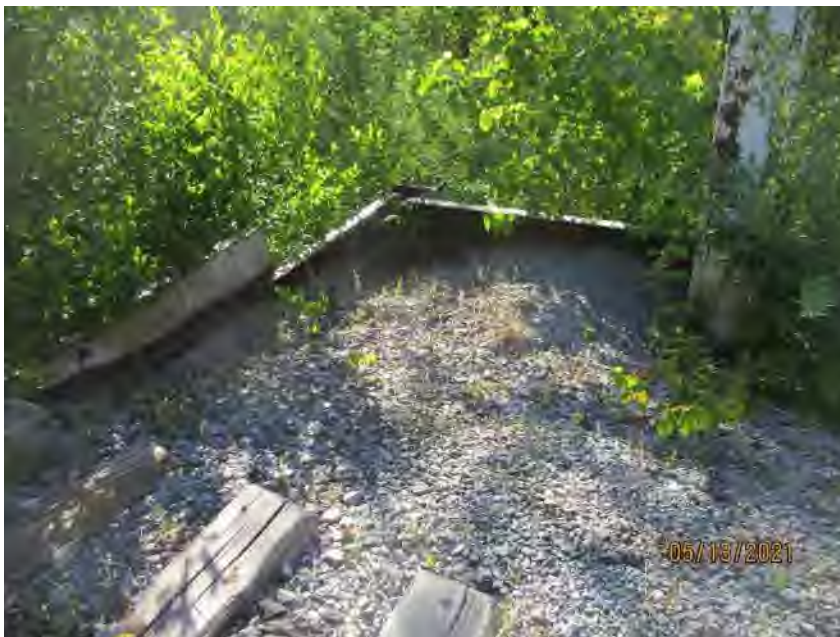
Photo #4

Abutment A

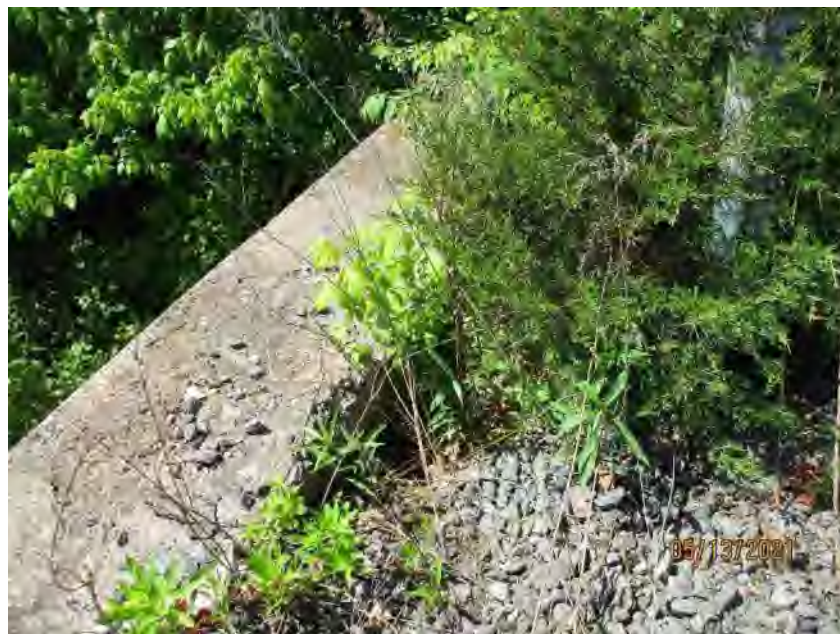
Photo #4

Abutment A has an area of erosion along downstream side of abutment. Erosion measures 6' long x 3' wide x 1.5' deep. See Photos #4-#5. Spalling on the upstream wingwall measured 7' long x 15" wide x 2.5" deep. Spalling on the corner measured 5' long x 6" wide x 2" deep. See Photos #5-#6.

Abutment A downstream side.

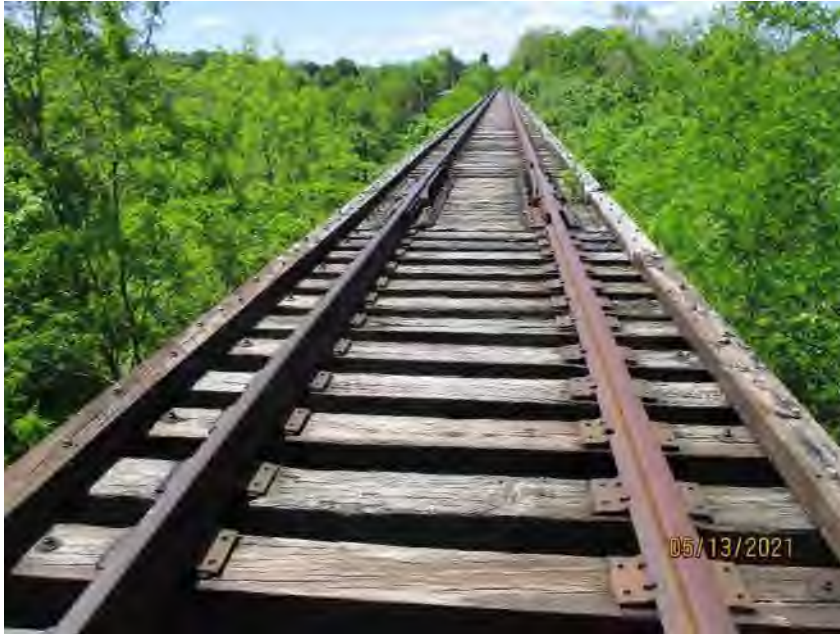
Photo #1

The condition of the timber railroad ties visible from each abutment are mildly deteriorated. See Photo #1.

Looking south at Abutment A.

Timber railroad ties shown are mildly deteriorated.

- Remove railroad ties.
- Install a suitable transition from the gravel railroad bed at both ends of the structure, including grade transitions and installation of a safety guardrail at the transition to the structure.
- Install a pedestrian railing that meets current safety standards.
- Preparation and paint superstructure.
- Repair erosion areas at both abutments.

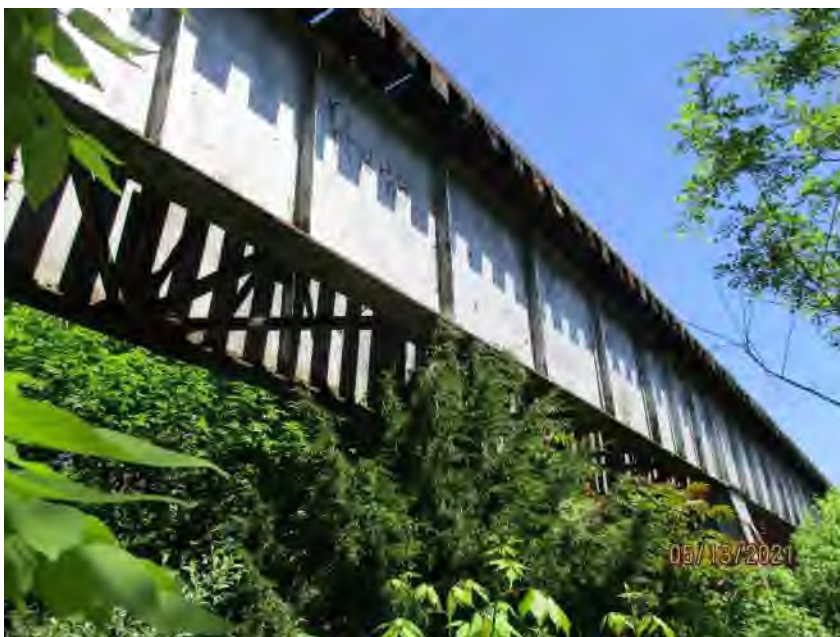
Photo #2

In general, the steel superstructure elements are in good condition. Surface rust exists on all steel members. The superstructure exhibits minor to moderate paint failure. At time of inspection no measurable section loss was observed to members. See Photos #2-#3.

Underside of the girders from the downstream side.

Typical girder configuration with failed protective coating and minor surface rust throughout.

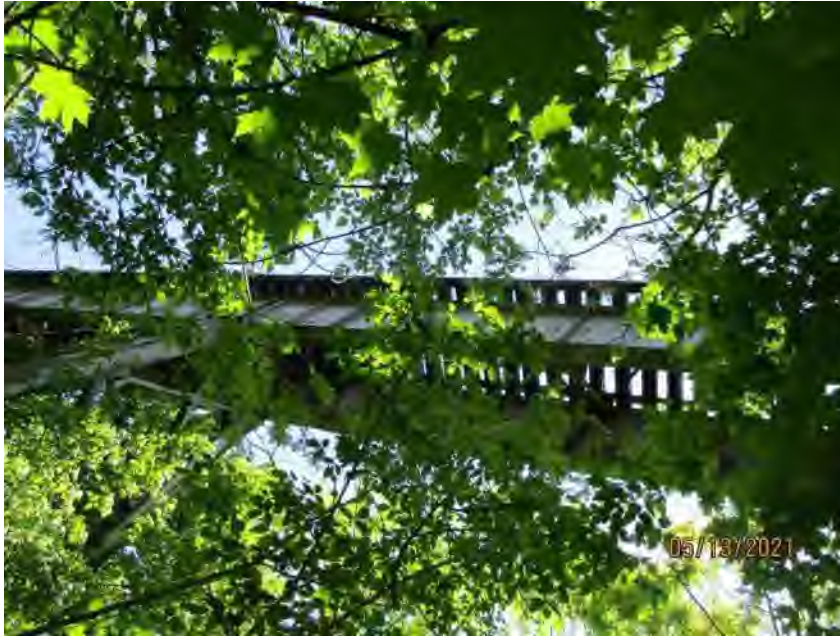
Photo #3

Underside of the girders from the upstream side.

Typical girder configuration with failed protective coating and minor surface rust throughout.

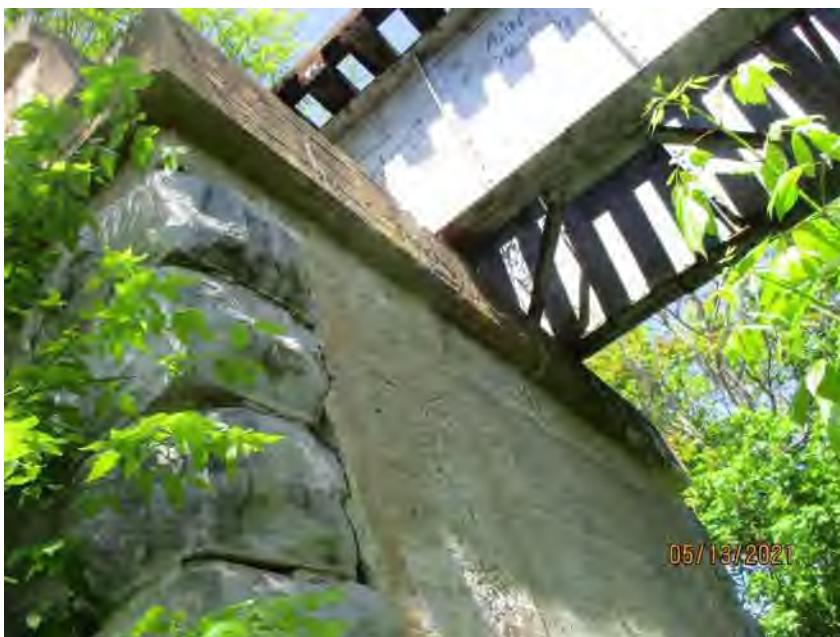
Photo #4

Abutment A is in good condition with minor loss of mortar between stones. Abutment A has light erosion on the downstream side and heavy erosion and missing timber beam on the upstream side. See Photos #4-#6.

Abutment A

Abutment is in good condition with few areas of missing mortar.

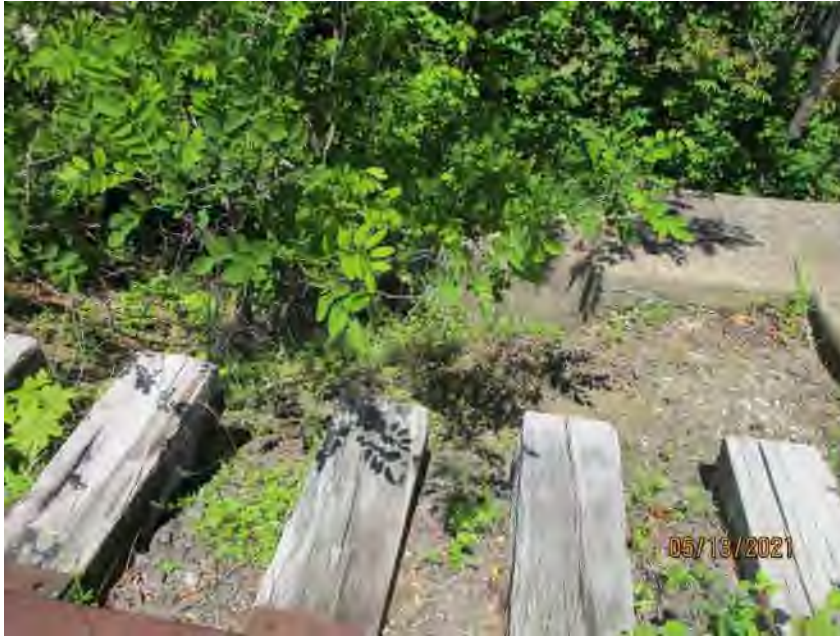
Photo #5

Abutment A

Upstream side erosion with missing timber beam.

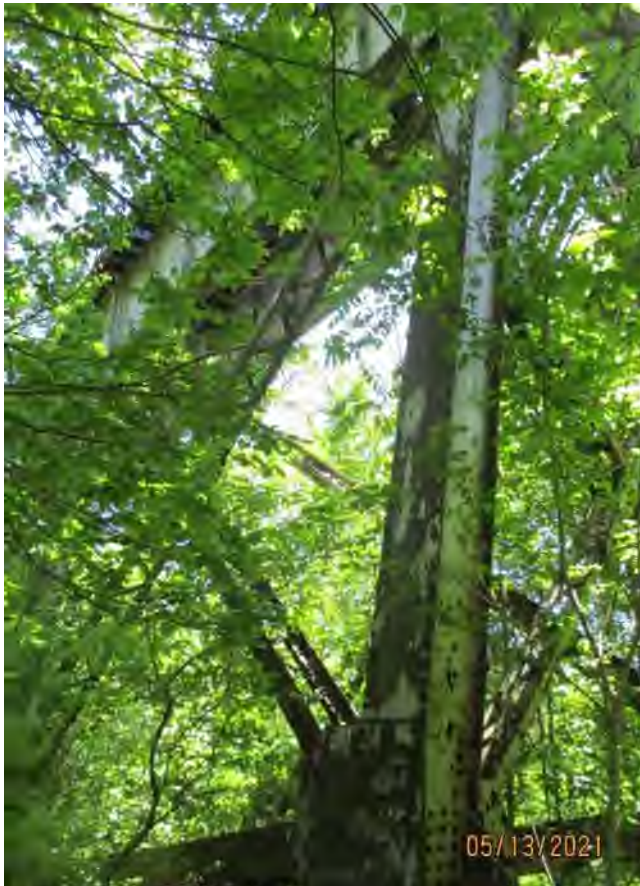
Photo #7

Pier 1 supports Spans 1-3. Structure is in fair condition with surface rust throughout and scaling at the footings. See Photos #7-#8.

Pier 1

Typical steel pier with failed protective coating and minor surface rust throughout.

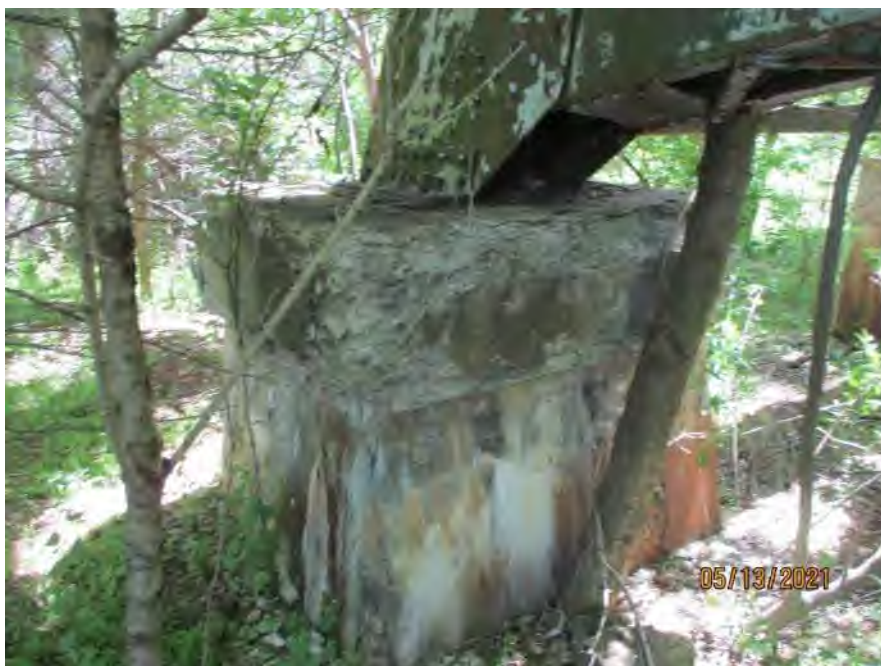
Photo #8

Pier 1

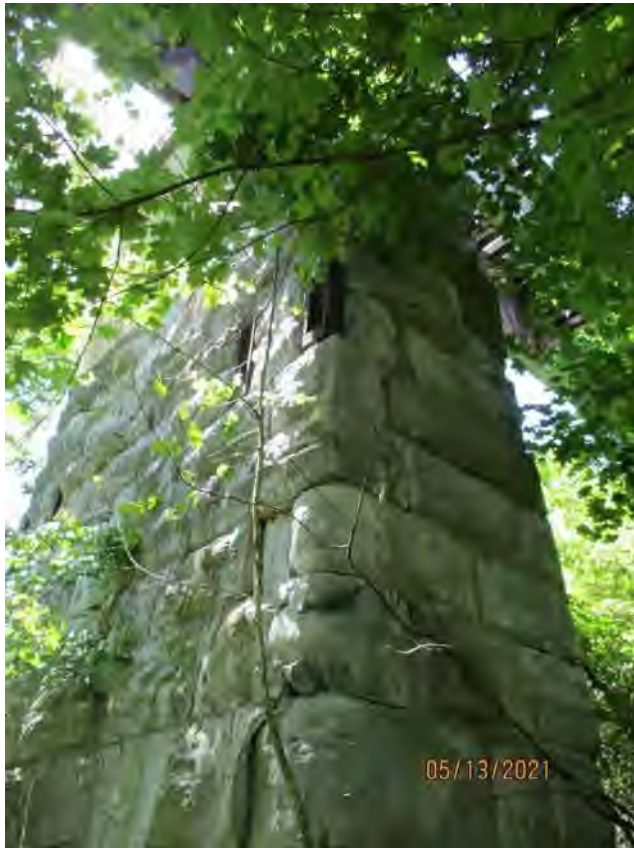
Photo #9

Pier 2 supports Spans 3 and 4. Structure is in good condition with a few areas of missing mortar. See Photo #9.

Pier 2

Stone wall with concrete cap.

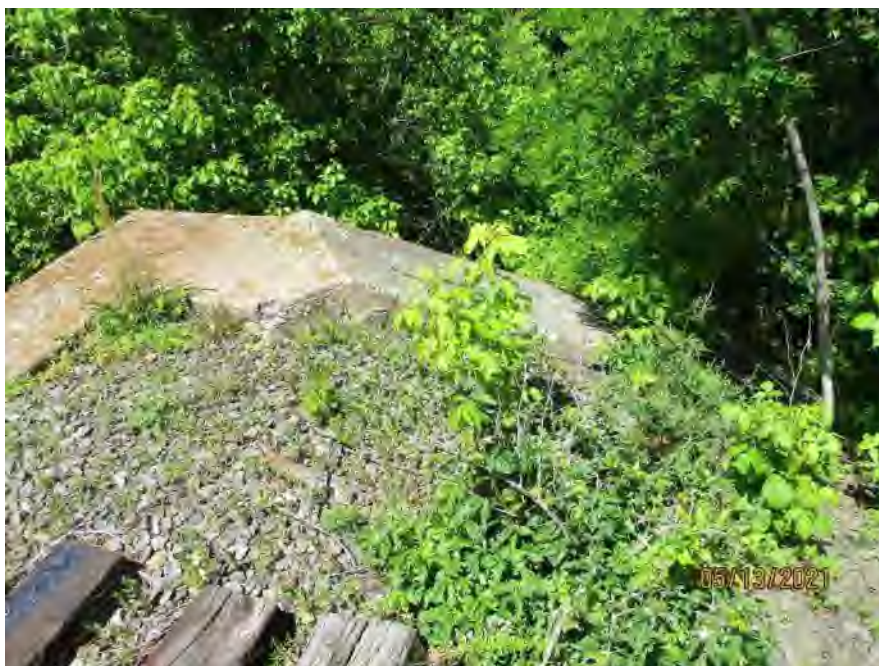
Photo #10

Abutment B has light erosion and missing timber beam on both sides. See Photo #10.

Abutment B

Upstream side erosion with missing timber beam.

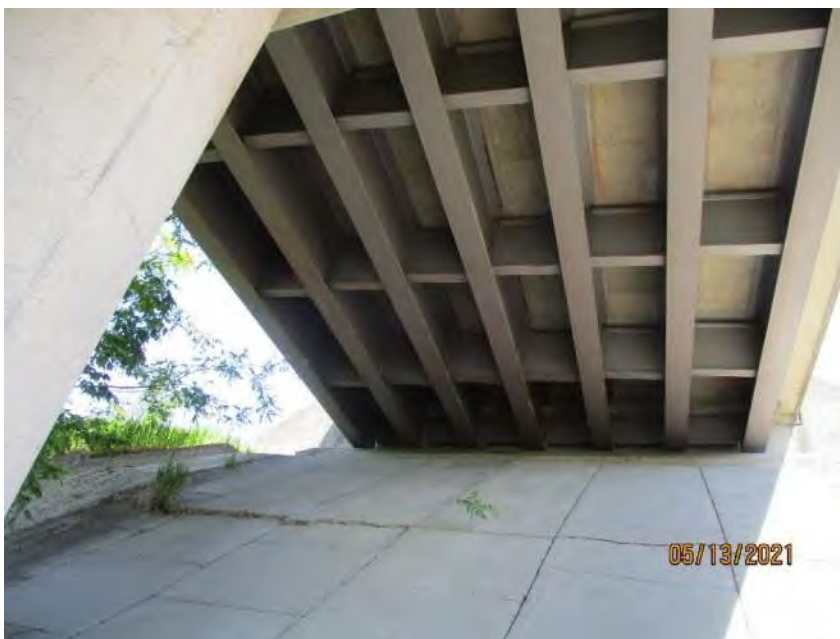
Photo #2

The steel superstructure elements are in good condition with slight paint loss. At time of inspection no measurable section loss was observed to members. See Photos #2-#3.

Span 3

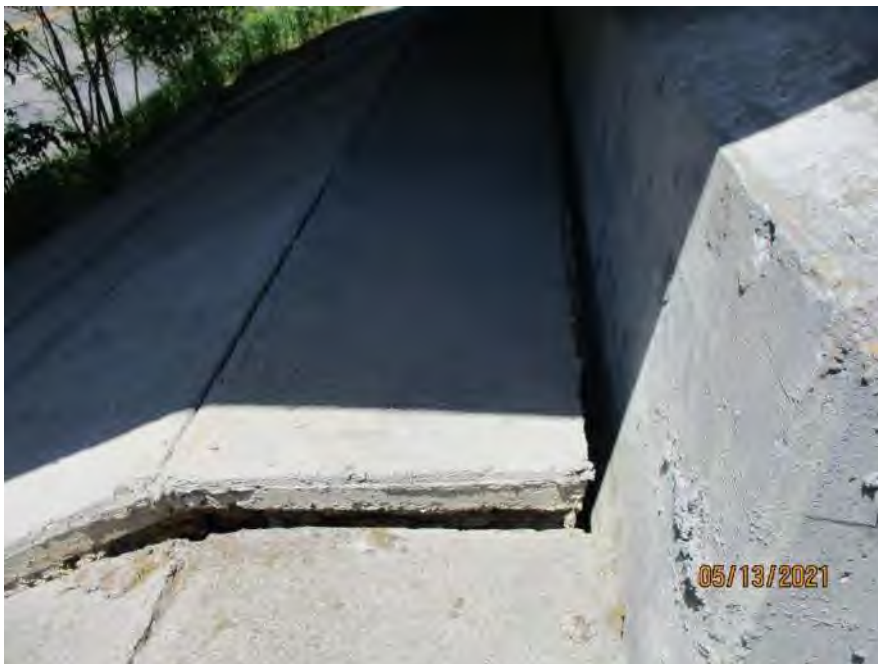
Photo #6

Abutment B is in good condition with the slope protection separated from bearing by 1.5" and settled 2.5". See Photo #6.

Abutment B

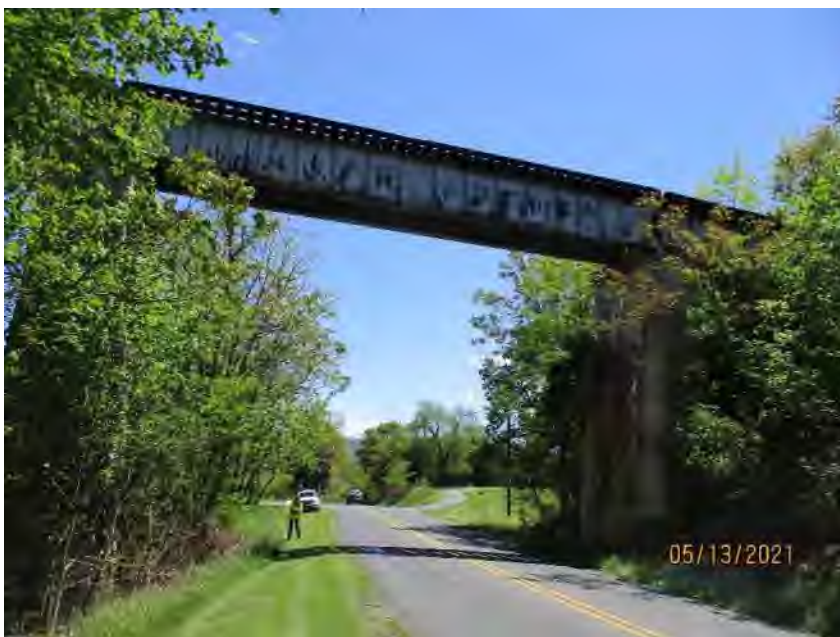
Photo #2

In general, the steel superstructure elements are in good condition. Surface rust exists on all steel members. The superstructure exhibits trace evidence of paint with no protective value remaining. At time of inspection no measurable section loss was observed to members. See Photos #2-#3.

Span 2

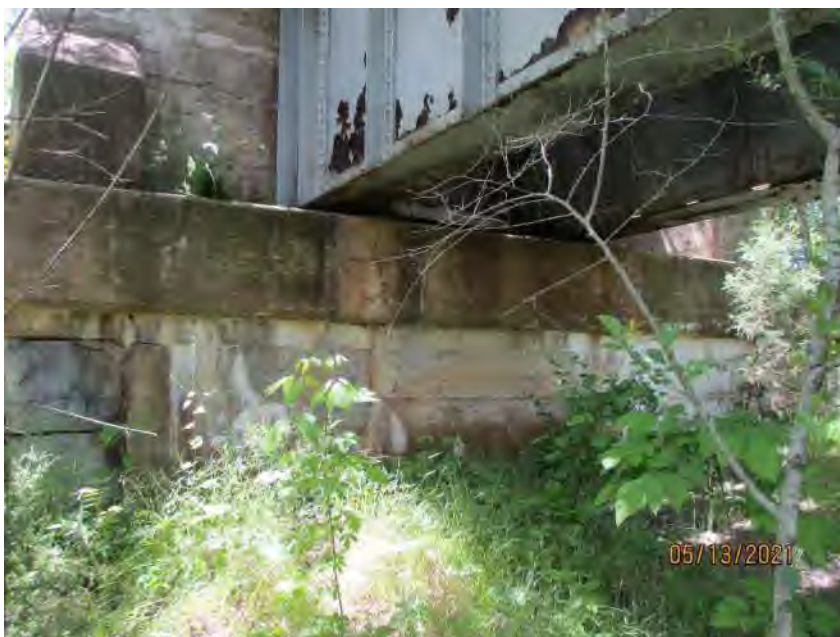
Photo #4

Abutment A is in good condition with vertical cracking throughout and stone masonry missing mortar. See Photo #4.

Abutment A

Abutments are in good condition with few areas of missing mortar and vertical cracking.
